FEMA Levee Certification
Ventura County, California

Ventura River Levee (VR-1)
Pacific Ocean to Canada de San Joaquin

Evaluation Report
February 20, 2009

Evaluation Report

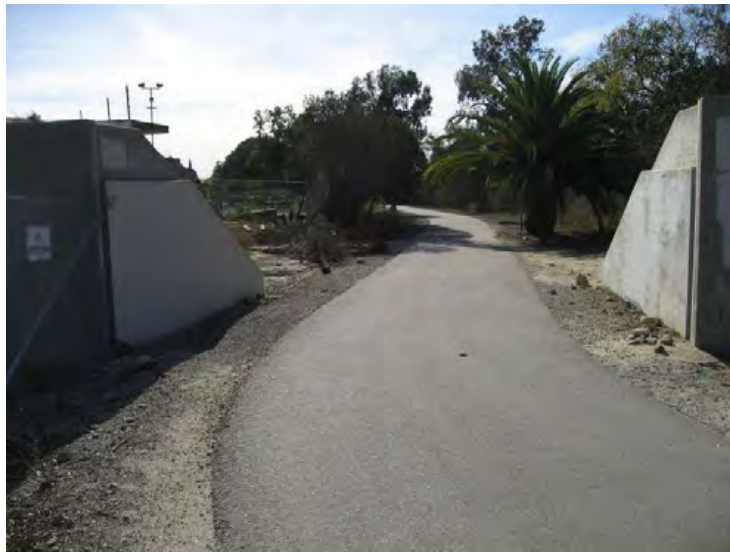
2. Multiple cracks were observed on the downstream stop log concrete structure.
3. Restoration of levee top is required in certain locations due to runoff erosion.

Ventura River Levee, From Ocean to Canada de San Joaquin. (Photo No. P1) - 12 beam stop log system at bicycle path crossing (riverward side)

Documentation of this structure is required as part of the certification. Work will also include an assessment of the impacts of the cracks in the structure observed during the field investigation and any corrective actions that may be required.

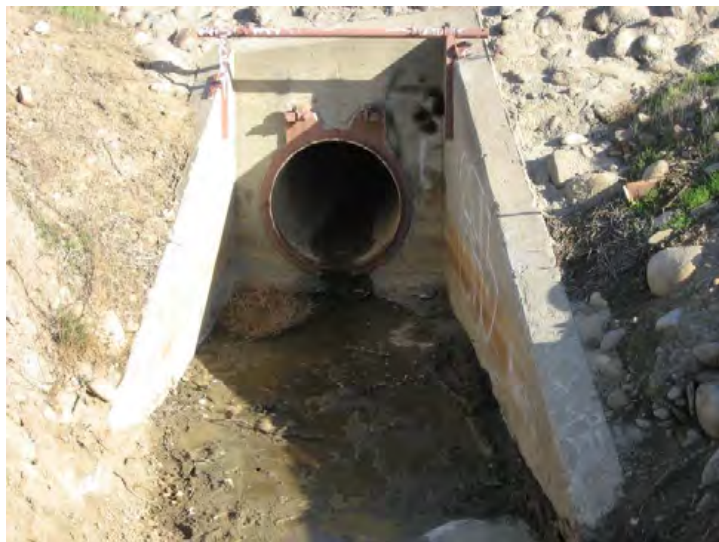
5. Stanley Drain outlet is missing its closure device (flap gate). County personnel stated that it was being repaired. Closure devices are necessary to avoid flooding behind the levee caused by the backup of the channel flow.

Ventura River Levee, From Ocean to Canada de San Joaquin. (Photo No. P6) - 48" RCP with missing flap gate being repaired on 12/10/08, Stanley Drain (riverward side)

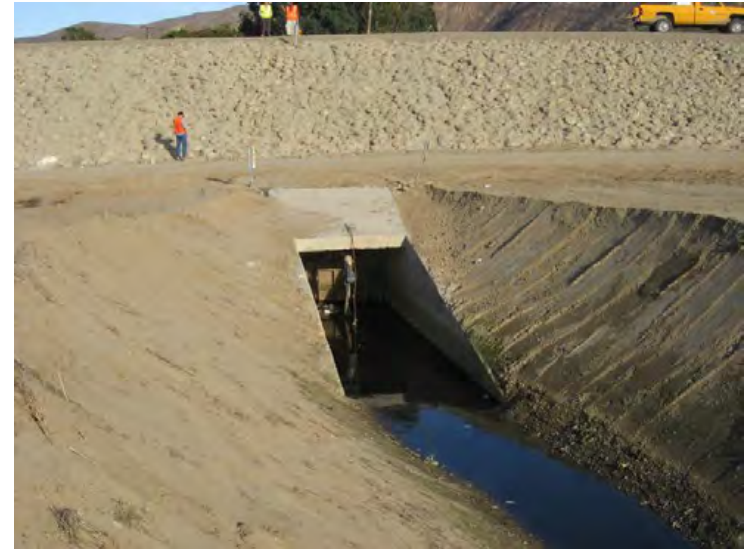
6. The Romona Drain concrete outlet structure is spalling and has exposed rebar. The concrete outlet structure should be repaired.

Ventura River Levee, From Ocean to Canada de San Joaquin. (Photo No. P11) - 72" RCP with flap Gate, Ramona Drain (riverward side)

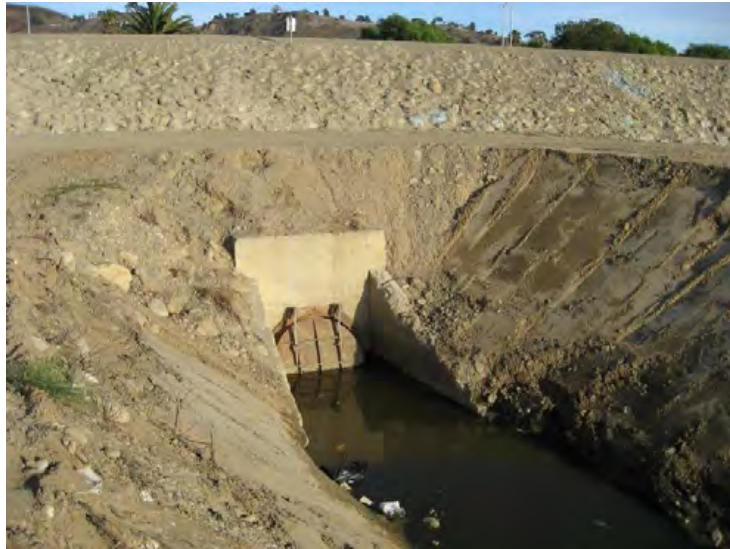
7. The Simpson Drain concrete outlet structure is spalling and has exposed rebar. The concrete outlet structure should be repaired. Also the flap gate is stuck open due to sediment debris. Removal of sediment that has accumulated in is required to allow drainage and proper operation of the flapgate.
8. Broken up concrete and debris have been dumped over the levee bank near the Main Street gate obscuring any observation of the rip-rap.
9. Multiple animal burrows were observed in the field. They are located near the toe of the slope.
10. Removal of heavy vegetation (trees, shrubs, willows) within 15 feet of levee toe is required between the (3) 48" drainage outlet from the CalTrans yard and the end of the levee.

Ventura River Levee, From Ocean to Canada de San Joaquin. (Photo No. P13) - 48" pipe with flap gate, Simpson Drain (riverward side)

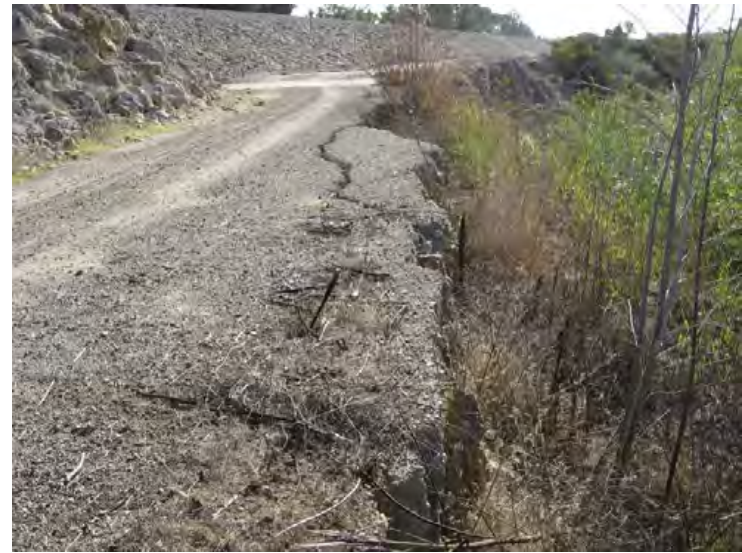
Ventura River Levee, From Ocean to Canada de San Joaquin. (Photo No. F3) – Looking d/s at low flow erosion (riverward side)

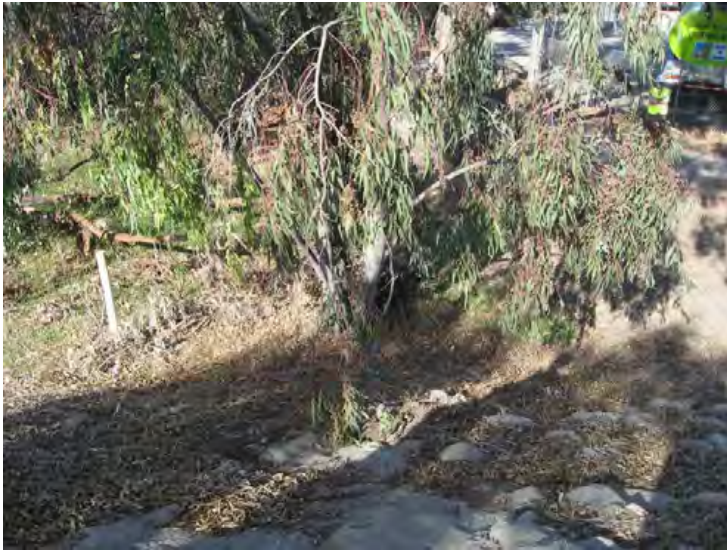
GPS		*Photo No.	Description	Action Required
Lat	Long			
<i>Ventura River Levee (VR-1)</i>				
N34.30771	W119.29797	M1	Vegetation within 15’ of levee toe (riverward side)	Remove vegetation and root ball, fill voids with impervious material and firmly compact.
N34.28953	W119.30733	M2, M3	Damaged concrete on 72” RCP Ramona Drain headwall with rebar exposed (riverward side)	Repair the concrete headwall portion of outlet structure
N34.28646	W119.30661	M4, M5	Damaged concrete on 48” Simpson Drain headwall with rebar exposed, flap gate stuck open with sediment (riverward side)	Repair concrete. Remove sediment from pipe opening and ensure complete seal around flap gate
N34.27725 to N34.27552	W119.30705 to W119.30687	M6, M7	Vegetation within 15’ of levee toe, approximately 500’ along levee (riverward side)	Remove vegetation and root ball, fill voids with impervious material and firmly compact.
N34.30764 to N34.30745	W119.29728 to W119.29767	M8	Vegetation within 15’ of levee toe, approximately 123’ along levee (landward side)	Remove vegetation and root ball, fill voids with impervious material and firmly compact.

Ventura River Levee, From Ocean to Canada de San Joaquin. (Photo No. M1) - Vegetation within 15' of levee toe (riverward side)

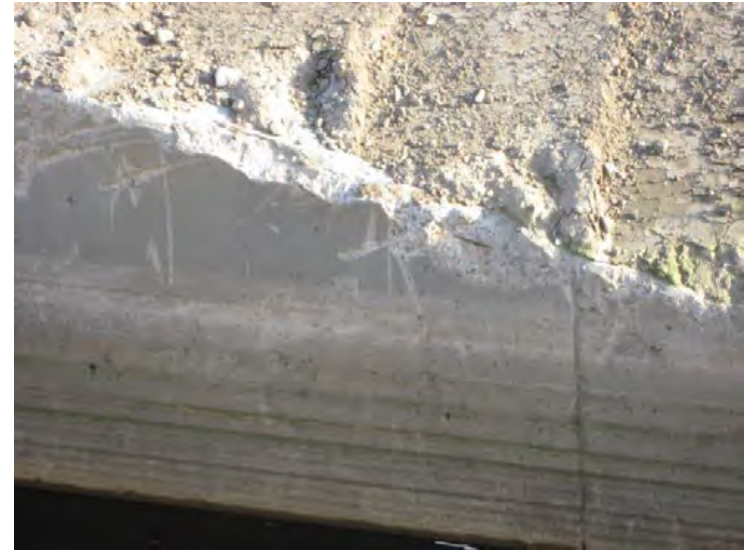
Ventura River Levee, From Ocean to Canada de San Joaquin. (Photo No. M3) - Damaged concrete on headwall with rebar exposed (riverward side)

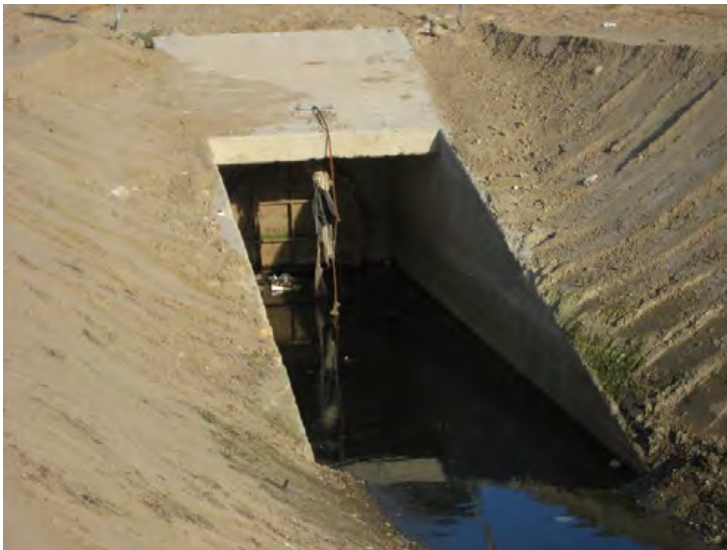
Ventura River Levee, From Ocean to Canada de San Joaquin. (Photo No. M2) - Damaged concrete on 72" RCP headwall (riverward side)

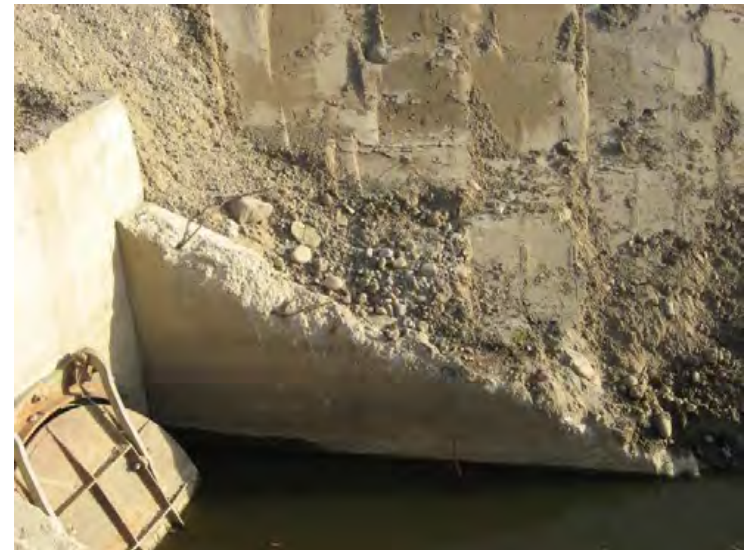
Ventura River Levee, From Ocean to Canada de San Joaquin. (Photo No. M4) - Damaged concrete on headwall with flap gate stuck open (riverward)

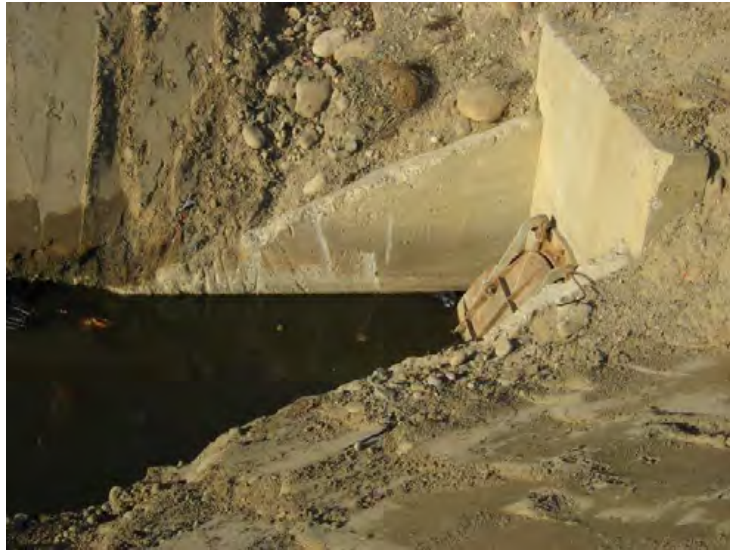
Ventura River Levee, From Ocean to Canada de San Joaquin. (Photo No. M5) - Damaged concrete on headwall with rebar exposed (riverward side)

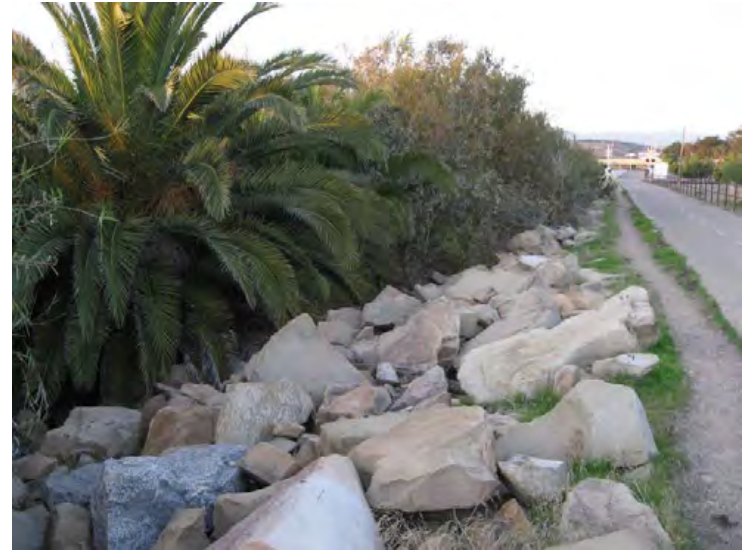
Ventura River Levee, From Ocean to Canada de San Joaquin. (Photo No. M7) - Vegetation within 15' of levee toe, looking u/s (riverward side)

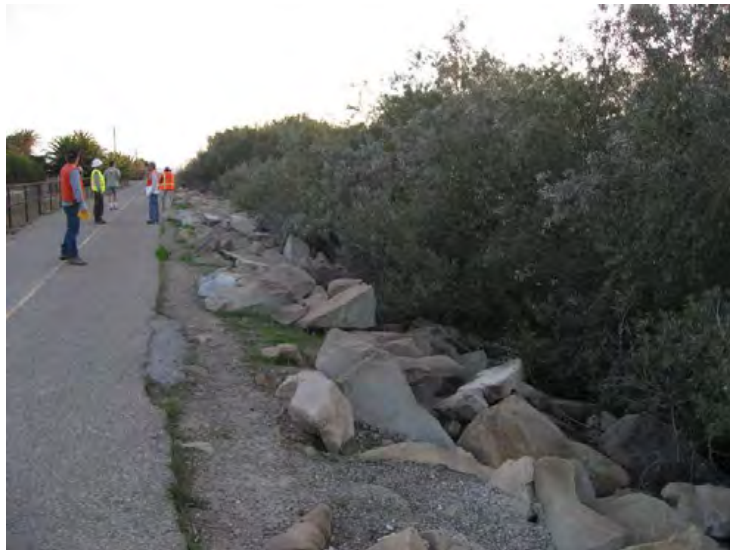
Ventura River Levee, From Ocean to Canada de San Joaquin. (Photo No. M6) - Vegetation within 15' of levee toe, looking d/s (riverward side)

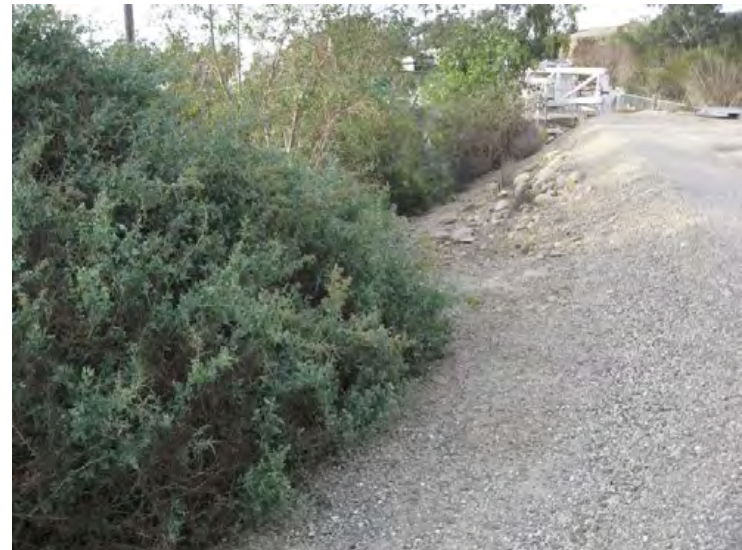
Ventura River Levee, From Ocean to Canada de San Joaquin. (Photo No. M8) - Vegetation within 15' of levee toe, looking d/s (landward side)

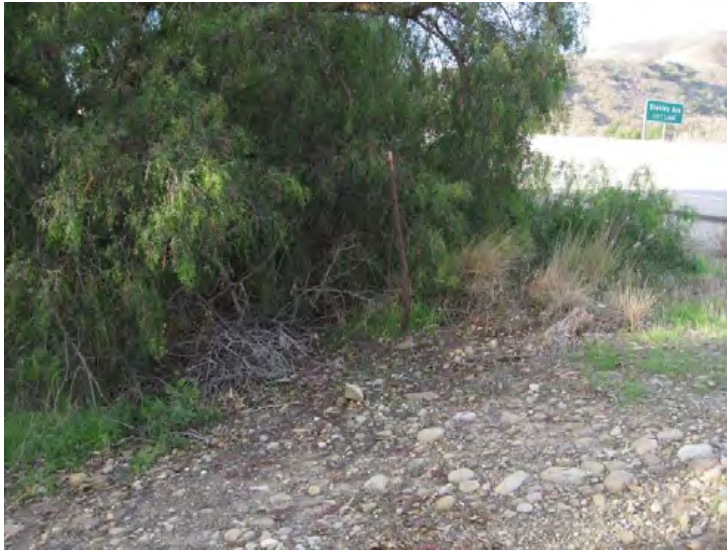
Ventura River Levee, From Ocean to Canada de San Joaquin. (Photo No. M9) - Vegetation within 15' of levee toe, looking d/s (landward side)

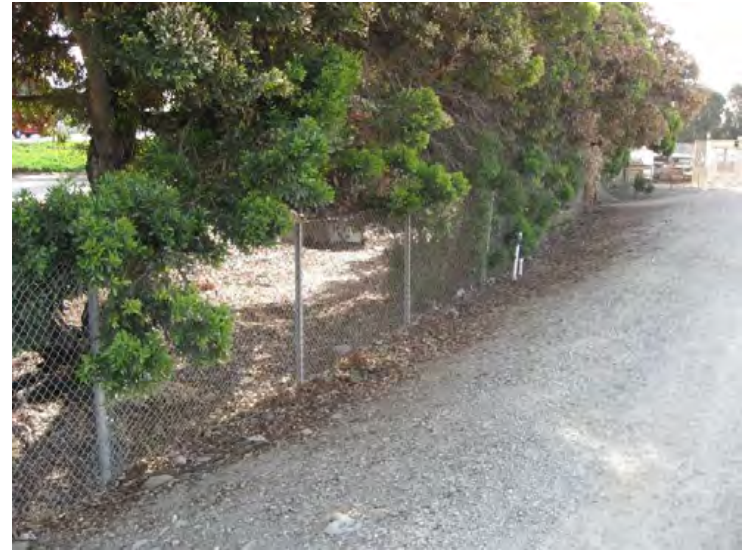
Ventura River Levee, From Ocean to Canada de San Joaquin. (Photo No. M11) - Vegetation within 15' of levee toe, looking d/s (landward side)

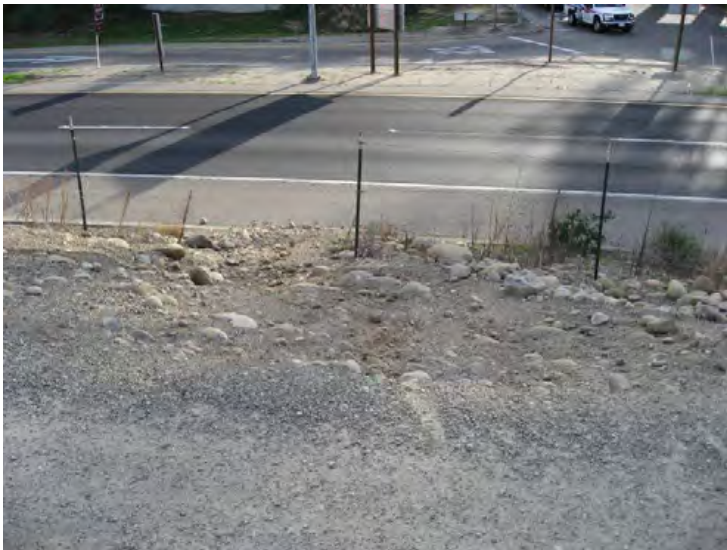
Ventura River Levee, From Ocean to Canada de San Joaquin. (Photo No. M10) - Erosion on levee top and embankment (landward side)

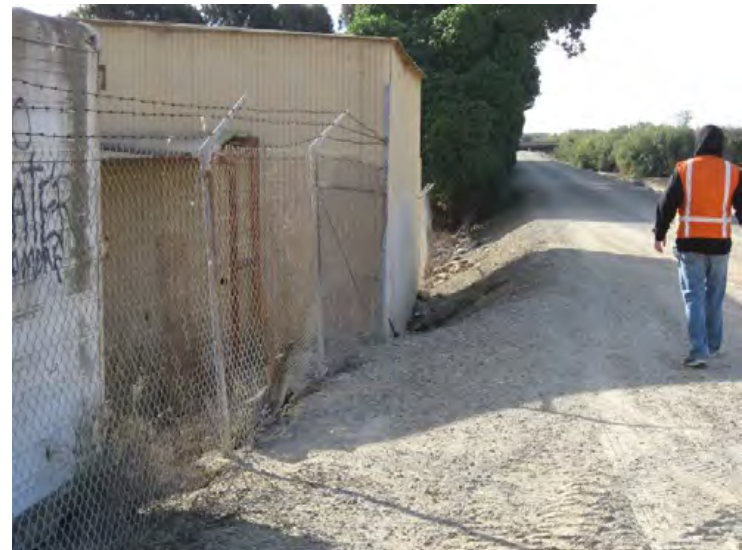
Ventura River Levee, From Ocean to Canada de San Joaquin. (Photo No. M12) - Tin storage shed and miscellaneous debris at levee toe (landward)

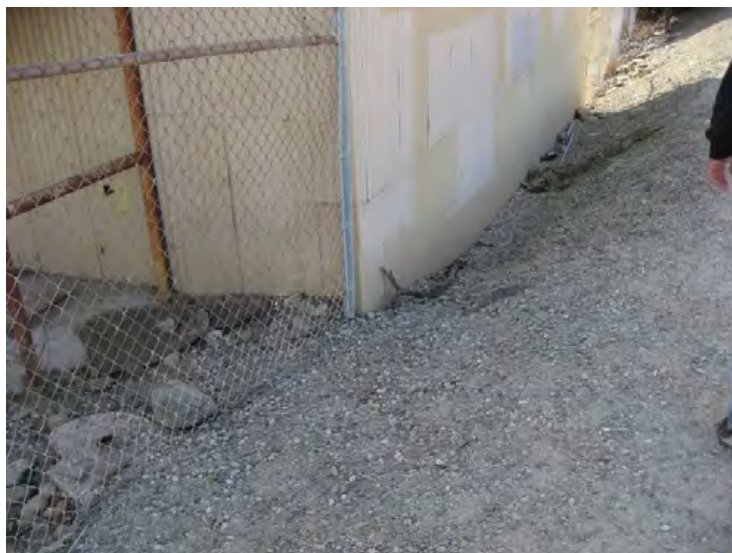
Ventura River Levee, From Ocean to Canada de San Joaquin. (Photo No. M13) - Tin storage shed at levee toe (landward side)

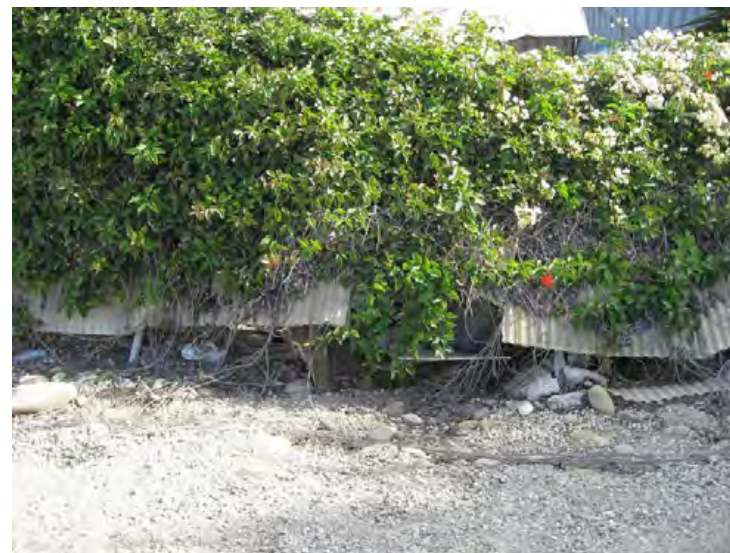
Ventura River Levee, From Ocean to Canada de San Joaquin. (Photo No. M15) - Vegetation within 15' of levee toe (landward side)

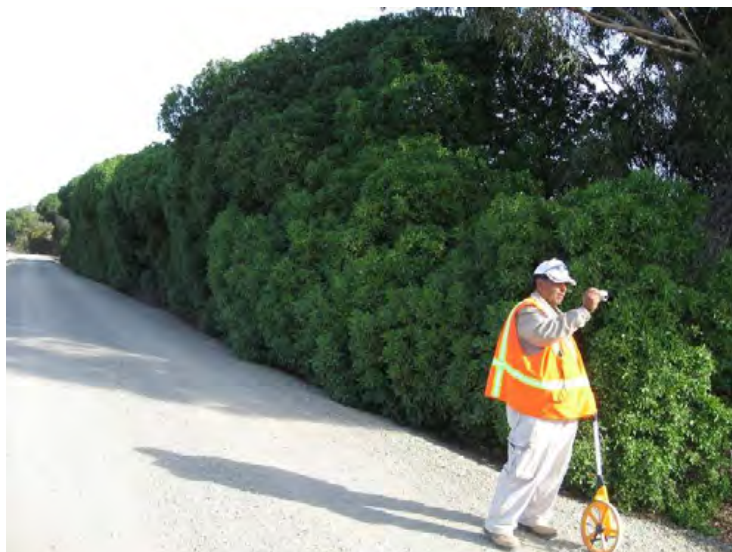
Ventura River Levee, From Ocean to Canada de San Joaquin. (Photo No. M14) - Vegetation within 15' of levee toe, looking d/s (landward side)

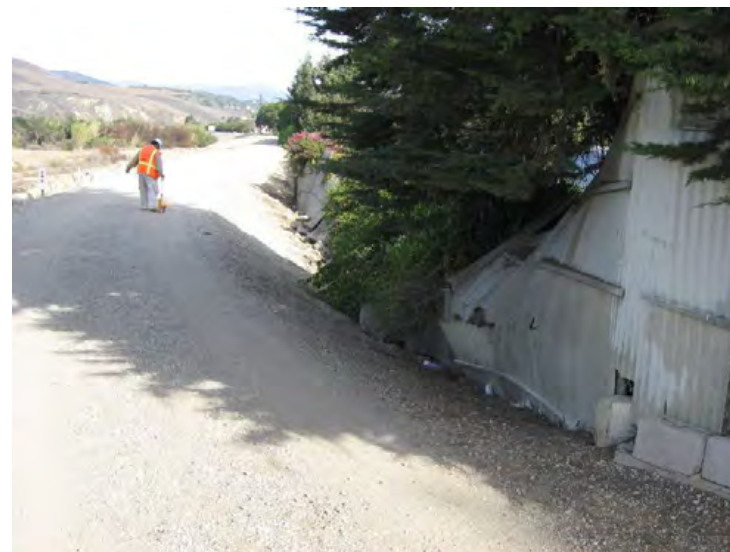
Ventura River Levee, From Ocean to Canada de San Joaquin. (Photo No. M16) - Vegetation within 15' of levee toe, looking u/s (landward side)

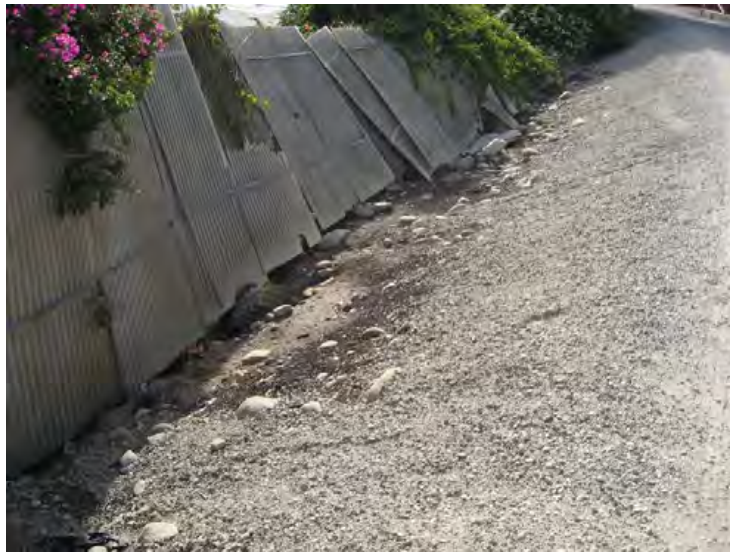
Ventura River Levee, From Ocean to Canada de San Joaquin. (Photo No. M17) – Levee toe has been undercut (landward side)

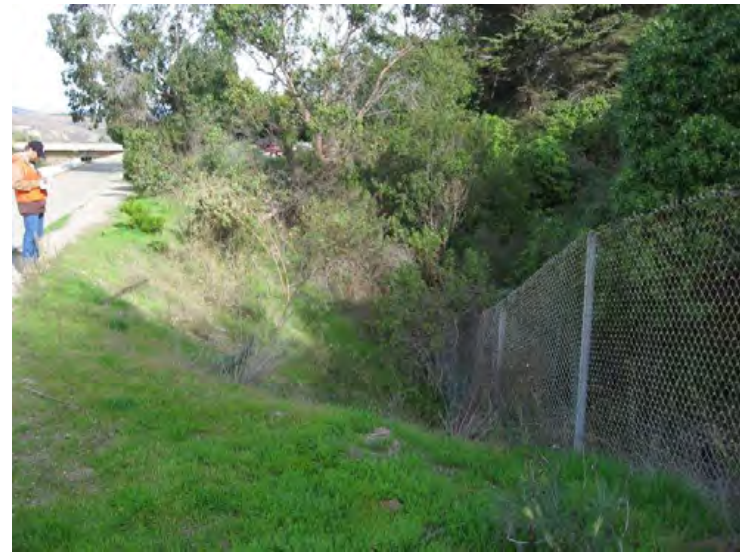
Ventura River Levee, From Ocean to Canada de San Joaquin. (Photo No. M19) - Vegetation within 15' of levee toe (landward side)

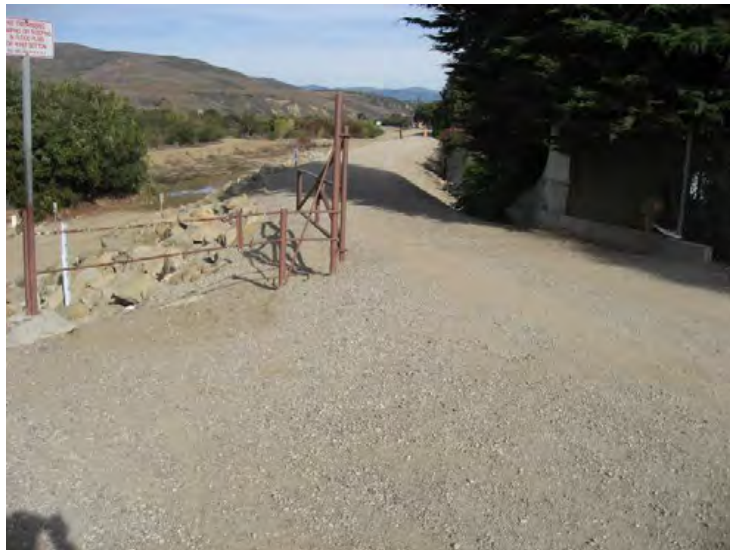
Ventura River Levee, From Ocean to Canada de San Joaquin. (Photo No. M18) - Vegetation within 15' of levee toe, looking d/s (riverward side)

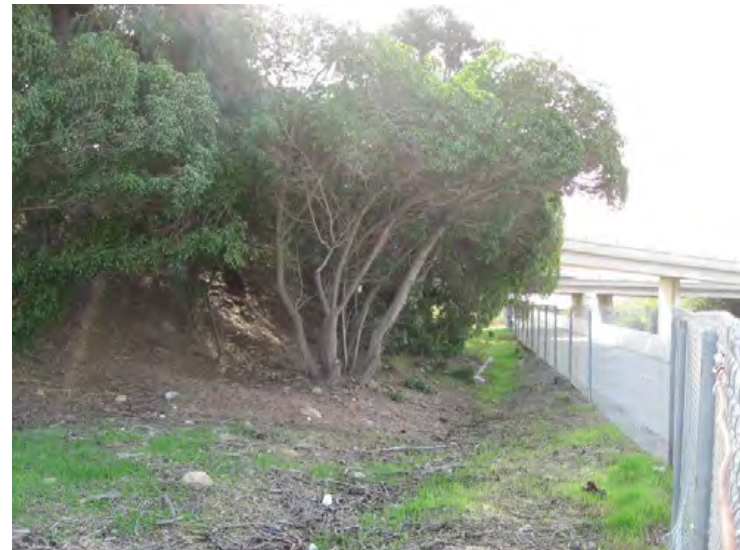
Ventura River Levee, From Ocean to Canada de San Joaquin. (Photo No. M20) - Vegetation within 15' of levee toe, looking u/s (landward side)

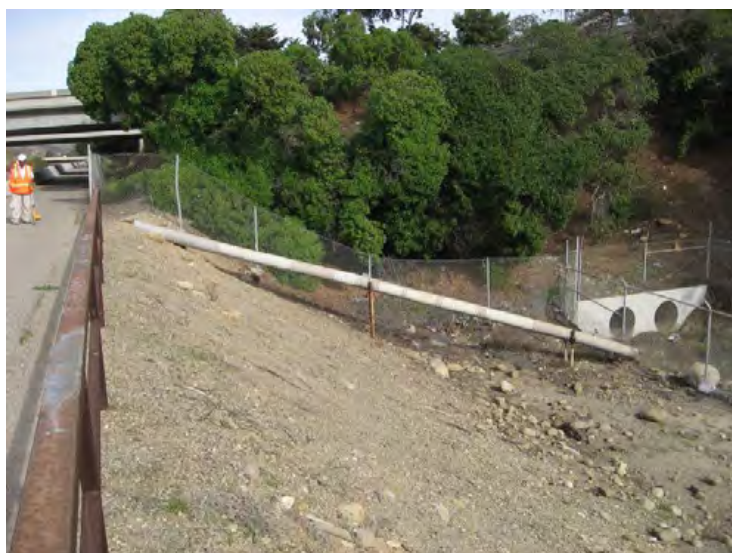
Ventura River Levee, From Ocean to Canada de San Joaquin. (Photo No. M21) – Vegetation within 15' of levee toe, looking u/s (landward side)

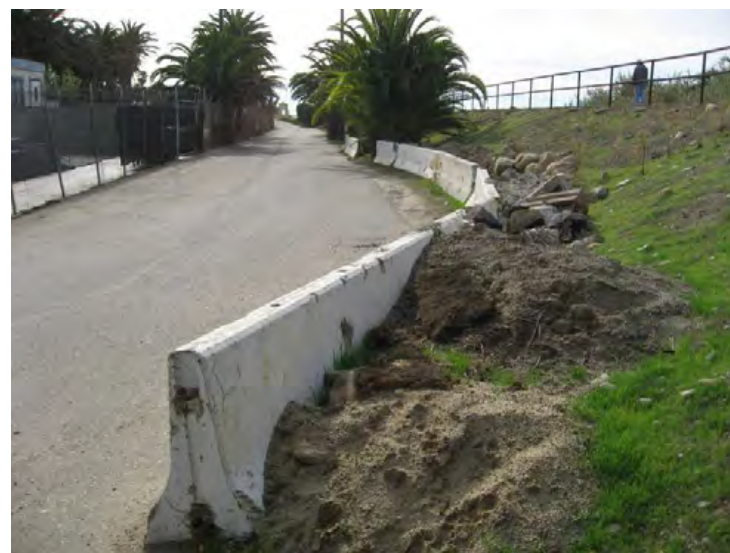
Ventura River Levee, From Ocean to Canada de San Joaquin. (Photo No. M23) – K-rails and debris along levee toe, looking d/s (landward side)

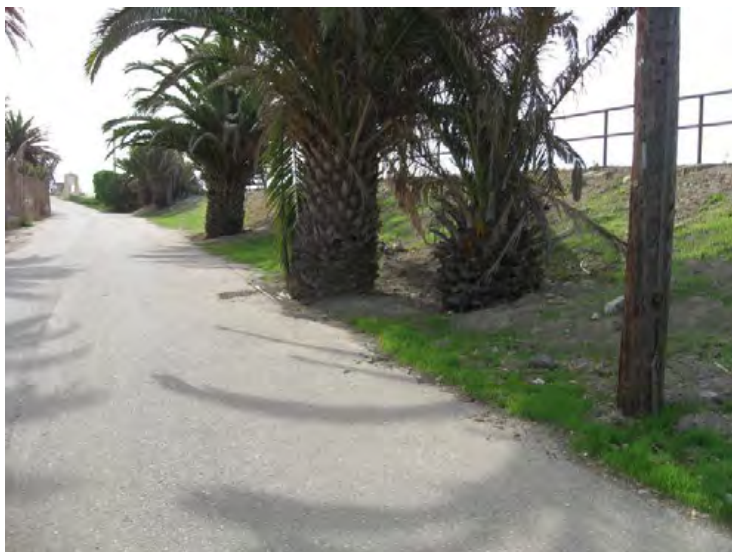
Ventura River Levee, From Ocean to Canada de San Joaquin. (Photo No. M22) - Vegetation within 15' of levee toe, looking d/s (landward side)

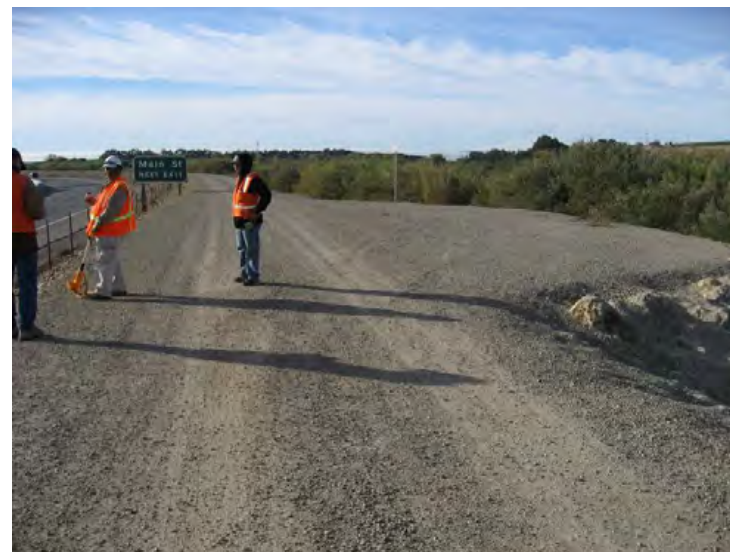
Ventura River Levee, From Ocean to Canada de San Joaquin. (Photo No. M24) – Freeway sign installed in levee bank looking u/s (landward side)

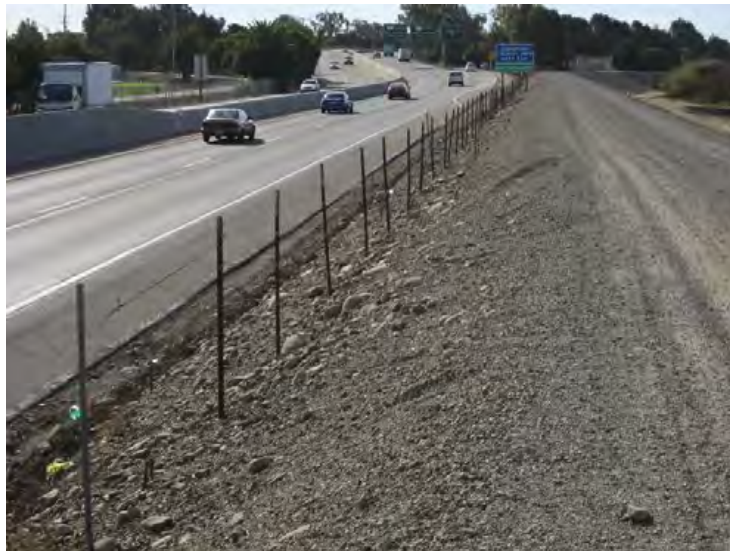
Ventura River Levee, From Ocean to Canada de San Joaquin. (Photo No. M25) – Freeway sign installed in levee bank, looking u/s (landward side)

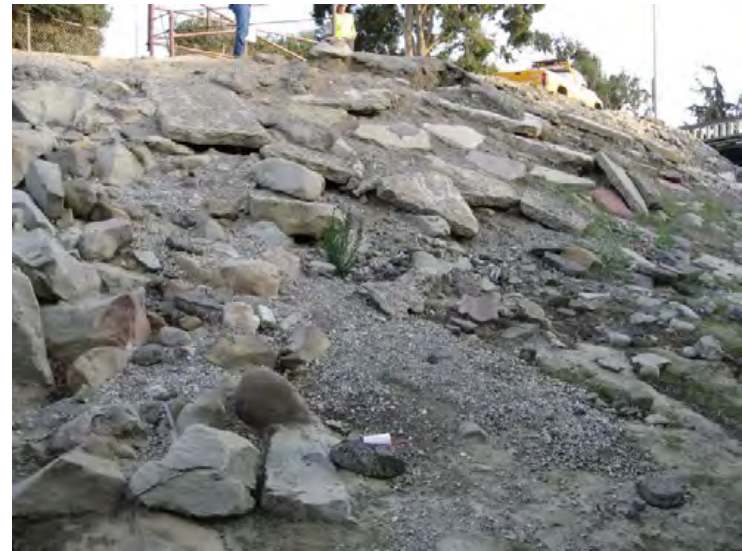
Ventura River Levee, From Ocean to Canada de San Joaquin. (Photo No. M27) – Dumped debris over levee embankment (riverward side)

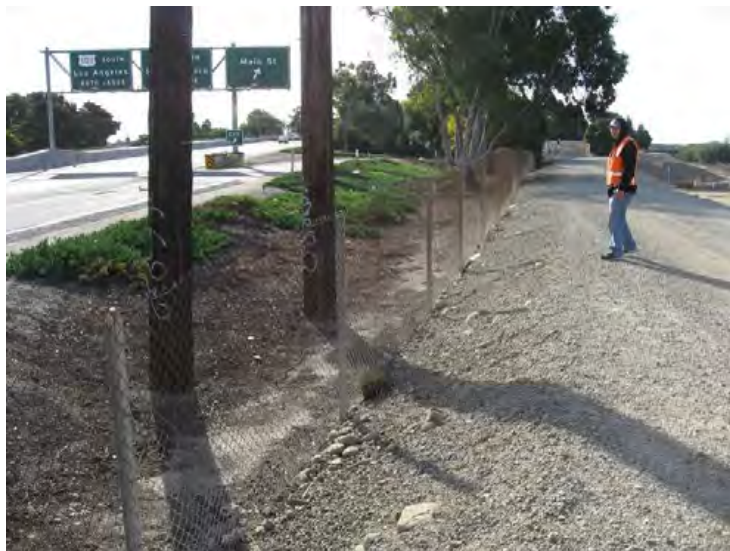
Ventura River Levee, From Ocean to Canada de San Joaquin. (Photo No. M26) – Power poles within 15' of levee toe, looking d/s (landward side)

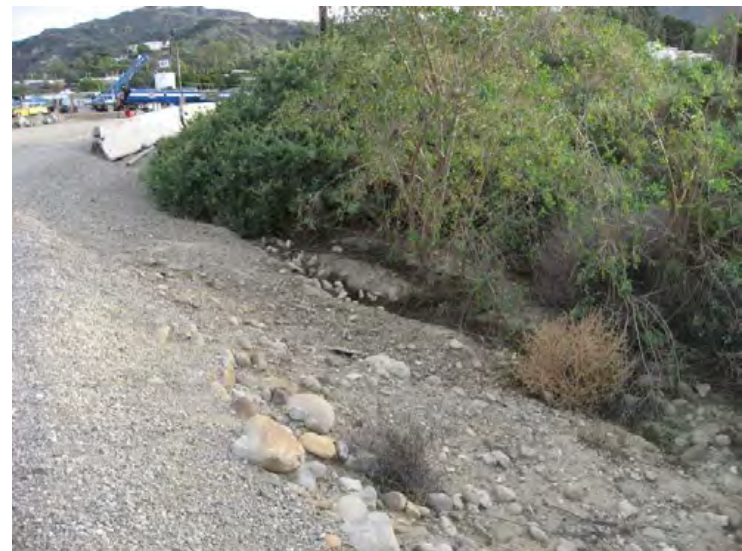
Ventura River Levee, From Ocean to Canada de San Joaquin. (Photo No. M28) – Erosion along levee toe (landward side)

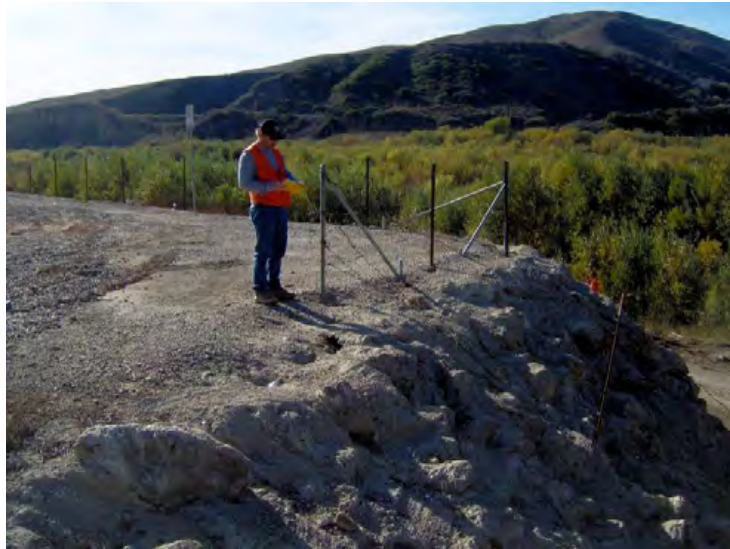
Ventura River Levee, From Ocean to Canada de San Joaquin. (Photo No. M29) – Fence piping on top of levee bank, looking u/s (riverward side)

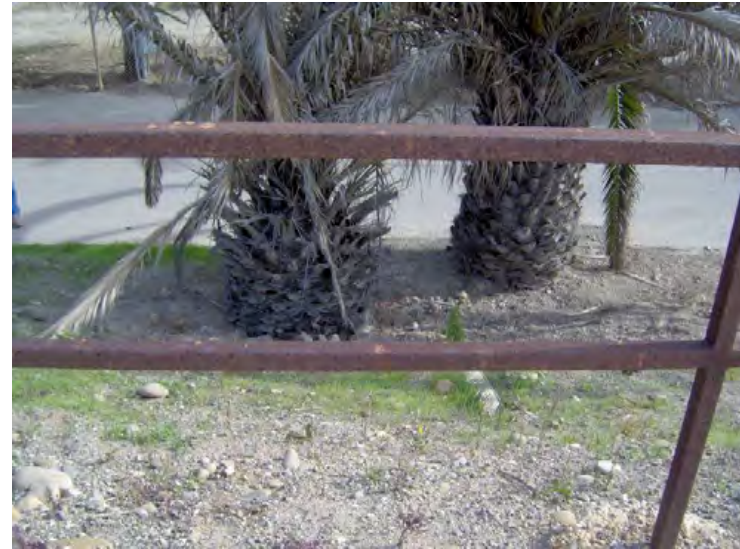
Ventura River Levee, From Ocean to Canada de San Joaquin. (Photo No. M31) – Animal burrows along levee toe (landward side)

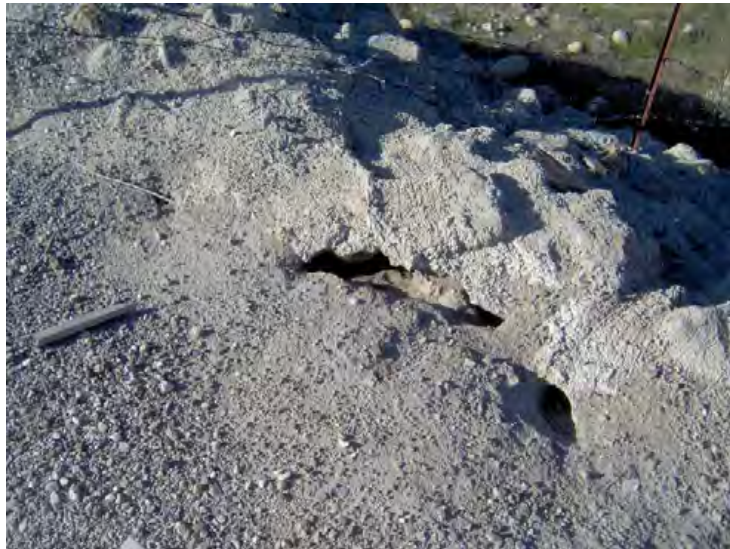
Ventura River Levee, From Ocean to Canada de San Joaquin. (Photo No. M30) – Sink holes on top of levee embankment (riverward side)

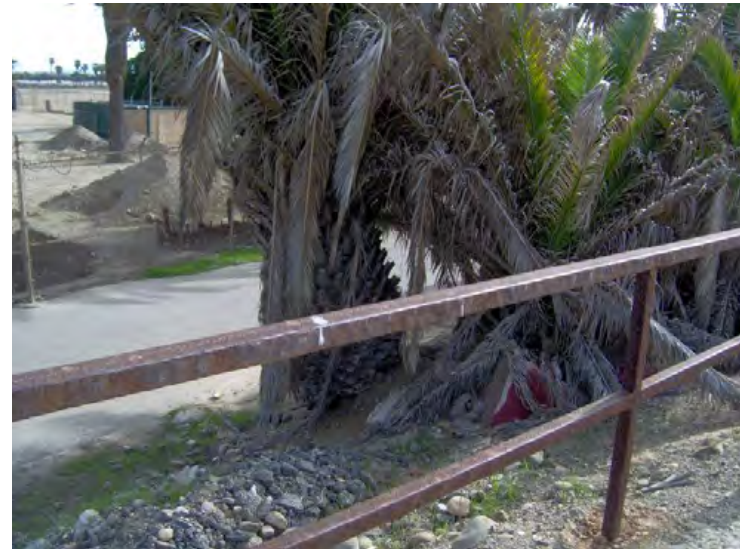
Ventura River Levee, From Ocean to Canada de San Joaquin. (Photo No. M30) – Animal burrows along levee toe (landward side)

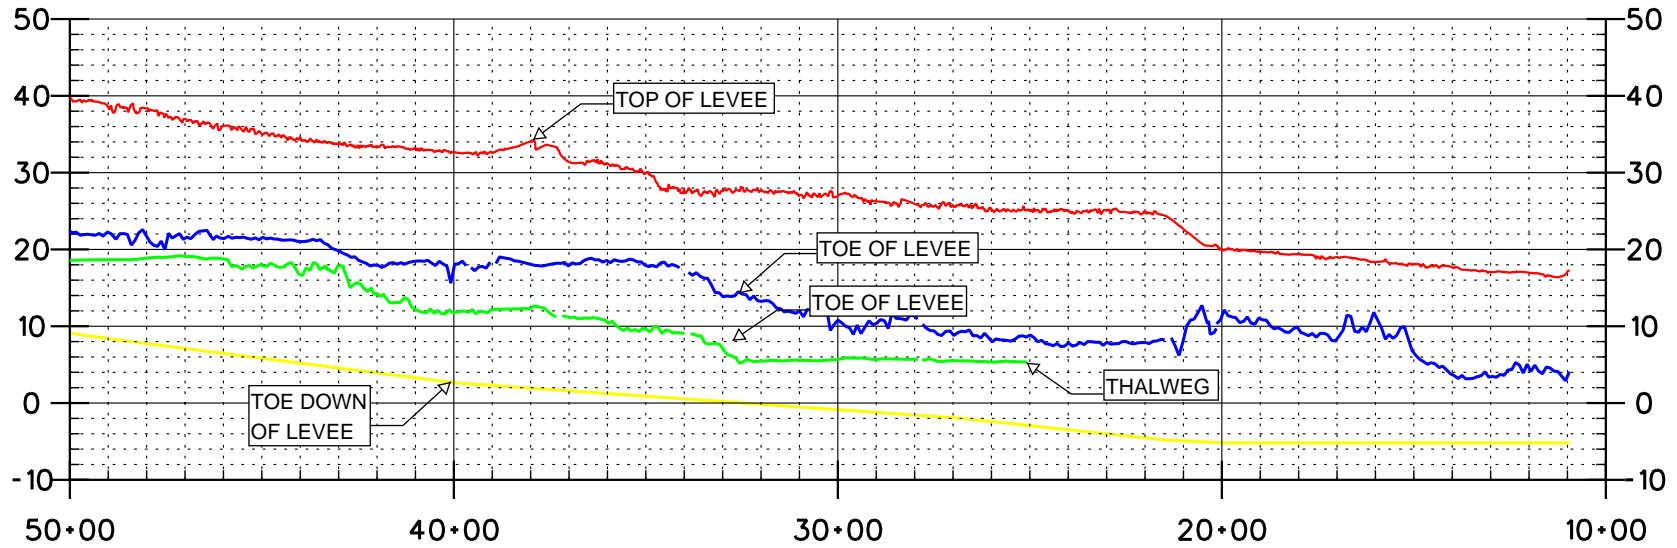
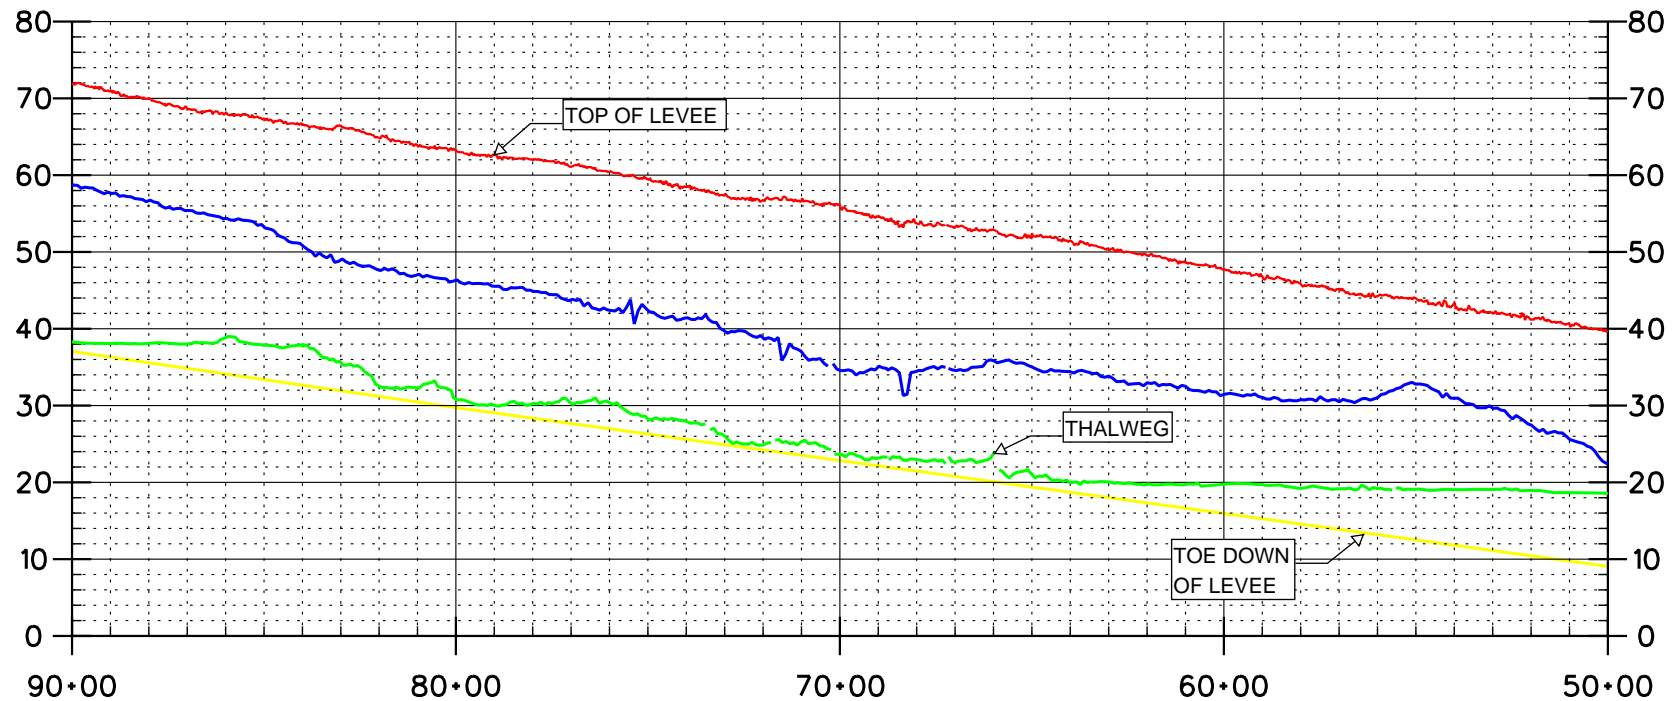
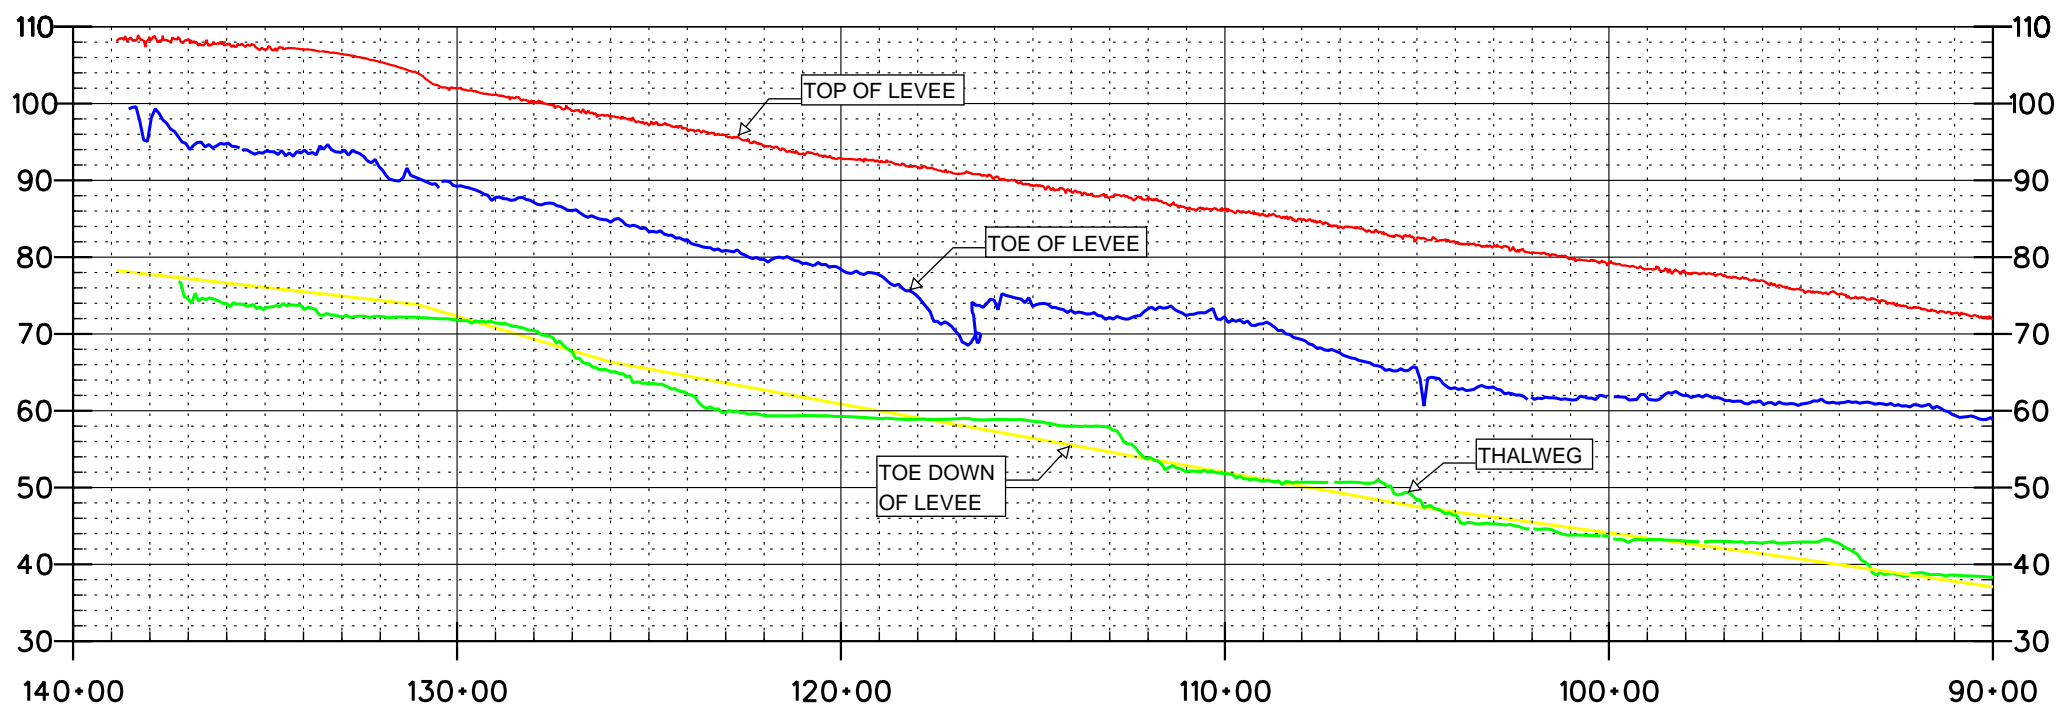
prepared and is presented in Exhibit 2. The 1949 as-built plans show 8-feet of toedown was provided when the levee was initially constructed. Over the last 60 years the Ventura River has degraded along the VR-1 levee to a point where currently, there is minimal to no toedown protection.

Presented in Exhibit 2 are the profiles of the existing thalweg and the levee toedown along the entire 2.65-mile levee system. It reveals that approximately 1.4 miles of the Ventura River thalweg, from Station 64+00 to Station 138+50, is either below or very close to the existing levee toedown. There are no geological features, such as bedrock, or manmade feature, such as rock groins, that would prevent the thalweg of the river from migrating toward the levee and undermining the toedown. Thus, the existing levee has a reasonable failure potential due to toedown undermining during major flood events and cannot be certified in its current condition.
