FEMA Levee Certification
Ventura County, California

Ventura River Levee (VR-1)
Pacific Ocean to Canada de San Joaquin

Evaluation Report
February 20, 2009

Evaluation Report

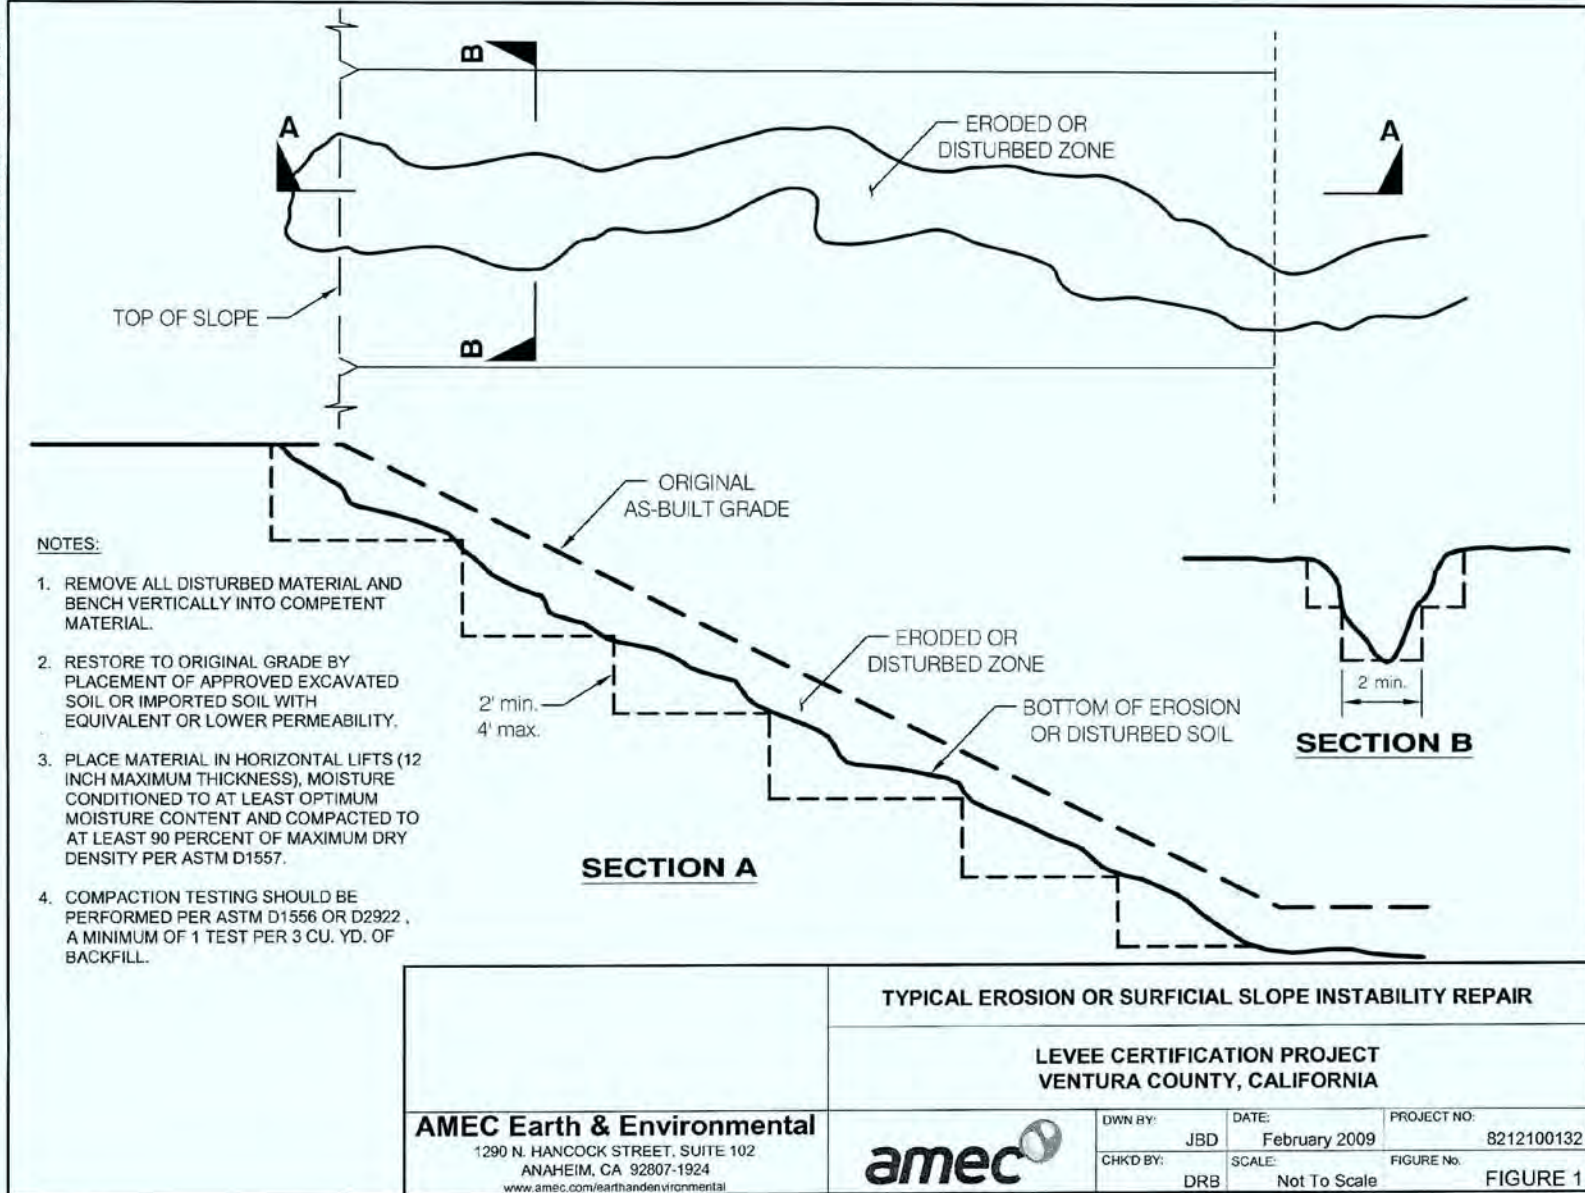
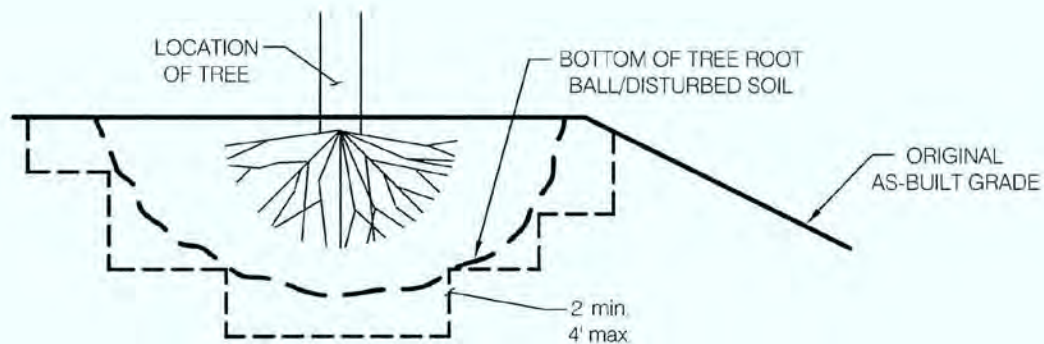
FILE: 8212100132-001 EROSION REPAIR - PLOT DATE: 2/4/2009

Field investigations have identified several locations where the levee embankment has been impacted and requires restoration/mitigation. The District is aware of and working on a design improvement for the location where the maintenance road is failing near levee Station 121+00.

1. REMOVE ALL DISTURBED MATERIAL AND BENCH VERTICALLY INTO COMPETENT MATERIAL.
2. RESTORE TO ORIGINAL GRADE BY PLACEMENT OF APPROVED EXCAVATED SOIL OR IMPORTED SOIL WITH EQUIVALENT OR LOWER PERMEABILITY.
3. PLACE MATERIAL IN HORIZONTAL LIFTS (12 INCH MAXIMUM THICKNESS), MOISTURE CONDITIONED TO AT LEAST OPTIMUM MOISTURE CONTENT AND COMPACTED TO AT LEAST 90 PERCENT OF MAXIMUM DRY DENSITY PER ASTM D1557.
4. COMPACTION TESTING SHOULD BE PERFORMED PER ASTM D1556 OR D2922, A MINIMUM OF 1 TEST PER 3 CU. YD. OF BACKFILL.
