DRAFT WHITE PAPER

Documentation of Design Deficiencies for the Ventura Levee System (VR-1)

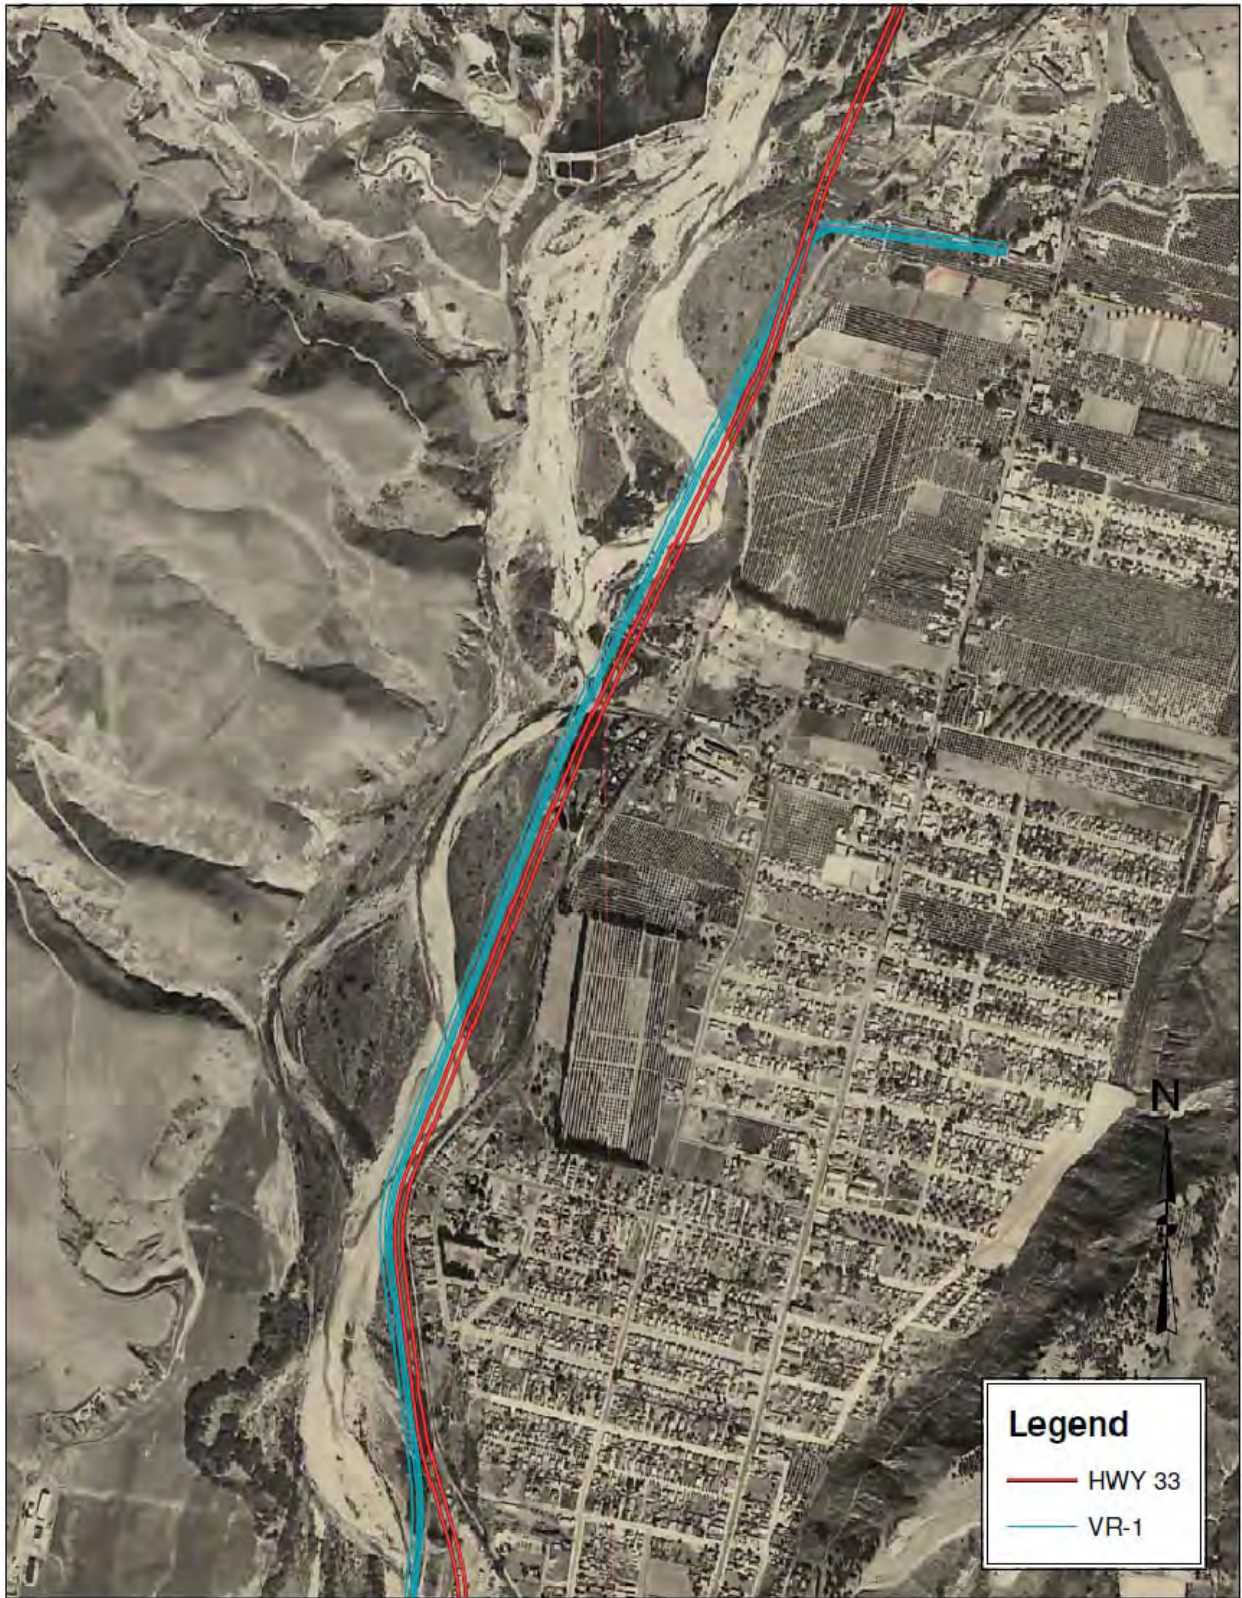
Figure 3: 1945 Aerial Photo of VR-1

Construction of VR-1 was completed in December 1948, and the levee was constructed within the active channel of the Ventura River. Historical aerial photography, flown in 1945, reveals

that at that time there were no less than four (4) separate locations along VR-1 where the primary braid of the Ventura River impinged directly against the east bank of the river at abrupt flow angles (see Figure 3: 1945 Aerial Photo of VR-1).

In this regard, review of as-built drawings does not indicate that any special design considerations were considered at these locations when grouted rock-riprap revetment was installed to arrest scour/erosion on the riverward side of VR-1. A recent (2007) aerial photograph reveals that three (3) out of four (4) of the points of impingement that existed in 1945 have been abated (see Figure 4: 2007 Aerial Photo of VR-1). Reasons for this abatement follow.

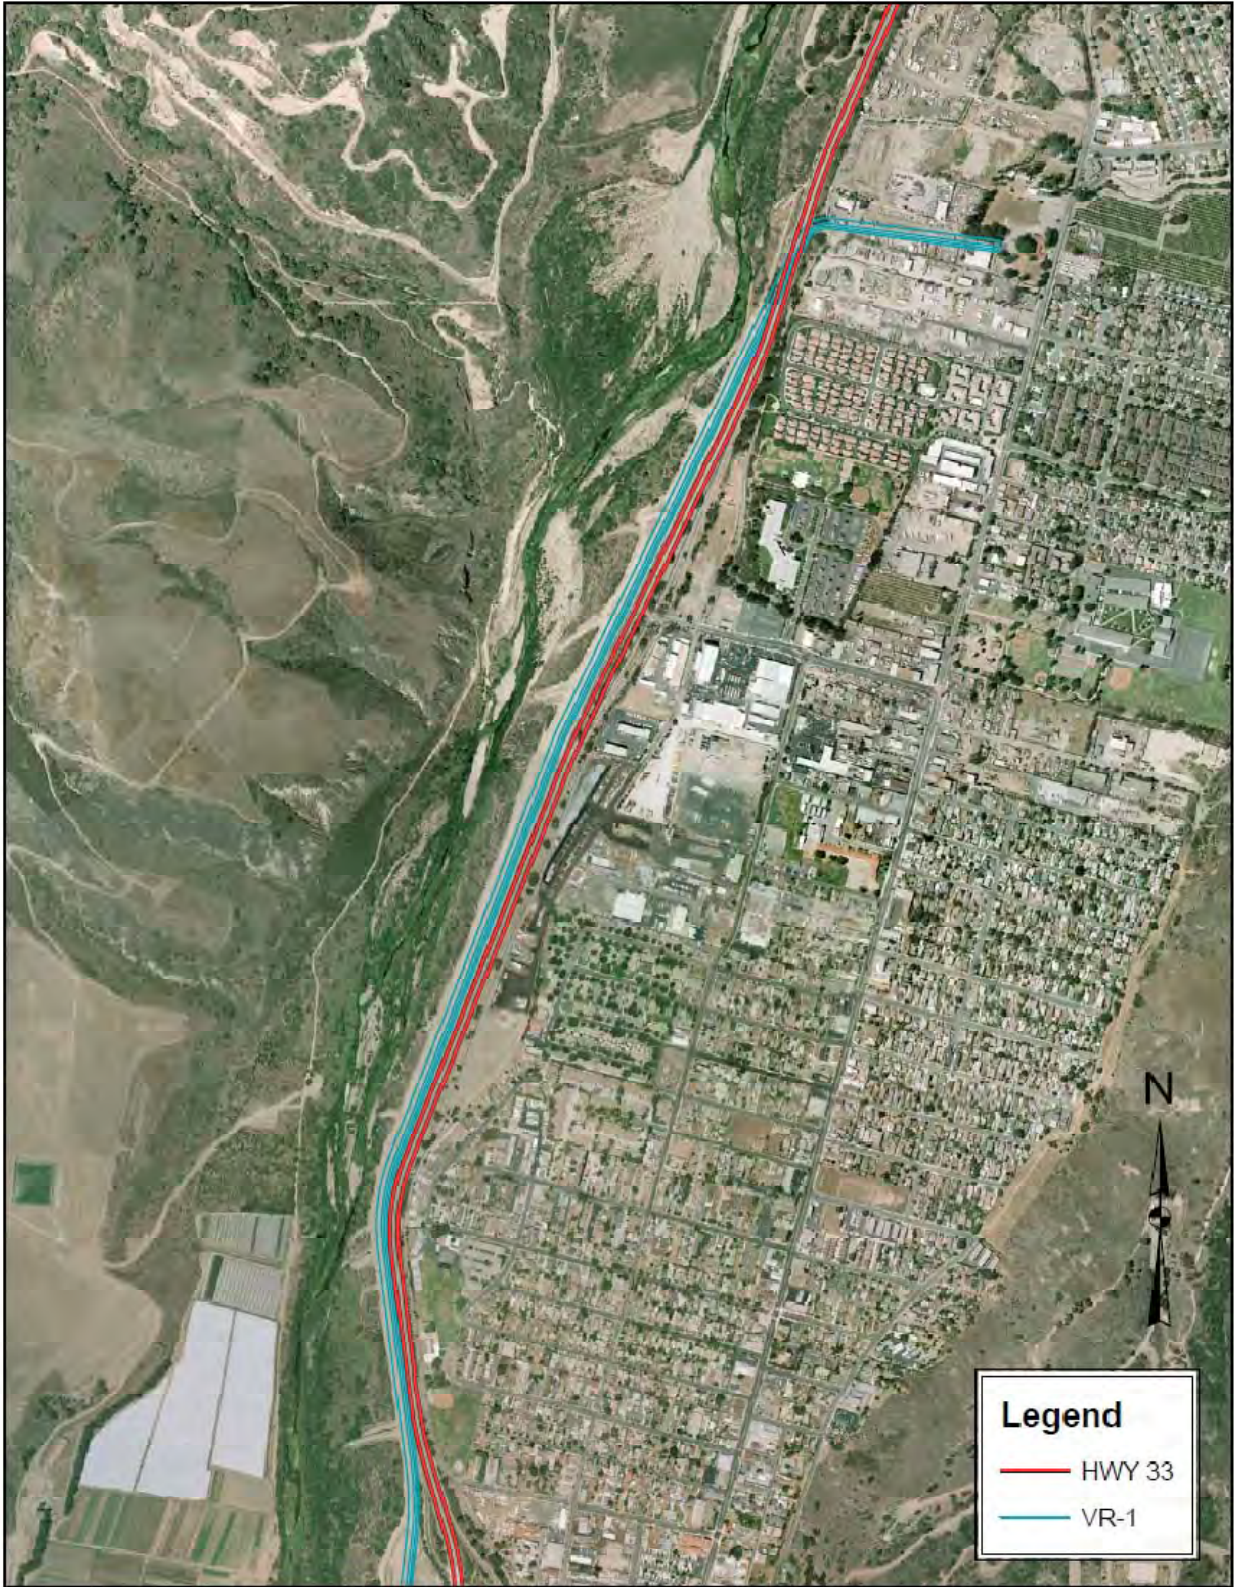
Figure 4: 2007 Aerial Photo of VR-1

Historical disruption of system-wide sediment continuity has occurred along the Ventura River that, over time, has had a very significant impact upon the fluvial geomorphology of VR-1. What was historically a braided channel system, created by an over-abundance of sediments emanating from upstream, steep-sloped mountainous regions, was abruptly modified via significant downstream sediment depletion initiated after the construction of the Matilija Dam in 1947; which was further exacerbated by the subsequent construction of the Robles Diversion Dam (1958), Lake Casitas Dam (1959), and several small debris basins that were constructed in the upstream contributing watershed areas of the Ventura River during the past 65 years. The downstream depletion of sediment supply, in turn, has led to stream-channel degradation, which has created a more pronounced, higher capacity, primary flow channel that conveys ordinary flows more to the center and western side of the Ventura River, partly due to flow confinement on the east by the VR-1 levee. In addition, this pronounced, higher capacity, primary flow channel has developed a more defined inner thread (low-flow-thalweg) that meanders in a gradual fashion inside the primary flow channel, causing an exacerbation of unanticipated scour problems. Furthermore, the depletion of the upstream sediment supply, which has led to long-term channel degradation (i.e., channel deepening), has also coarsened the in-situ distribution of streambed sediments, to some extent, thus exacerbating the tendency of the low-flow channel to meander within the primary channel of the Ventura River. In addition, due to a reduction in flood magnitude and sediment supply, created by upstream flood-control impoundments and watershed urbanization, respectively, a significant increase in both in-channel and near-channel riparian growth has occurred, which to some extent has tempered the meandering of the low-flow thalweg. All of these phenomena have been previously documented by others (USACE 2004; DOI 2004, DOI 2006; DOI 2009).

During both ordinary and extraordinary flow events, a wandering low-flow channel will create a highly non-uniform flow distribution along VR-1, which in turn will increase the potential for the initiation of high-angled flow impingements against the levees at various locations along the system, such as existed in 1945 before the presence of the extensive flood-control works that today exist within upstream watershed areas. As stated above, these altered flow conditions have, over the past 65 years, undoubtedly led to greater than originally anticipated channel degradation at the toe of VR-1.

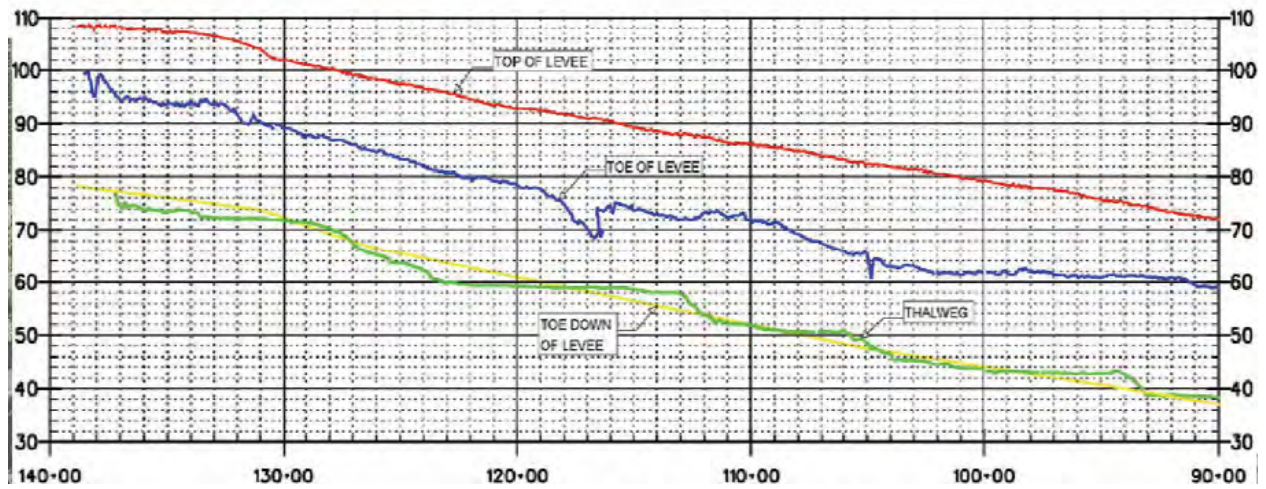
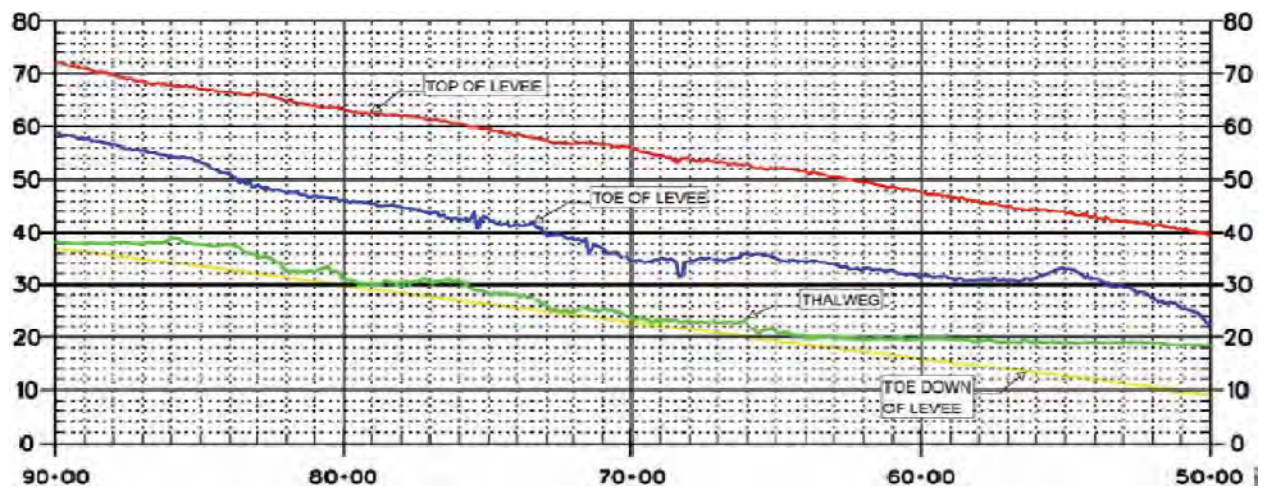
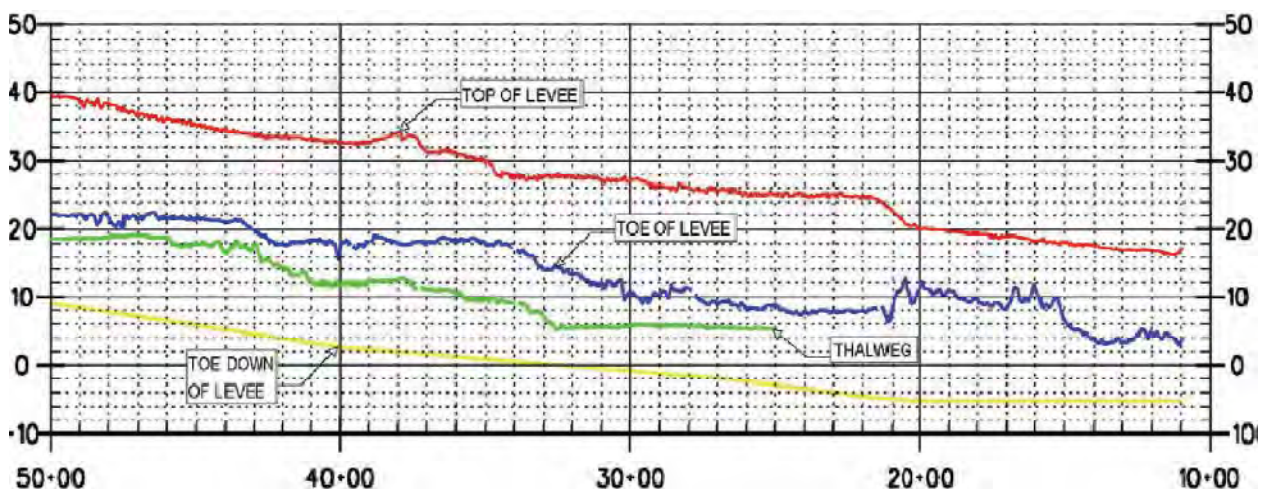
Figure 5: Profile along VR-1

As stated previously, the 1949 as-built plans for VR-1 reveal that a minimum of 8 feet of toedown was provided below the channel thalweg when the levee was initially constructed. Over the last 60 years, the Ventura River has degraded along the VR-1 levee to a point where currently, there is minimal to no toedown protection. Approximately 1.4 miles of the Ventura River thalweg along VR-1, from Station 64+00 to Station 138+50, is either below or very close to the existing levee toedown (see Figure 5: Profile Along VR-1). There are no geological features, such as bedrock, or manmade feature, such as rock groins, that would prevent the thalweg of the river from migrating toward the levee and undermining the toedown. Thus, in its

current condition the existing VR-1 levee has a reasonable failure potential due to toedown undermining during major flood events. Failure of the levee would result in countless millions of dollars of urban infrastructure and commercial/residential property losses, not to mention the potential for significant loss of life—particularly if a portion of the levee were to collapse suddenly during the night.
