January 18, 2010 Ormond Beach Lagoon Emergency Breach Incident Report

January 18, 2010 Ormond Beach Lagoon Emergency Breach Incident Photos

Ormond Beach Lagoon Emergency Breaching - January 18, 2010

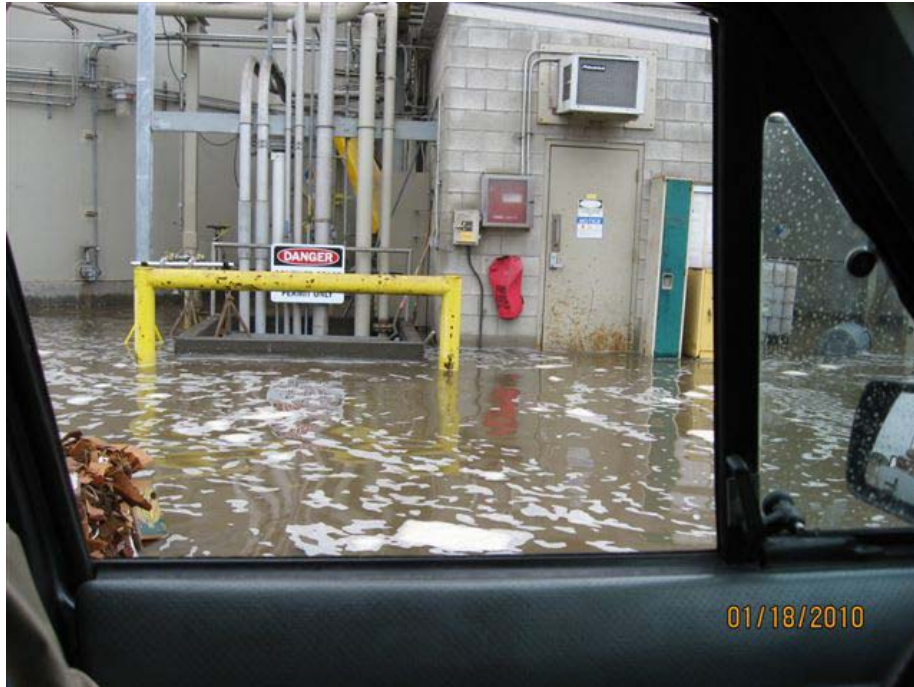
International Paper Plant¹: According to District Operations and Maintenance staff, this was the first time IPP had ever requested flood assistance. IPP staff observed on Monday morning at 3:00 am that a surge of water had rapidly flooded 50 - 60% of their property up to 4 feet deep in areas. OID had overtopped its banks and flooded adjacent open space as well as the IPP. IPP's storm water drainage system was overwhelmed and water could not be pumped off the property, as it would just return. Five diesel pumps were activated to remove the water, but were quickly overwhelmed. Based on observation of the sand elevation at Ormond Beach, IPP staff estimated that 3 to 4 feet of additional water surface elevation increase was needed for the lagoon to overtop the beach.

Between 8 am and 10 am floodwaters started to recede a bit, then rain began to fall again and flooded 80% of the IPP, causing 900- to 1200-pound bales of paper to float around the property, a safety hazard. Perkins Road essentially functioned as a river from McWane Boulevard to its south terminus as a result of overflow from OID. The IPP motor control center, which had never been inundated before, was short-circuited by floodwaters around 2 pm (this was after the breach channel was completed). With the motor control center off line, equipment was shutting down automatically. To prevent further damage to the plant's electrical system, workers shut down all remaining equipment.

Photo 1: Flooding at the IPP threatened its electrical systems and employees attempting to protect the facility.

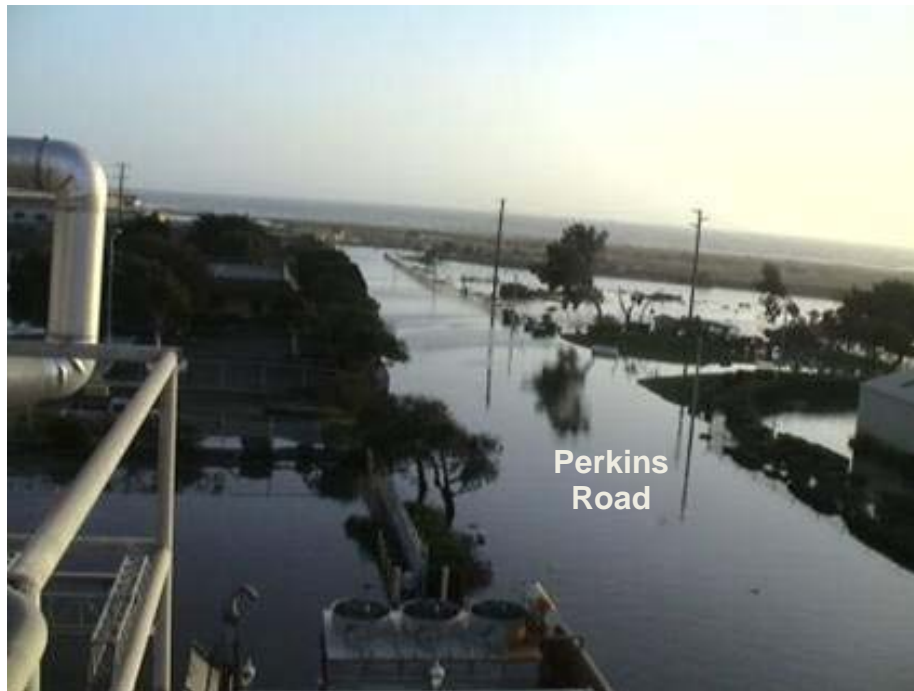
Photo 2: View southwest from the IPP toward flooded lands. The OWWTP lies along the right edge of the photo. Perkins Road separates the two properties and functioned as a secondary channel for OID. (Photo taken at 4 pm, 01-18-10)

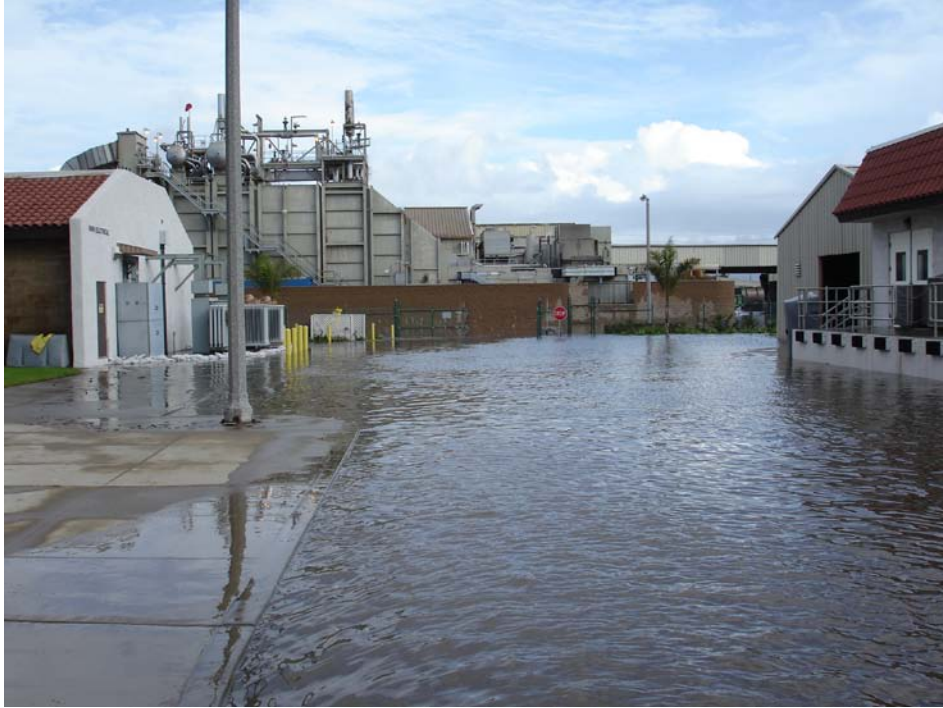
The maintenance shop and equipment storage building received 2 feet of water, which ruined some equipment (transformers, pumps, and motors) essential to plant function. The primary concern was inundation of the main electrical switch gear building, which is the plant's power distribution center, including emergency power.

Photo 3: View east toward Perkins Road and the IPP. The structure on the left whose entrance is protected by sandbags is the Main Electrical Building for OWWTP. Inundation of equipment in this building would have caused release of untreated sewage to residential, commercial, lagoon, beach, and ocean areas.

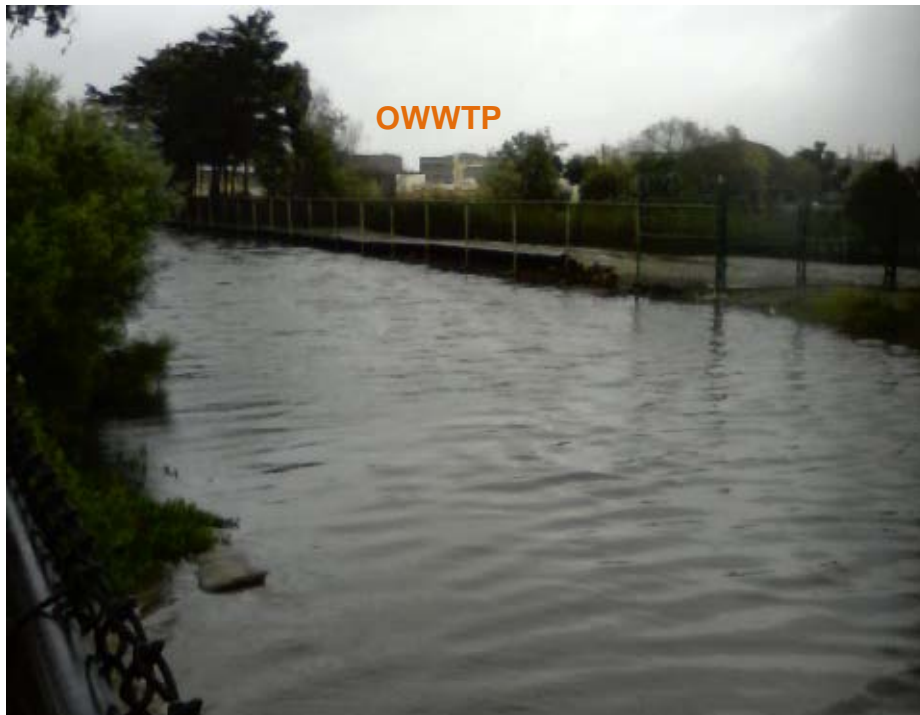
Photo 4: View northeast toward JSD, which was close to overtopping its banks and contributing additional floodwaters to the OWWTP, already flooded by OID.

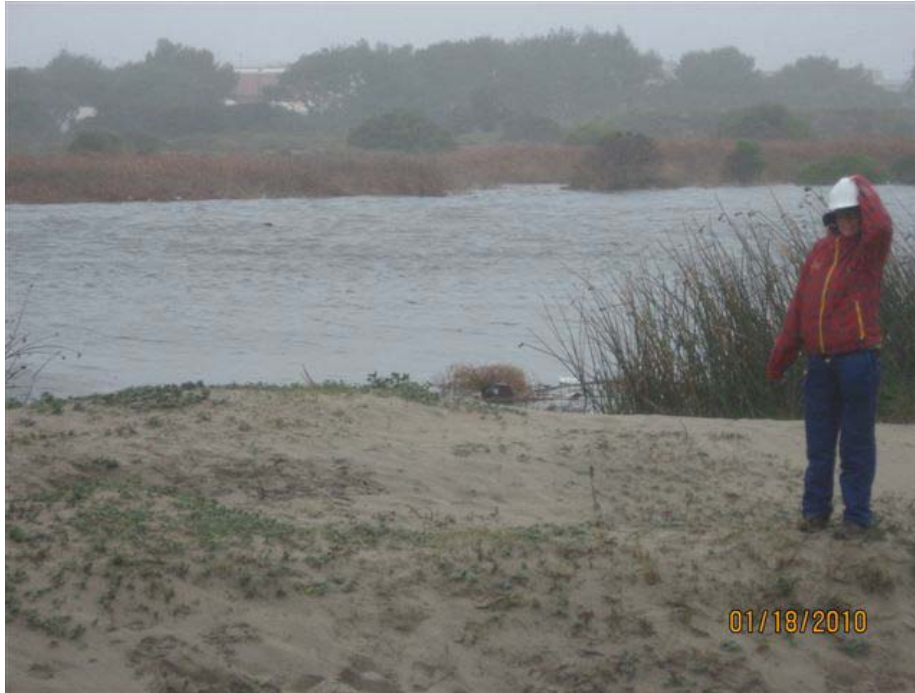
Instead, the biologist selected a point of low elevation along the southwestern margin of the lagoon to minimize the need for excavation and avoid disturbance of wetland vegetation such as California bulrush (*Scirpus californicus*) (see Photo 5).

Photo 5: Selected breach channel location prior to the beginning of work, view northeast toward Ormond Beach Lagoon. This site was chosen because the beach elevation was lower than surrounding areas and most of the wetland vegetation along the lagoon margin could be avoided. The biological monitor is on site.

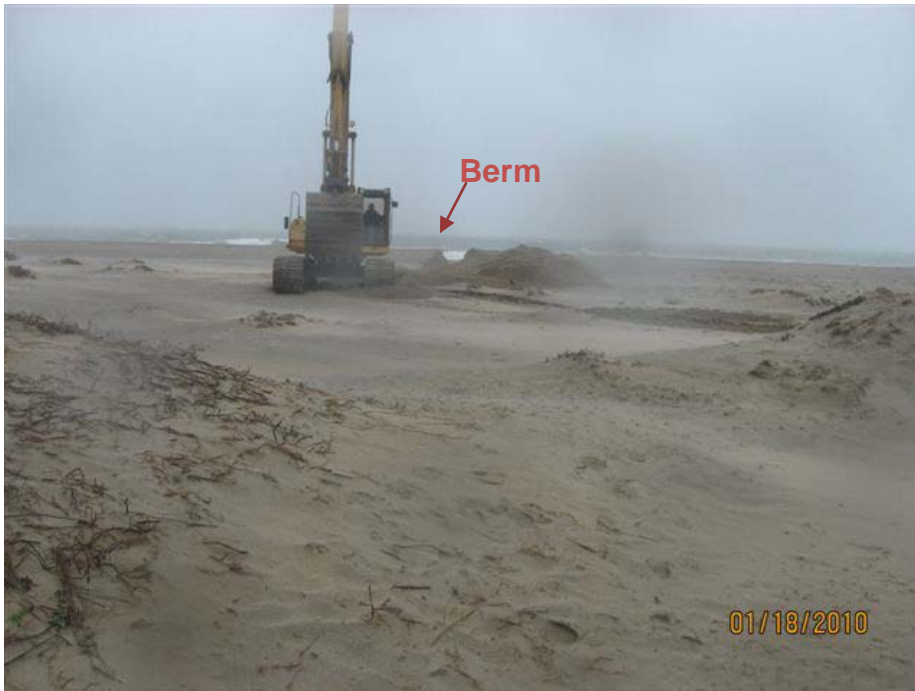
Photo 6: Excavation of the emergency breach channel, view southwest toward the Pacific Ocean. Work began at the ocean shoreline and progressed toward the lagoon shoreline.

The access route ended at the selected emergency breach channel location. Beginning near the edge of the ocean and working toward the lagoon, an excavator bucket was used to dig a 6-foot-wide channel between the two water bodies. As initially dug, the channel was not deep enough to allow water to flow through it, and the excavator retraced its path to carve out the channel a bit more

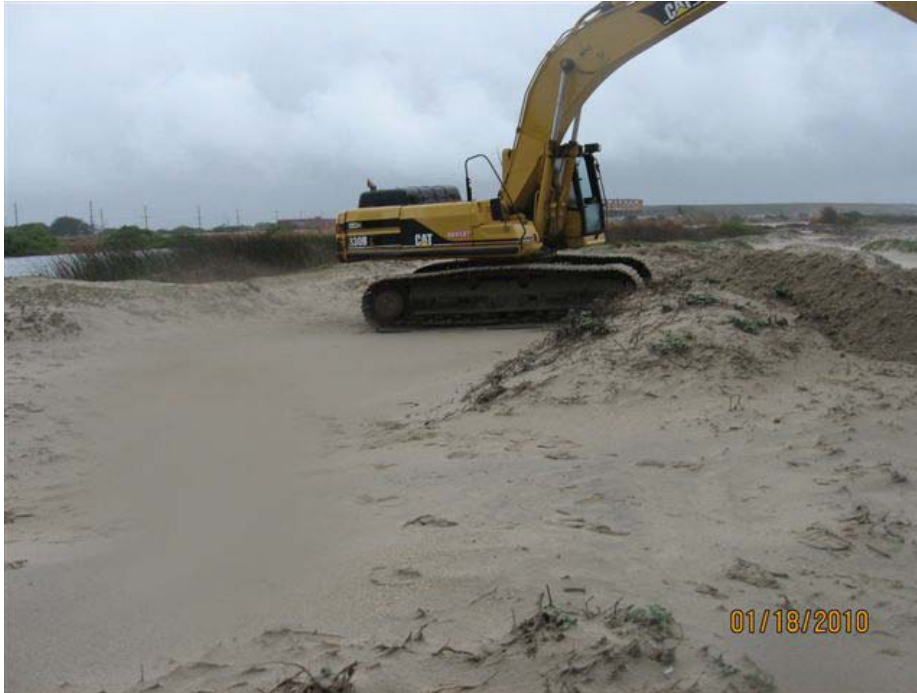
Photo 7: View southeast toward the excavator as it approached the lagoon.

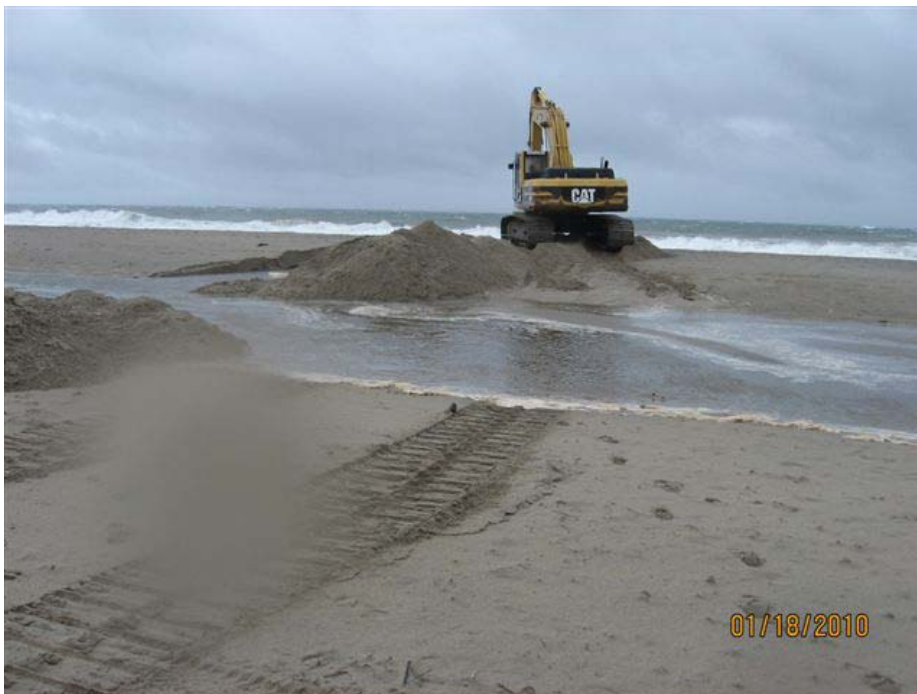
Photo 8: View southwest toward the excavator as it carved the end of the channel a bit deeper. Water that had escaped the lagoon near the natural breach location but still remained trapped behind the tall berm appears in the photo. This flow swept north along the coast, but could not reach the ocean, and was not observed to alleviate flooding at either plant property.

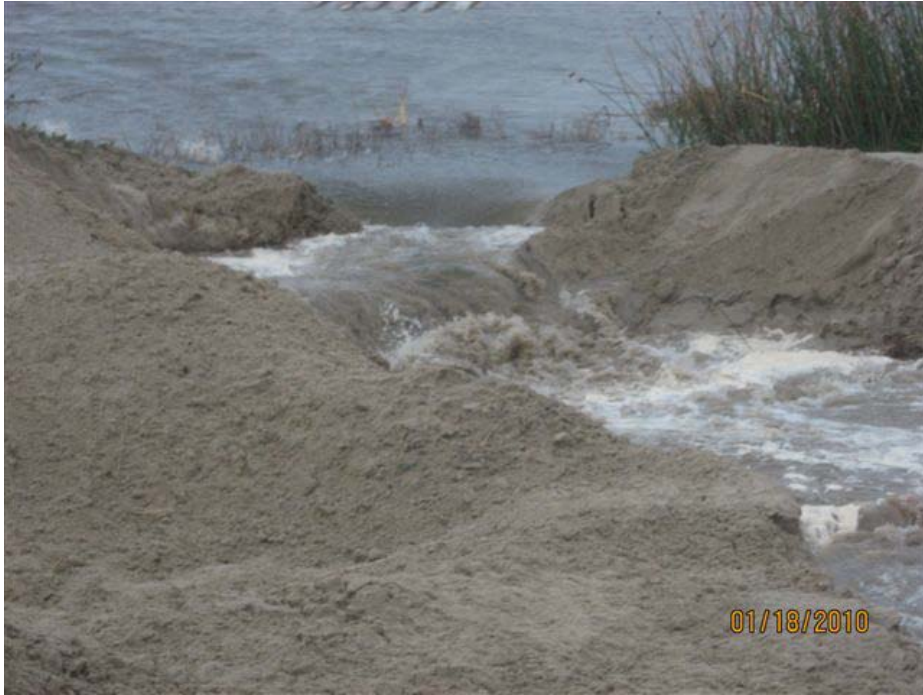
Photo 9: View northeast toward the junction of the excavated breach channel and the lagoon. This surface water release alleviated flooding at the IPP, OWWTP, Surfside III community, and streets within the City of Oxnard.

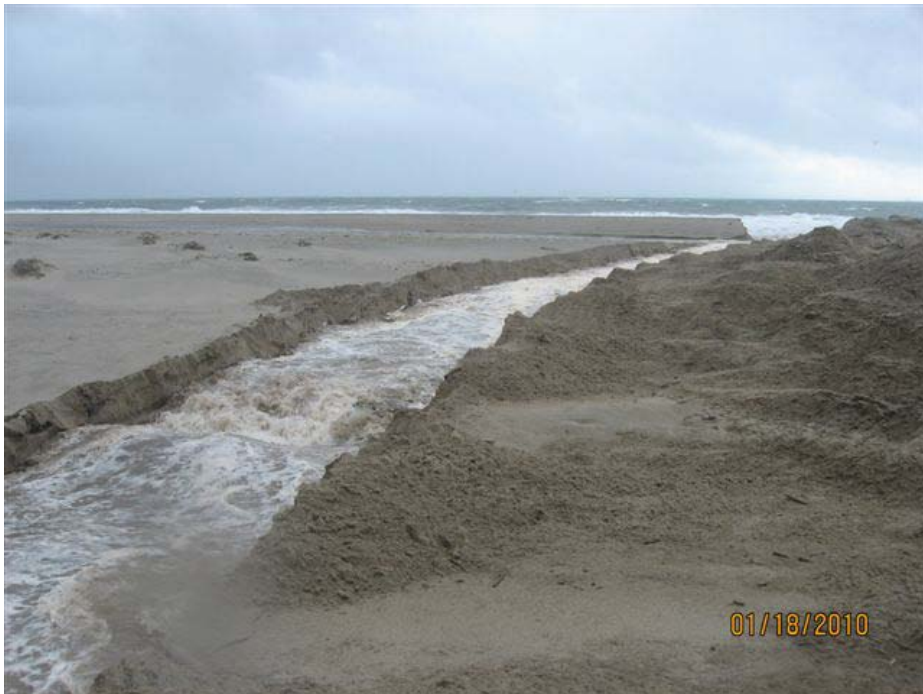
near the tallest part of the berm. The breach channel was approximately 295 feet long and varied from 1 to 5 feet deep, the greatest depth coinciding with the sand berm peak.

Photo 10: View south along the excavated breach channel toward its junction with the ocean.

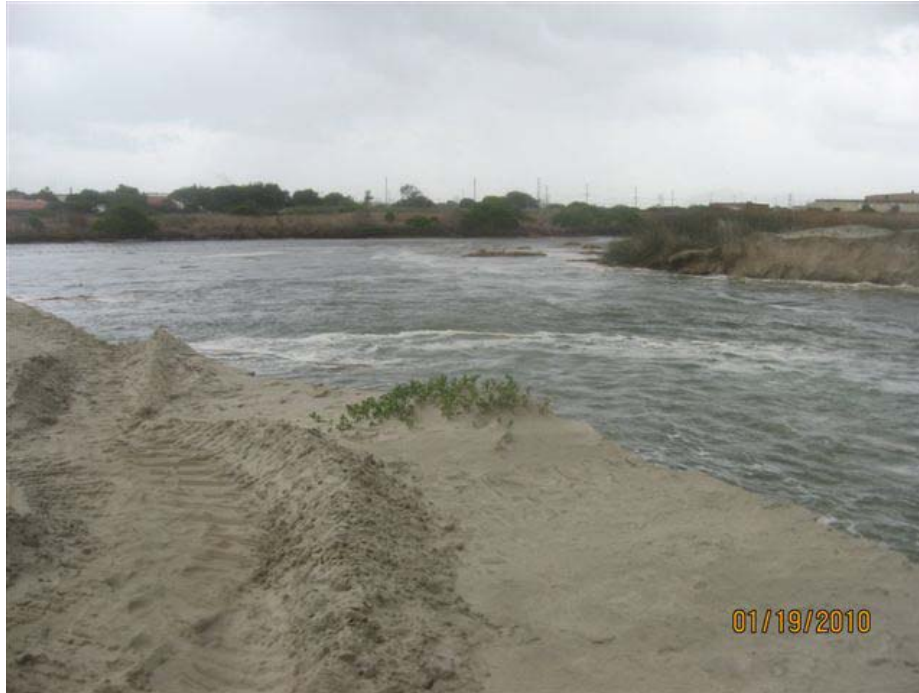
Photo 11: This photo was taken the day after the emergency action and shows that flow exiting the lagoon had considerably widened the excavated breach channel. View northeast toward the lagoon.

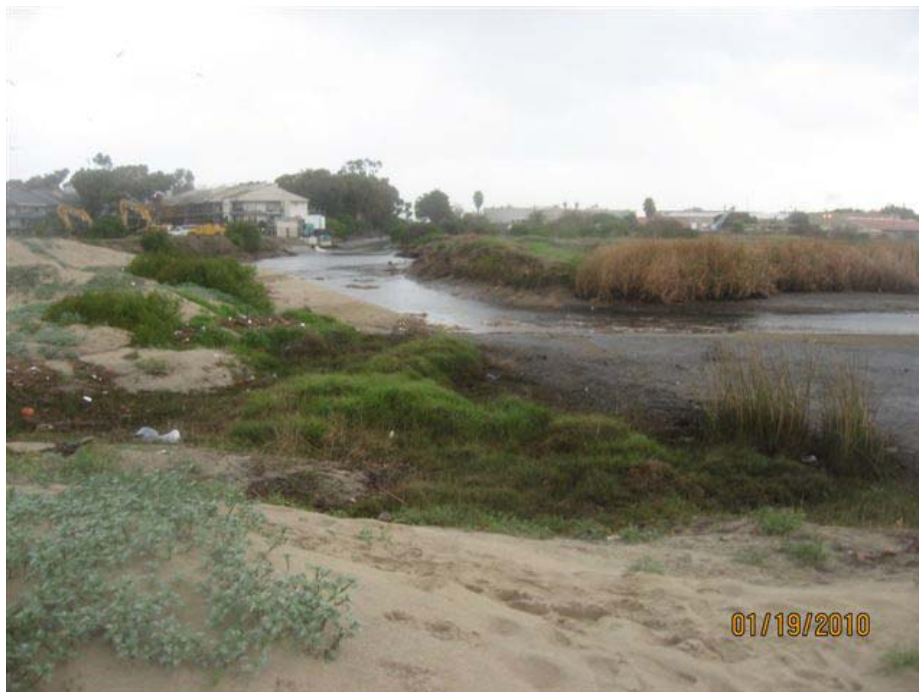
Photo 12: View north toward the lagoon and JSD the day after the emergency action. The lagoon surface water elevation had been lowered, but the lagoon still retained aquatic habitat.

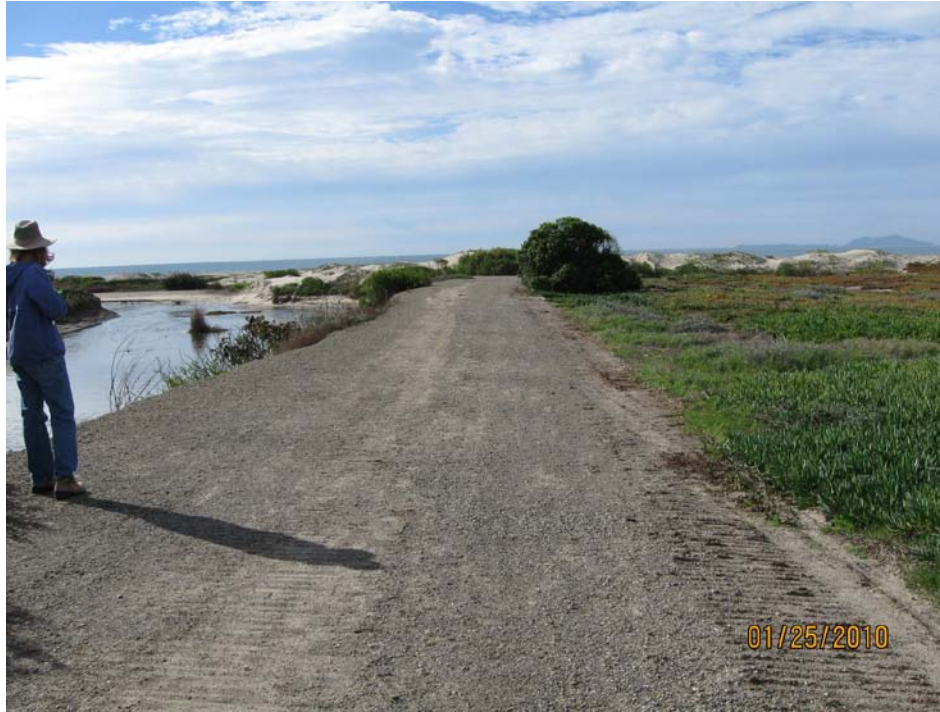
Photo 13: View southwest along the portion of the excavator access route on existing dirt road adjacent to the JSD. This and all subsequent photos were taken one week after the emergency breach action.

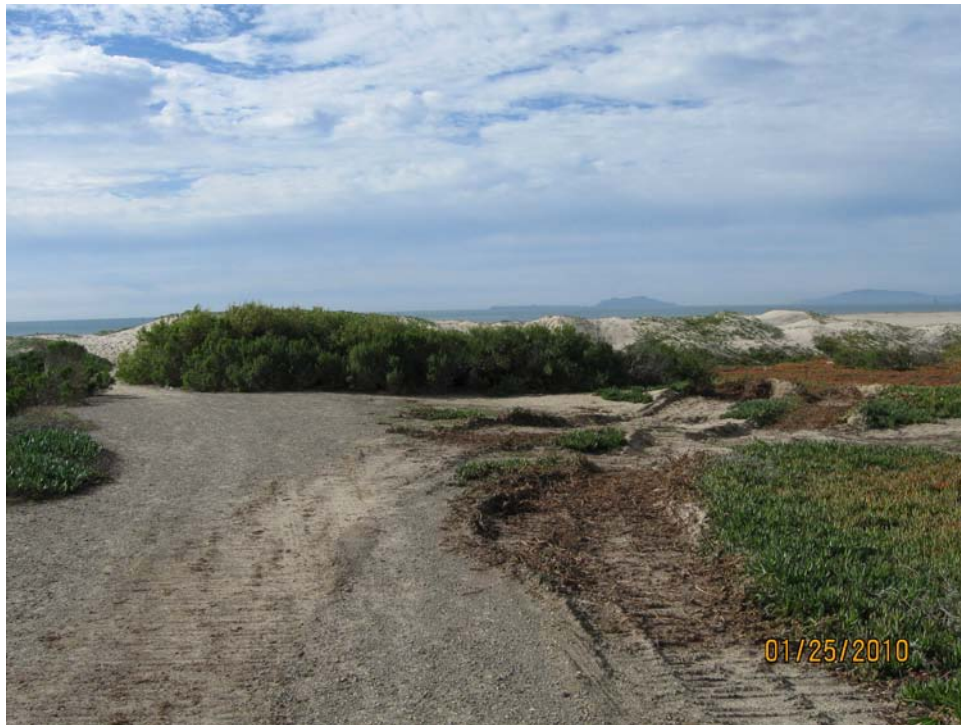
Photo 14: View southwest along the excavator access route at the point where it diverged from the existing dirt road onto a field of iceplant.

The District proposes a one-time removal of all iceplant, including pieces uprooted during passage of the tracked excavator, as soon as possible either prior to or immediately following the plover and tern nesting season. The removal would occur in a 1.9-acre area of southern foredune habitat bounded by the lagoon on the north and the temporary access route created on January 18, 2010 on all other sides (see attached aerial map). The method of removal will be worked out with the USFWS, as this area is within western snowy plover critical habitat. The primary issue is herbicide use versus digging out iceplant roots in critical habitat (in some cases, iceplant is growing within patches of native plants).

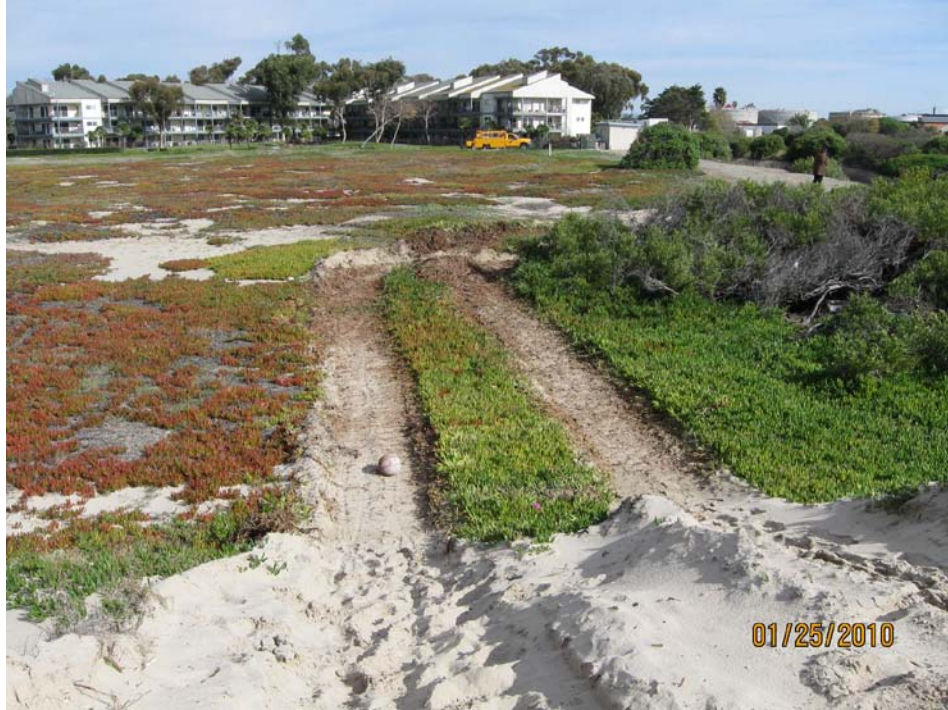
Photo 15: View northeast along the excavator access route at the point where it departs from the iceplant field and crosses beach dunes. The Surfside III community is at the top of the photo, and the OWWTP is at the top right corner.

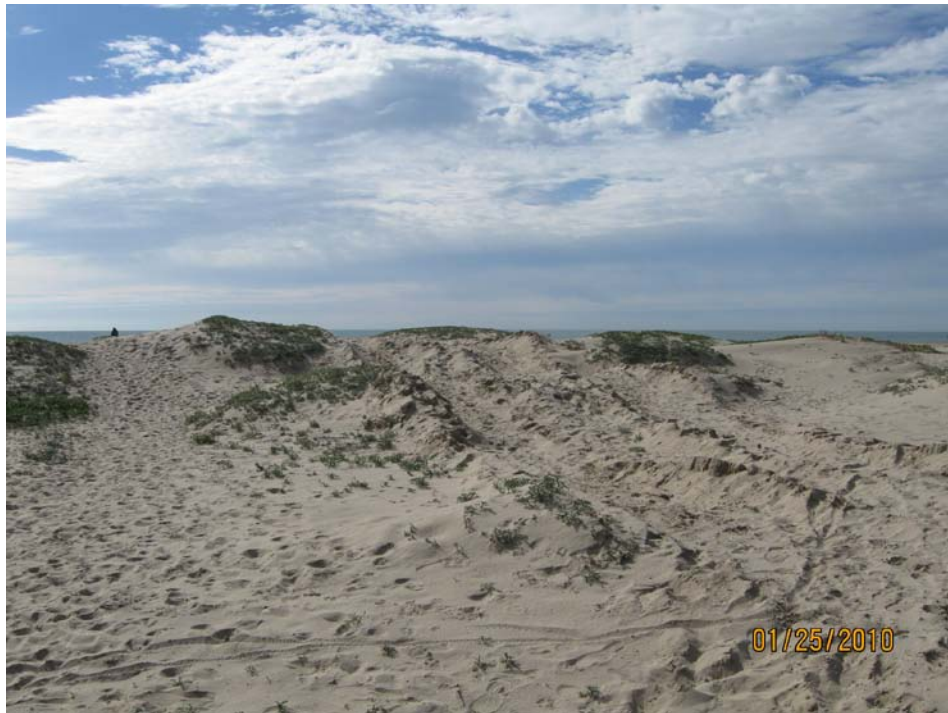
No permanent impacts resulted from the emergency action, however approximately 0.44 acre of critical habitat for threatened western snowy plover was temporarily impacted by the excavator's passage over the sand dunes and by creation of the breach channel. No direct impacts to plovers occurred because they were not present during the emergency work.

Photo 16: View south toward excavator tracks across the beach dunes.
