**DRAFT INITIAL APPRAISAL REPORT
VENTURA RIVER 1 LEVEE (VR-1)
VENTURA COUNTY, CALIFORNIA**

**LOS ANGELES DISTRICT
U.S. ARMY CORPS OF ENGINEERS**

AUGUST 2013

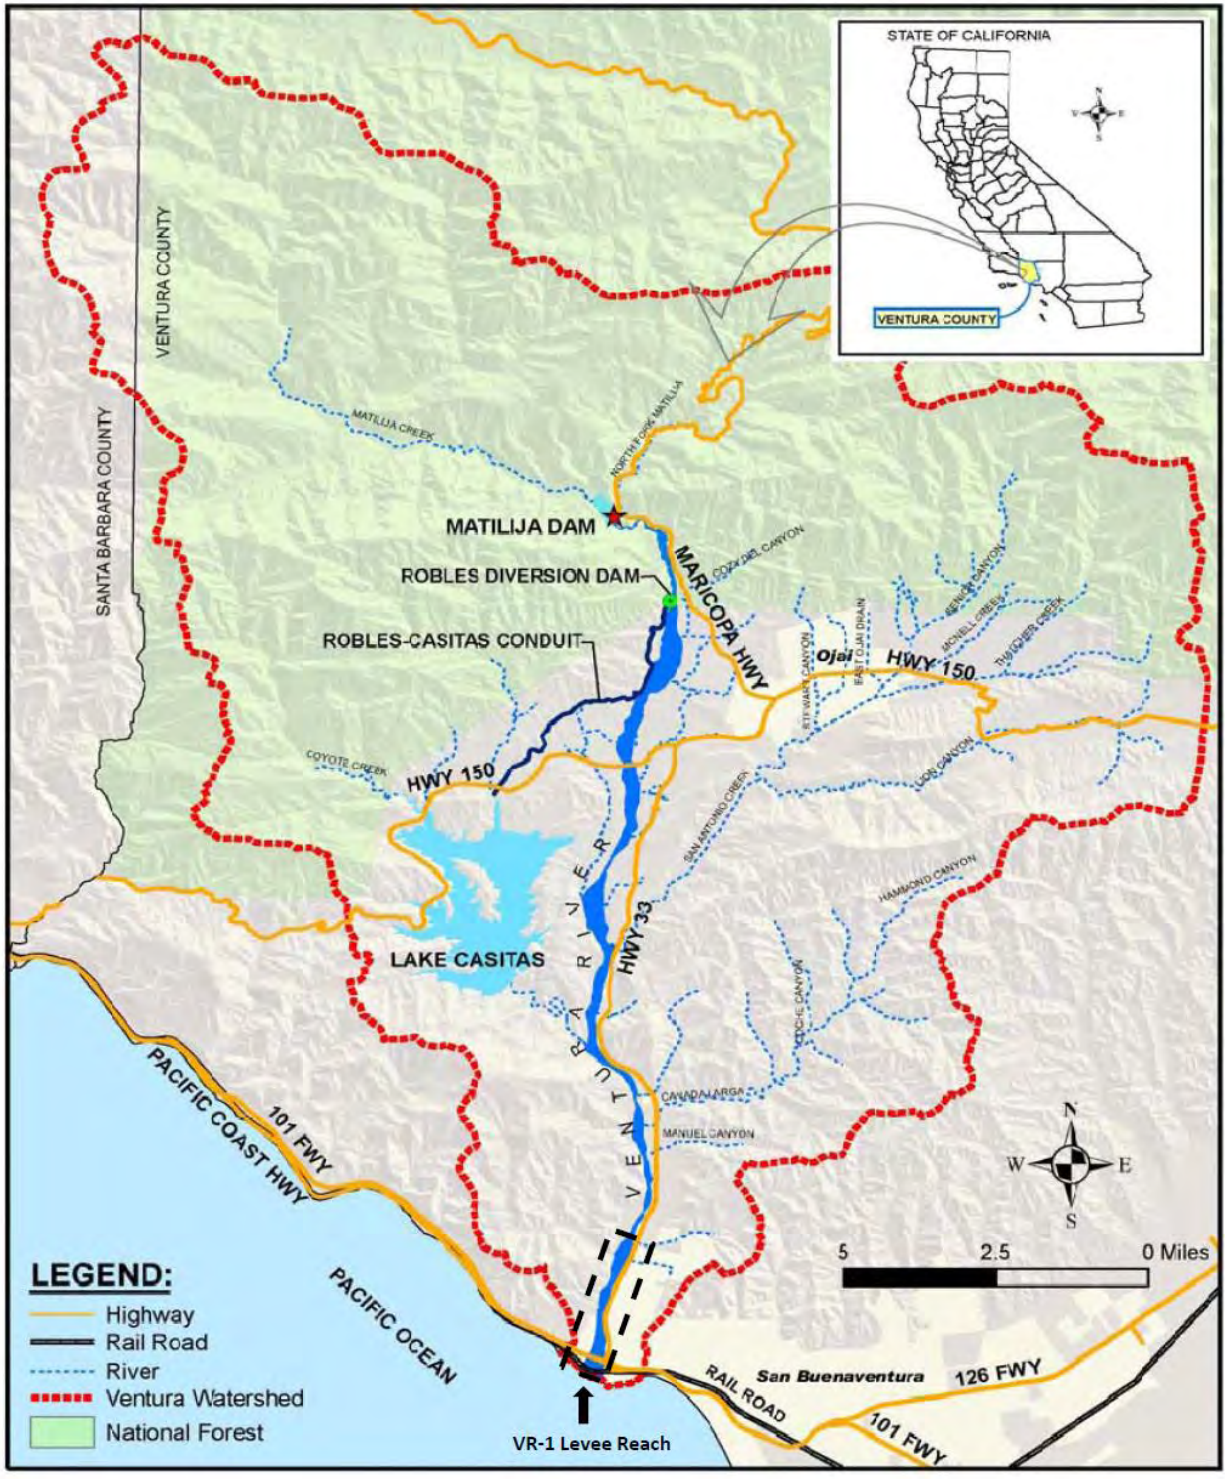
Figure 1: Ventura River Watershed. (Matilija Dam Ecosystem Restoration Feasibility Report, USACE 2004)

The project area is located within San Buenaventura (Ventura), California, along the Ventura River. Figure 1 shows the Ventura River Watershed, with the study area outlined at the bottom center. Figure 2 is an aerial photograph showing the levee alignment from the Pacific Ocean to the Canada de San Joaquin.

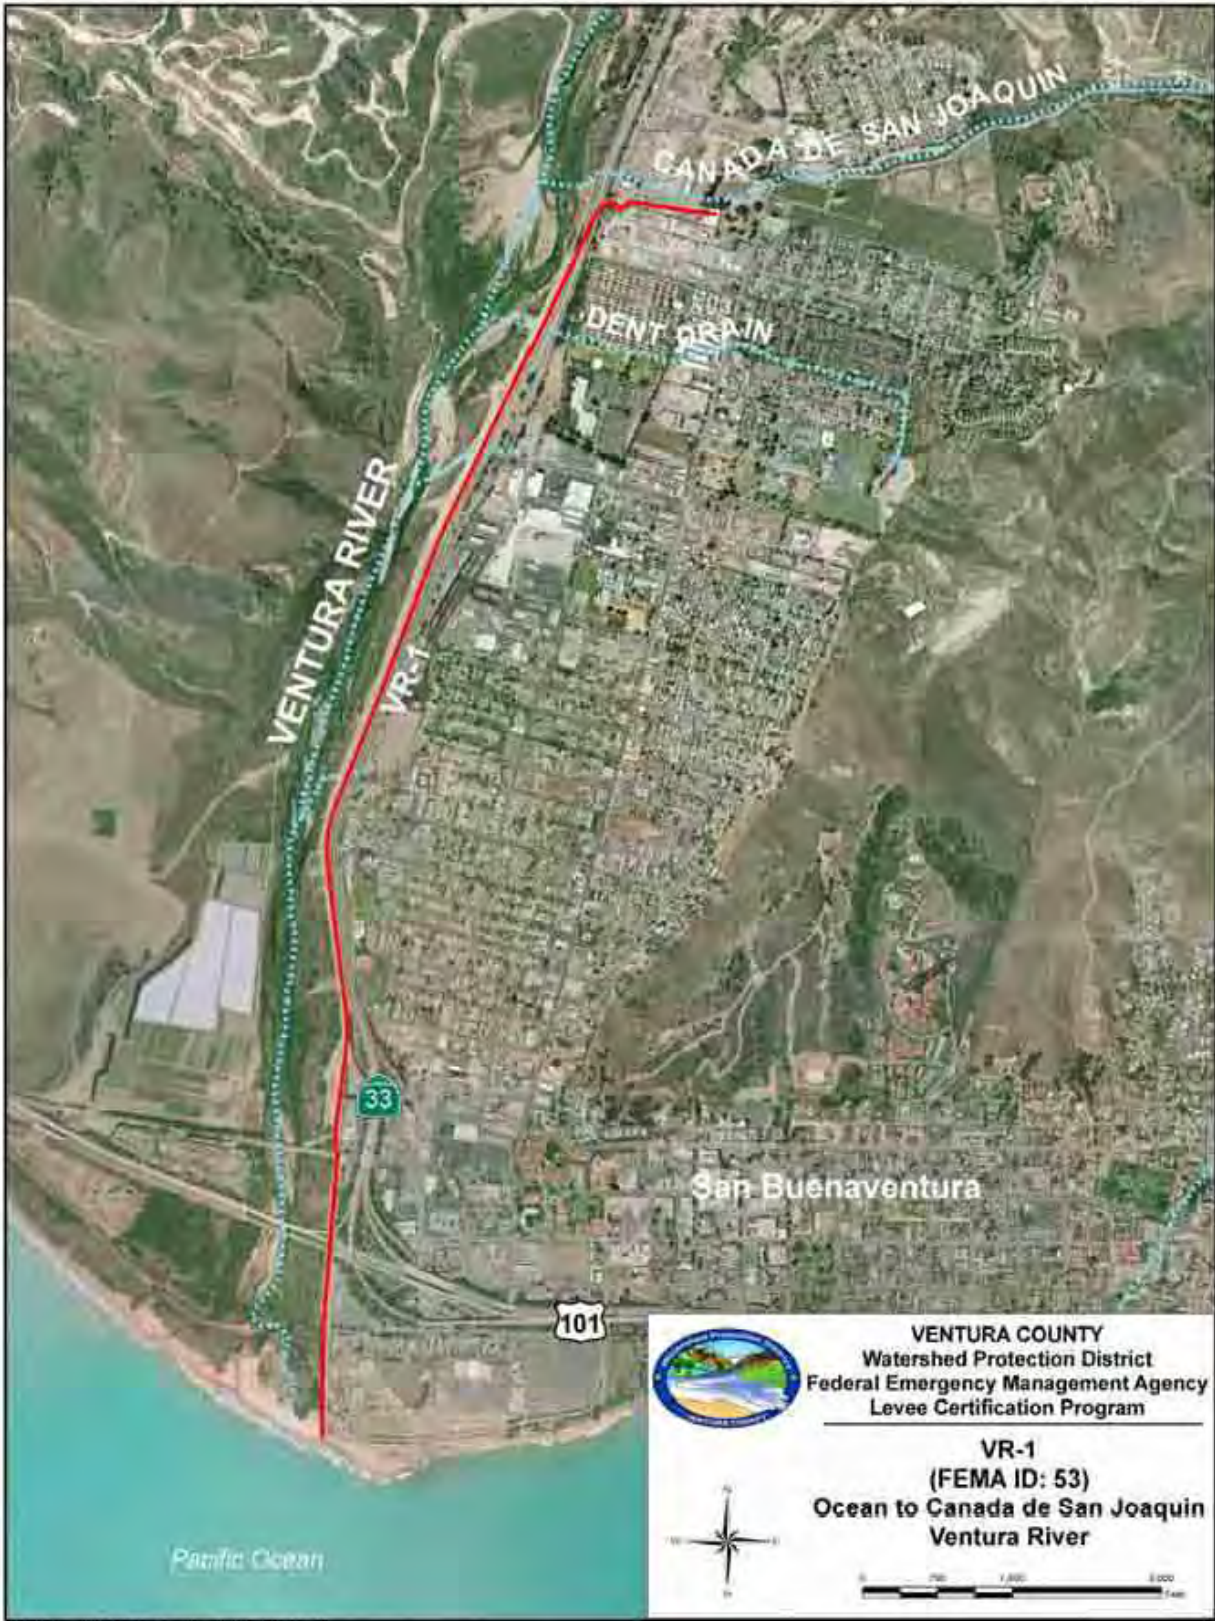
Figure 2: Location Map for Ventura River Levee (VR-1)

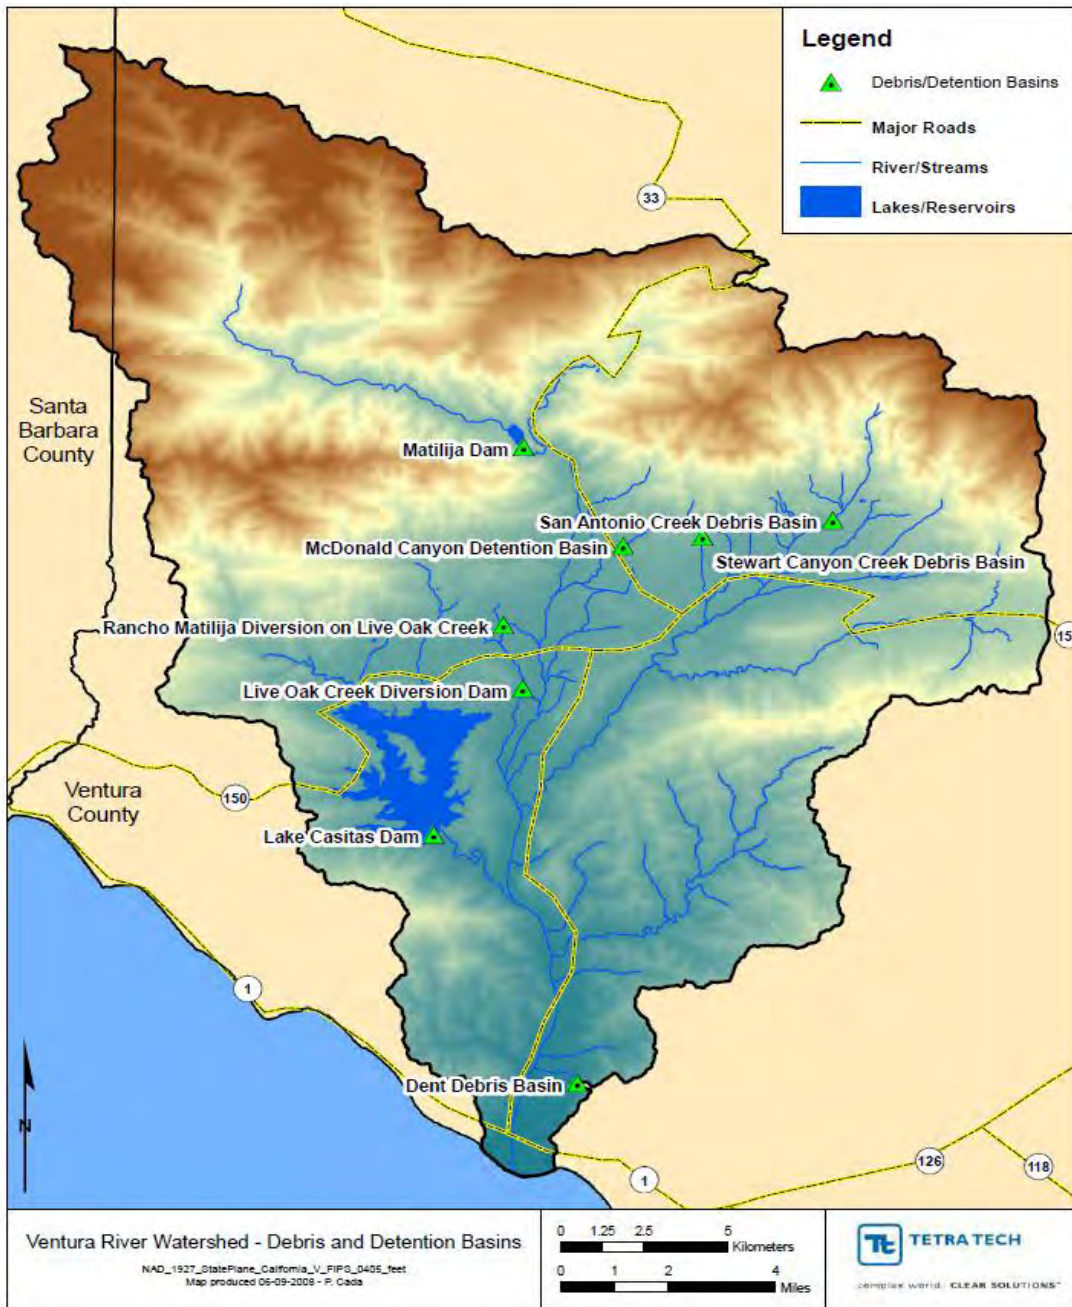
Figure 3: Dams and Debris Basins within the Ventura River Watershed

Large manmade features affecting the watershed include the following dams and debris basins. Figure 3 depicts locations of structures throughout the watershed.

- Matilija Dam, built in 1948
- Casitas Dam, built in 1959
- Robles Diversion Dam, built in 1958
- McDonald Detention Basin, built in 1998
- San Antonio Creek Debris Basin, built in 1986
- Stewart Canyon Debris Basin, built in 1963
- Dent Debris Basin, built in 1950, modified in 1981
