# Ventura River Levee Rehabilitation (VR-1)

Public Meeting Presentation

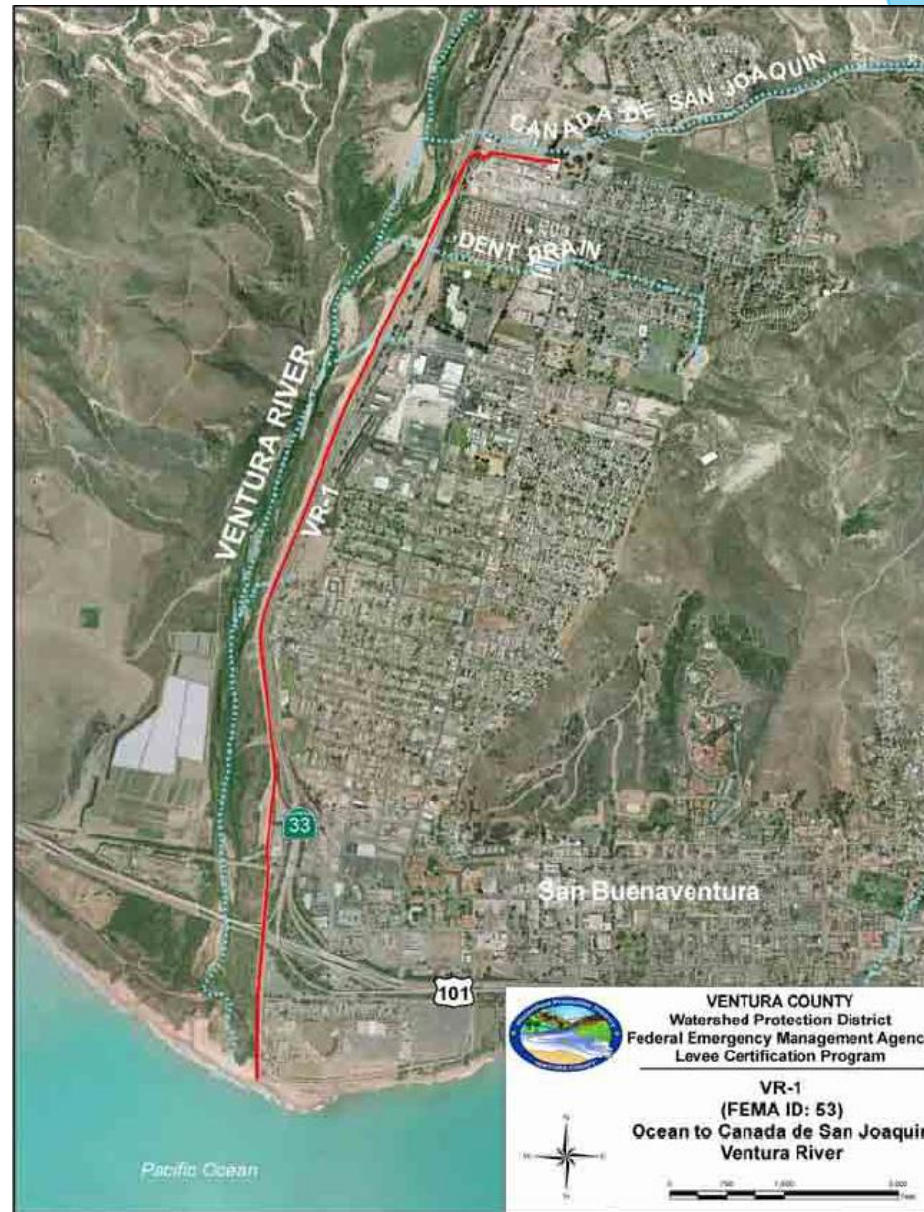
# Location of the Ventura River VR-1 System

- ▶ 2.65-mile-long levee system
- ▶ Extends along eastern bank of the Ventura River from the Pacific Ocean to the confluence with the Cañada de San Joaquin
- ▶ Extends 1000 ft east along the southern bank of the Cañada de San Joaquin

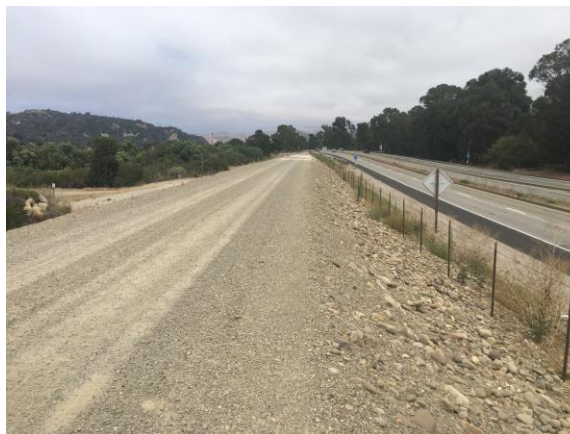
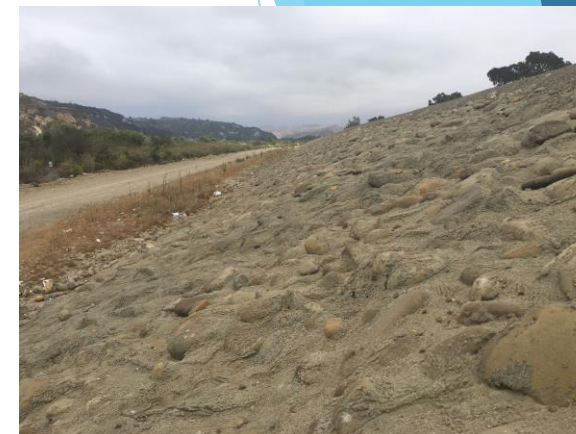
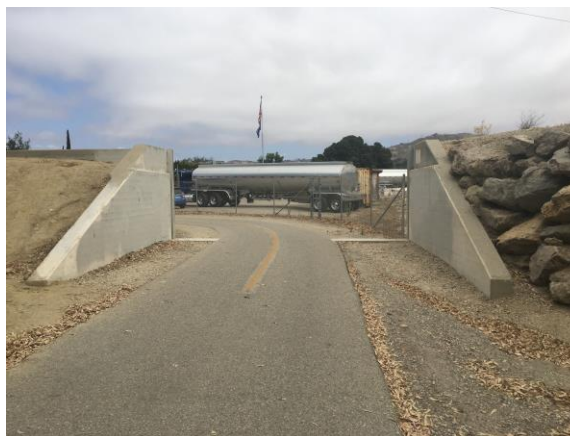
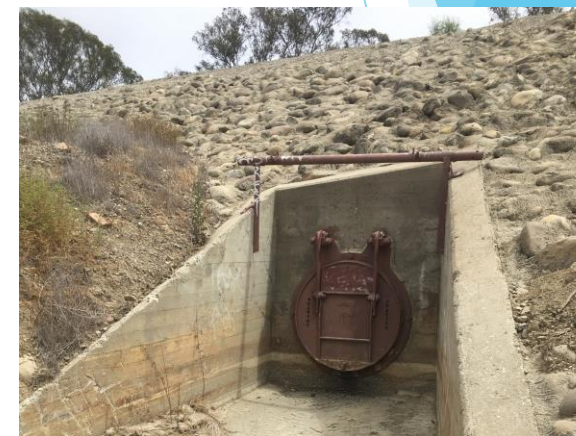
# Levee system components

- ▶ Embankment
- ▶ Side-slope protection (riverside) consisting of loose or grouted riprap, concrete floodwalls
- ▶ Side-drainage penetrations
- ▶ Stop-log structure at a bike trail crossing

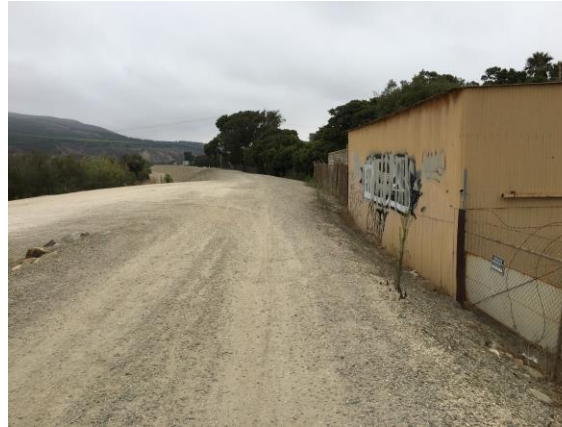
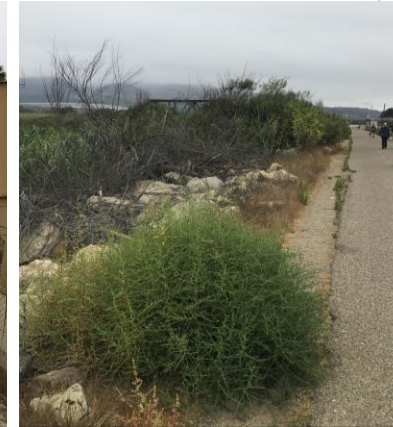
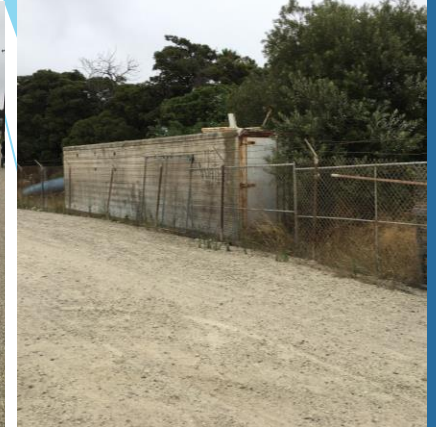
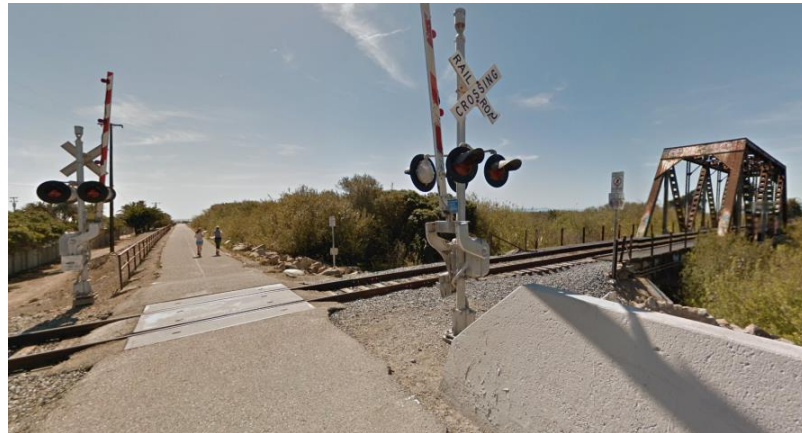
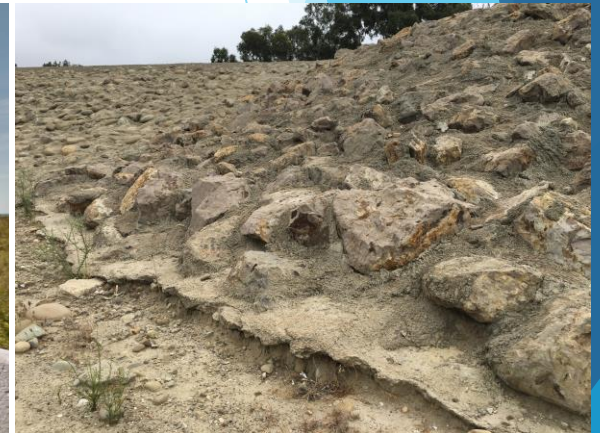
# Ventura River VR-1 System Deficiencies

- ▶ Encroachments into levee
- ▶ Vegetation Management D/S of UPRR
- ▶ Toe-down scour protection
- ▶ Freeboard
- ▶ Railroad Gap

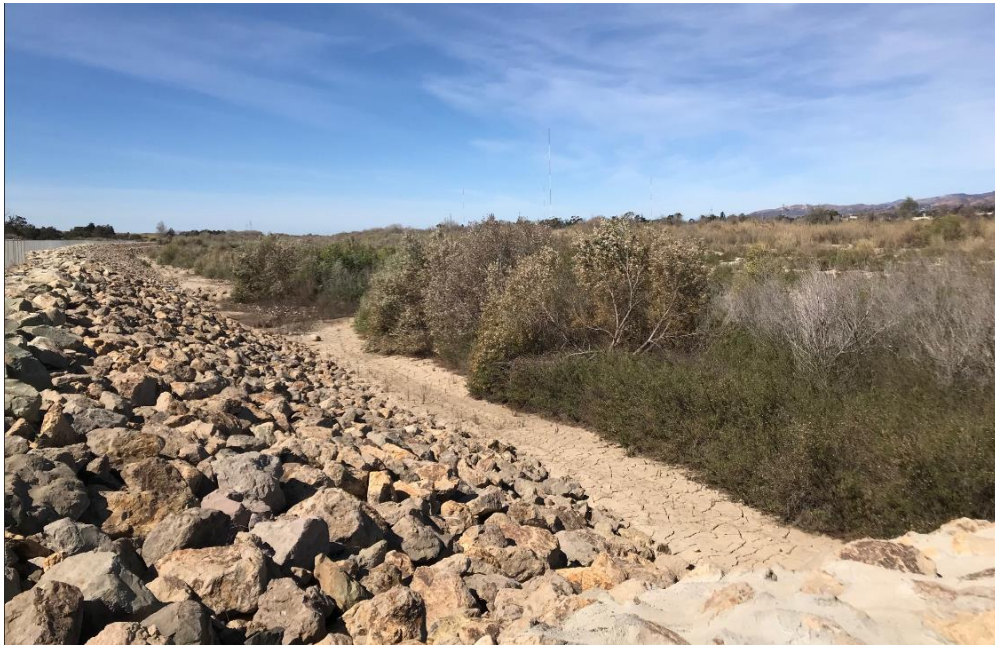
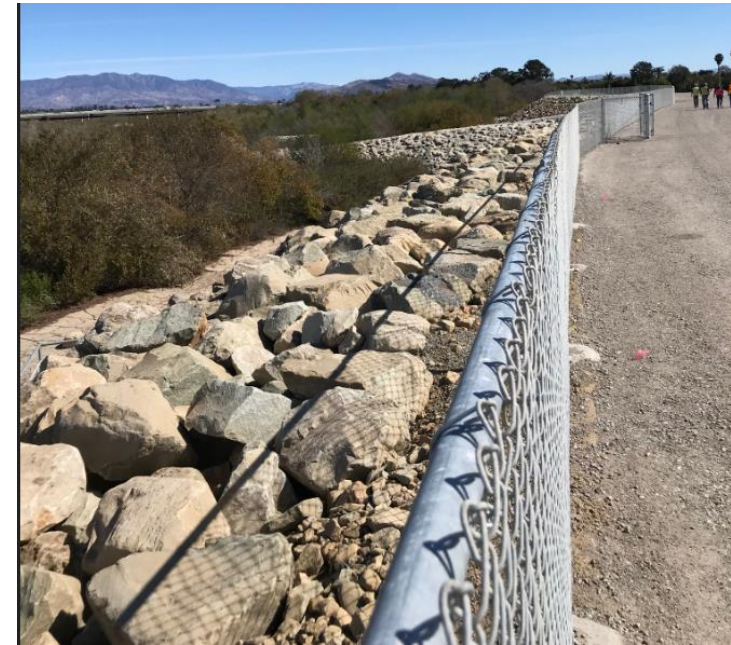
# Example of rock riprap bank protection

- ▶ Photo of recently completed Santa Clara River Levee (SCR-3) bank protection using rock riprap

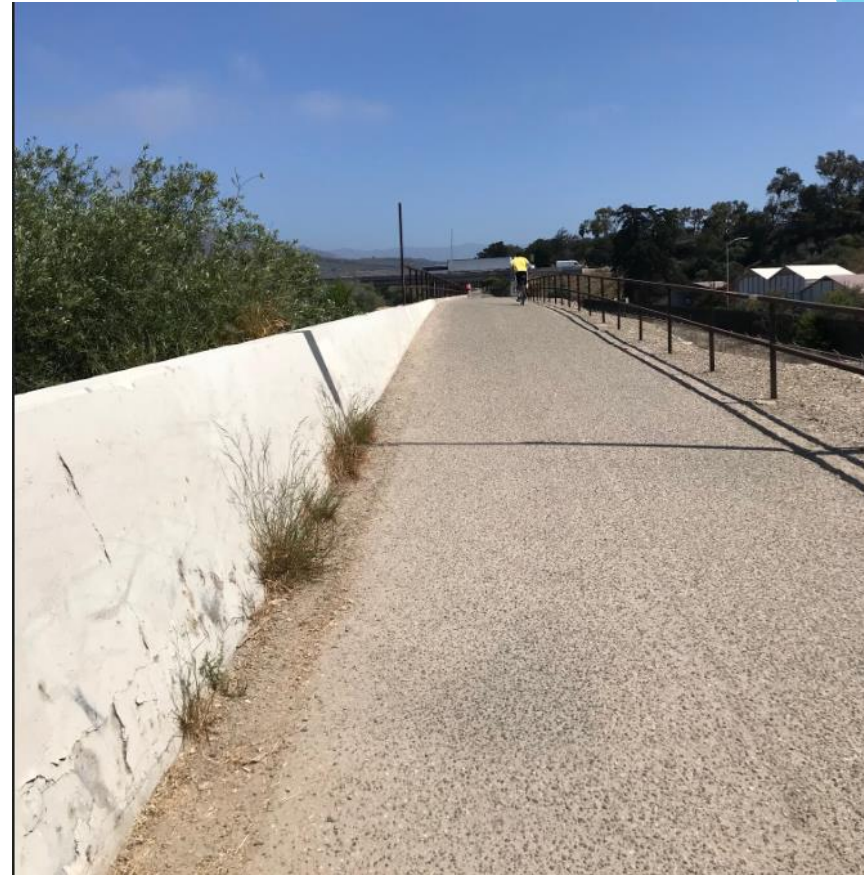
# Floodwall Alternatives

- ▶ Increase floodwall height, OR
- ▶ Replace floodwall if wall is structurally deficient
- ▶ Photo shows existing floodwall installed by USACE
