Stormwater Pollution Prevention

September 21, 2015

Presentation for

Oak Park Community

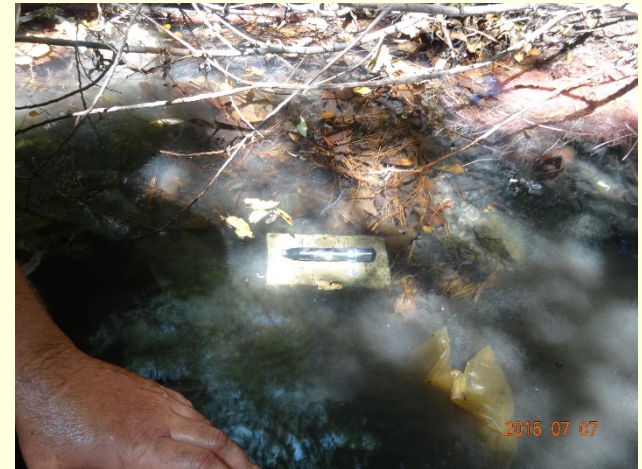
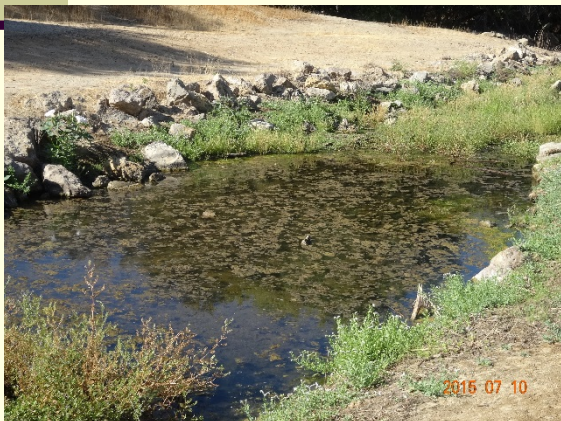
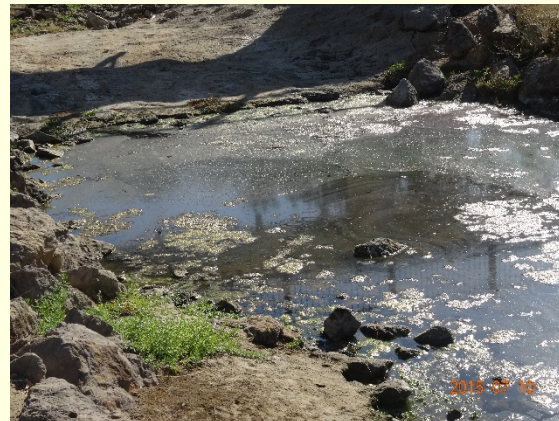
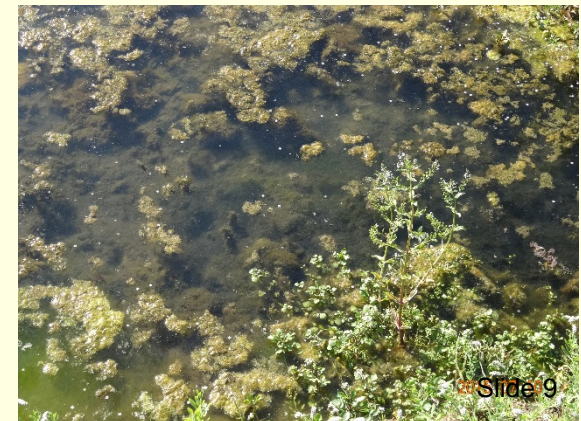
- Visual observations
 - 24 locations;
 - Mondays & Thursdays for 5 weeks (July/August, 2015);
- Installed level loggers for continuous monitoring to identify flow patterns (12 different sites).

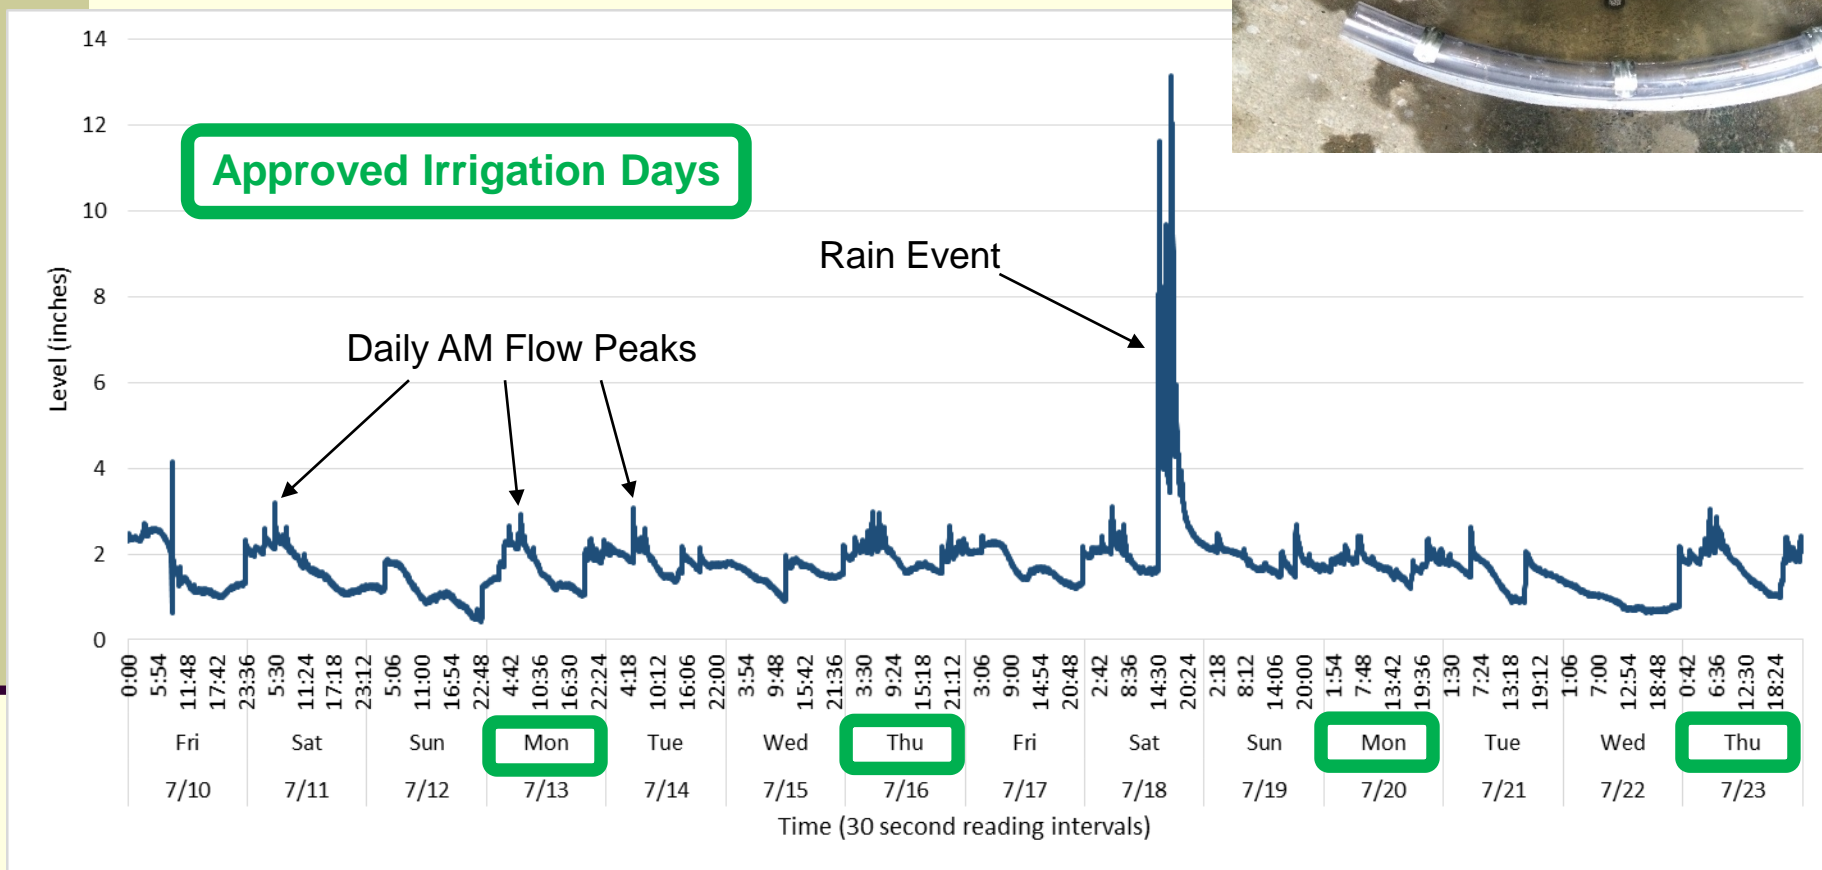
Example of flow monitoring data from outfall M01

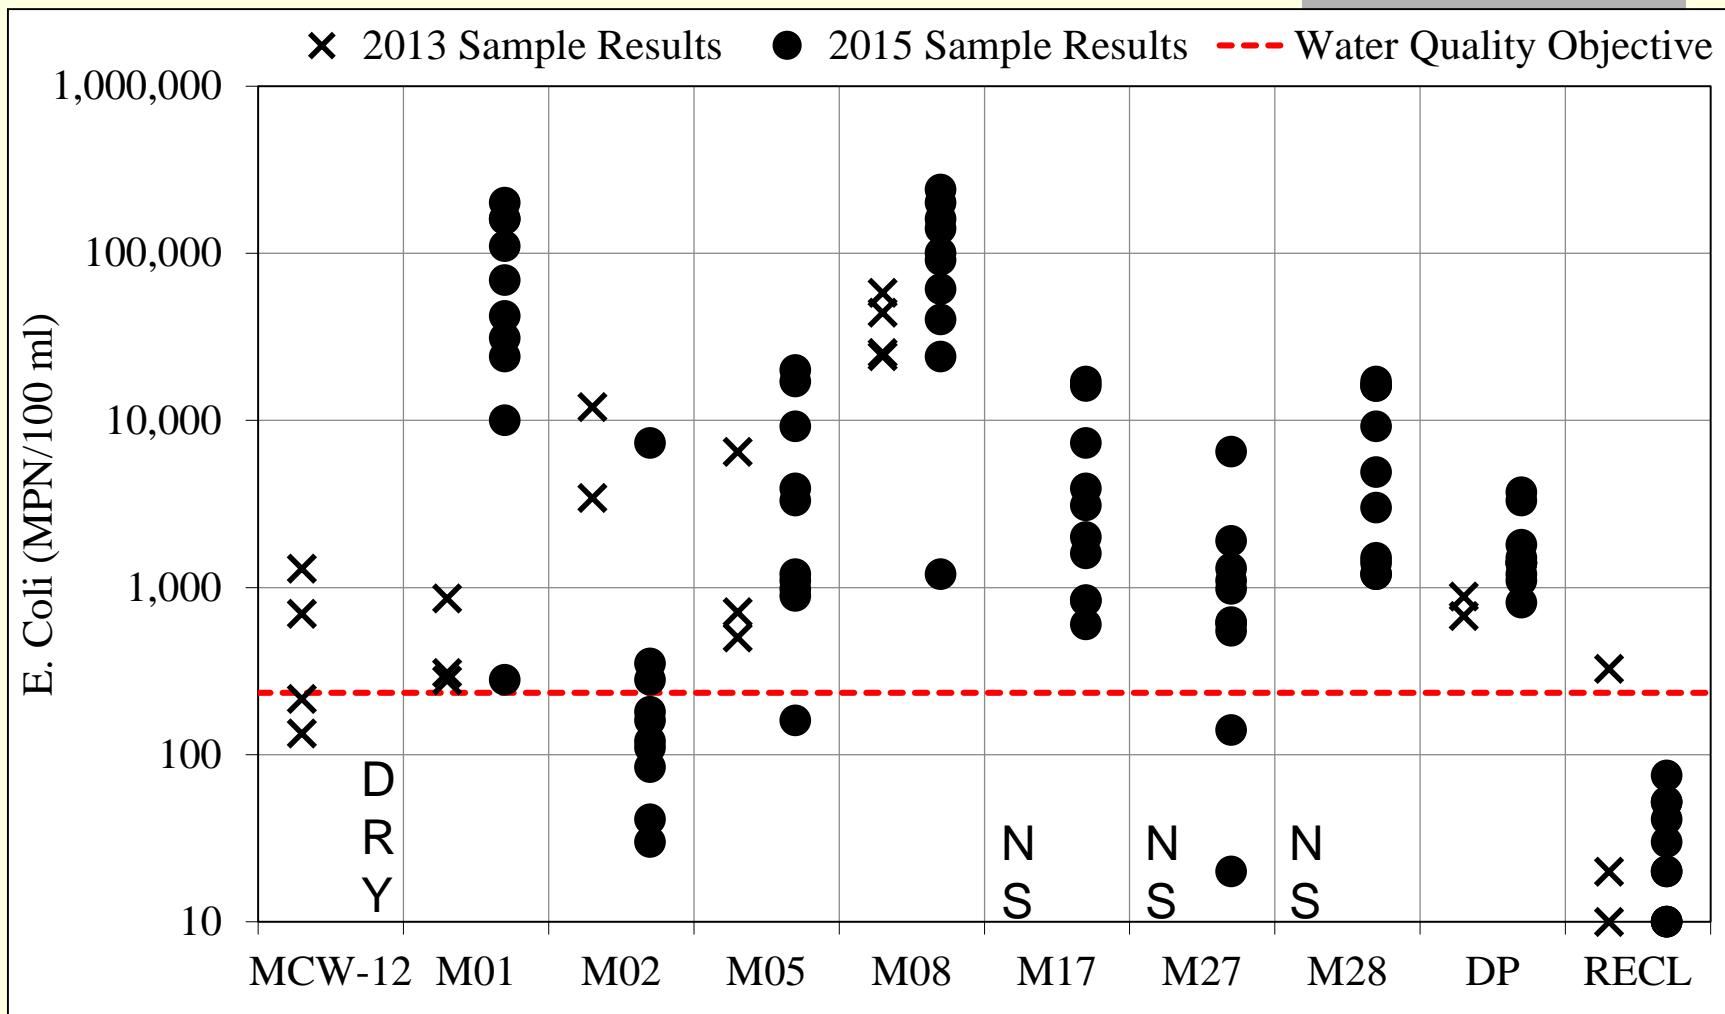
Bacteria Testing Results

"NS" – not sampled

Bacterial WQO Exceedance

■ % > 235 MPN/100ml

■ % < 235 MPN/100ml

- Prohibited dry weather flow is present at majority of outfalls, primarily from irrigation runoff
 - Daily, including days when irrigation is prohibited
- Bacteria levels frequently exceeded allowable limits
- **Dry weather flows, which are persistent and high in bacteria, need to be either eliminated or treated to achieve compliance**

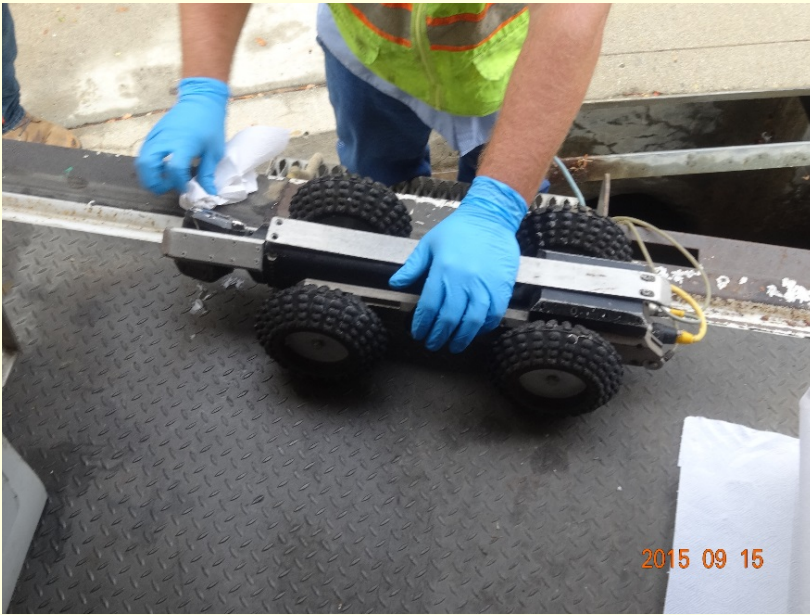
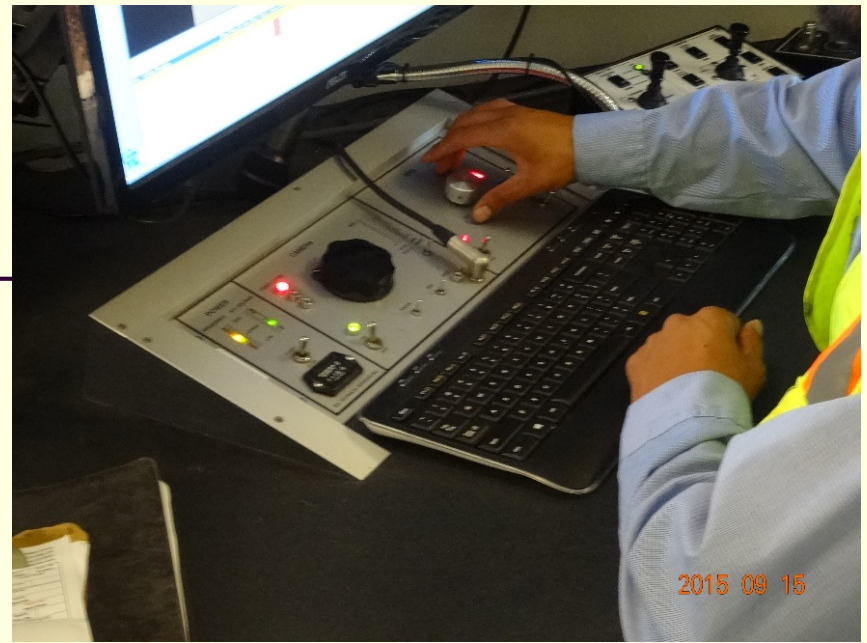
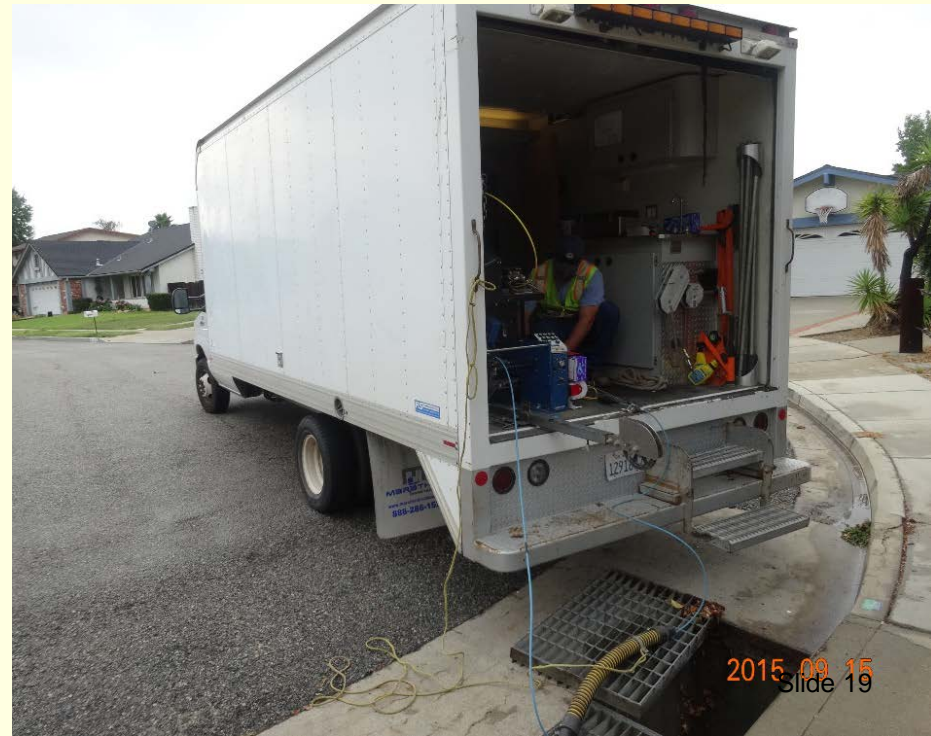
Outfall	Street	CCTV (feet)	% of Network	Notes
M01	Medea Creek Ln	1000	50%	2 locations animal feces in flow path
M02	Tamarind Ln	80	100%	none
M05	Conifer St	400	100%	2 pipe sags, 1 illegal dump
M08	Oak Hills St	500	10%	1 illegal connection, 4 potential intrusion stains

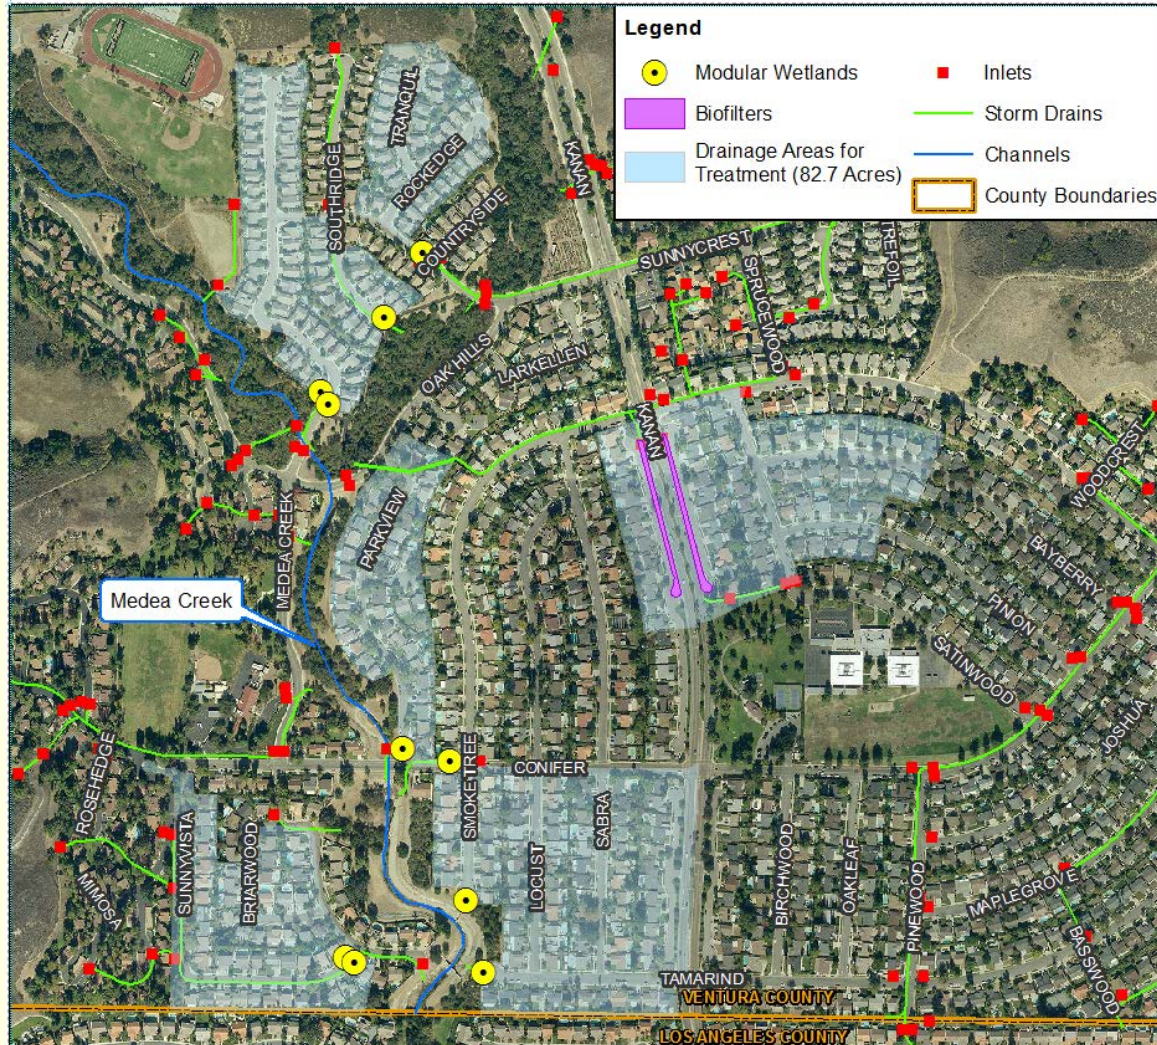
Proposed Kanan Biofilters and 10 distributed Modular Wetlands

No.	Community Comments	Effectiveness	Cost
26	Treatment in creek (Medea or Lindero), creek used for treatment	Green	Red
27	Compliance methods in LA County (City of Agoura Hills Regional Project)	Green	Red
28	Biofilters at outfalls	Green	Red
29	Proposed project: Kanan Biofilters & 10 distributed Modular Wetlands	Green	Green

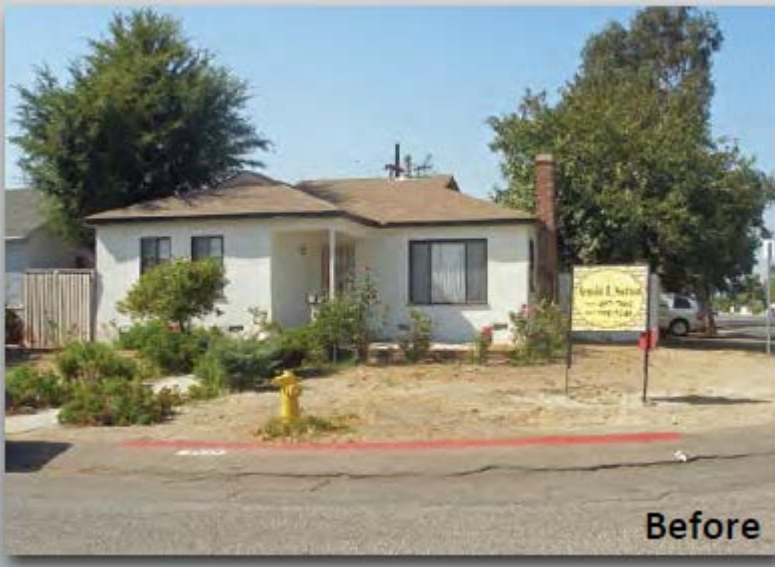
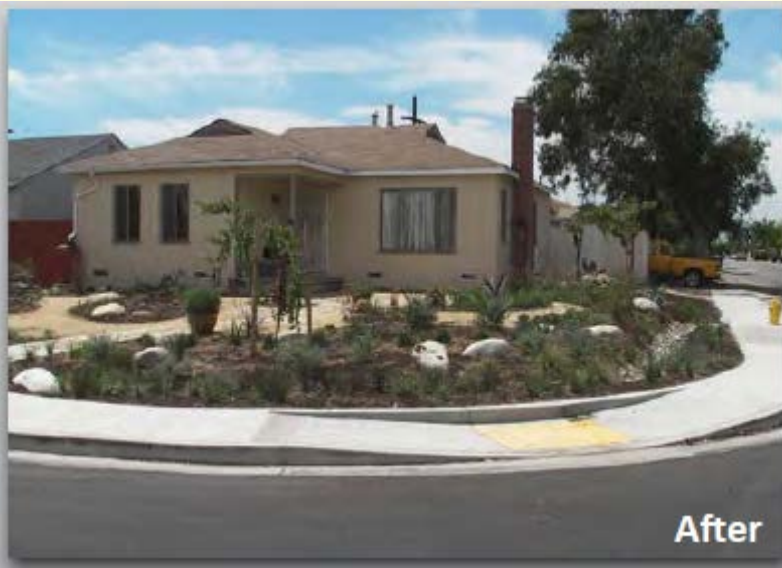
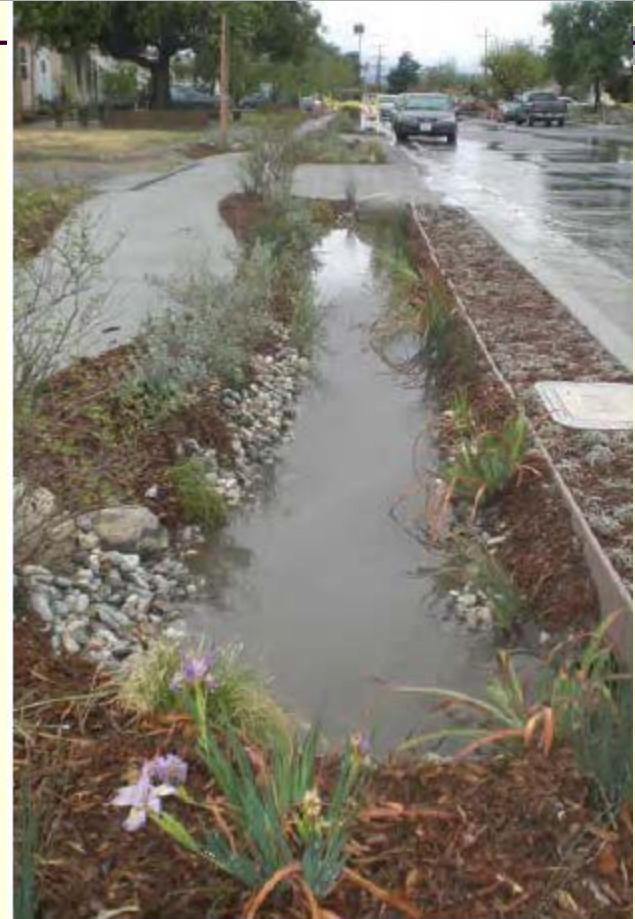
Stormwater flows through a curb inlet into a bioswale on Elmer Street. The water infiltrates into the soil within a day, preventing breeding mosquitoes.
