FEMA Levee Certification
Ventura County, California

Ventura River Levee (VR-1)
Pacific Ocean to Canada de San Joaquin

Evaluation Report
February 20, 2009

Evaluation Report

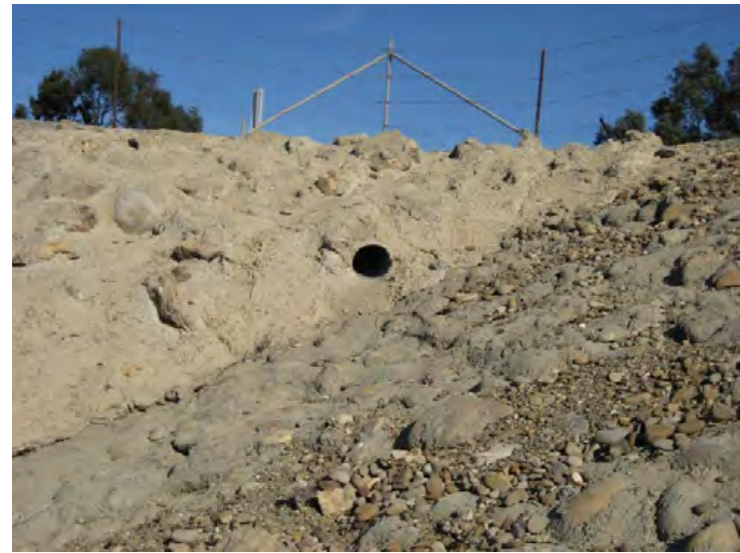
Ventura River Levee, From Ocean to Canada de San Joaquin. (Photo No. P3) - 12" CMP, drains turn out area adjacent to Hwy 33 (riverward side)

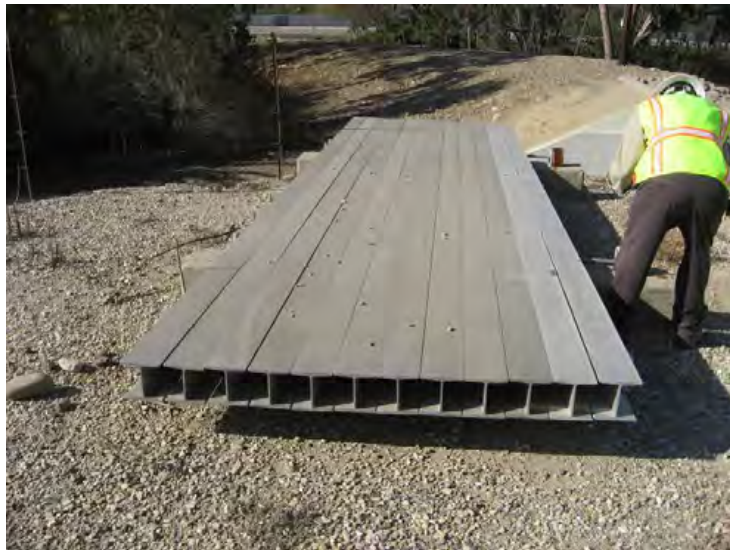
Ventura River Levee, From Ocean to Canada de San Joaquin. (Photo No. P2) - 12 beams for stop log system located on top of levee

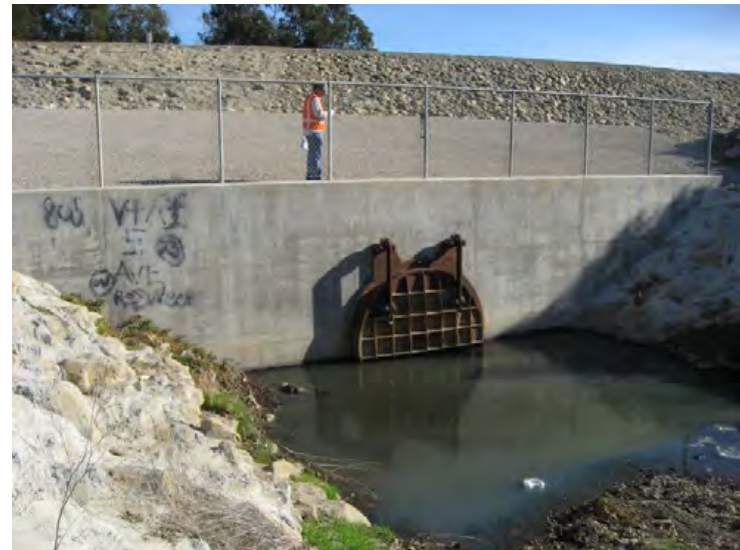
Ventura River Levee, From Ocean to Canada de San Joaquin. (Photo No. P4) - 90" RCP with flap gate, New Dent Drain (riverward side)

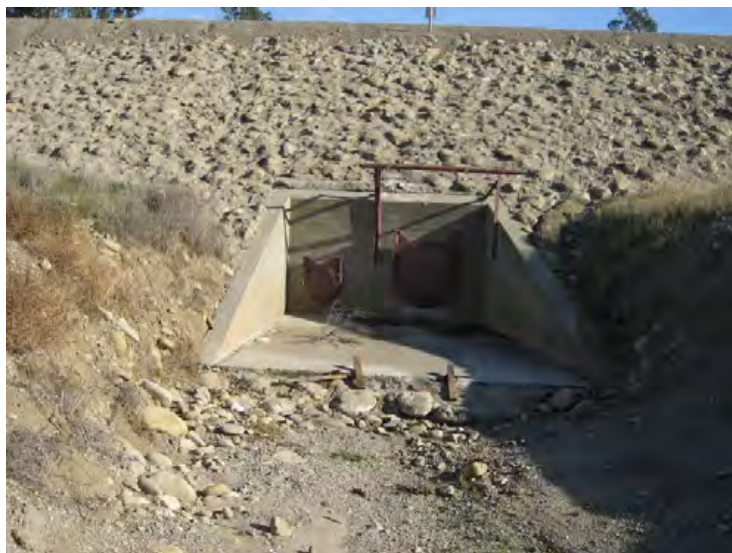
Ventura River Levee, From Ocean to Canada de San Joaquin. (Photo No. P5) - 24" & 42" CMP with flap gates, Old Dent Drain (riverward side)

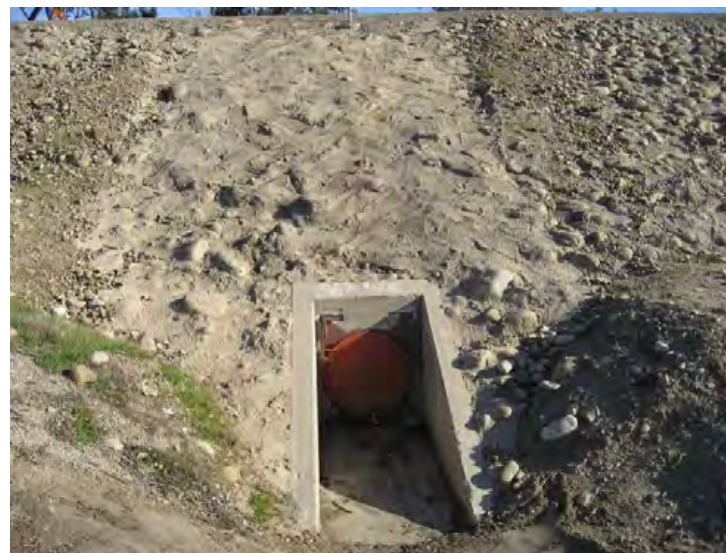
Ventura River Levee, From Ocean to Canada de San Joaquin. (Photo No. P7) - 36" Flap Gate, FWY #4 Drain (riverward side)

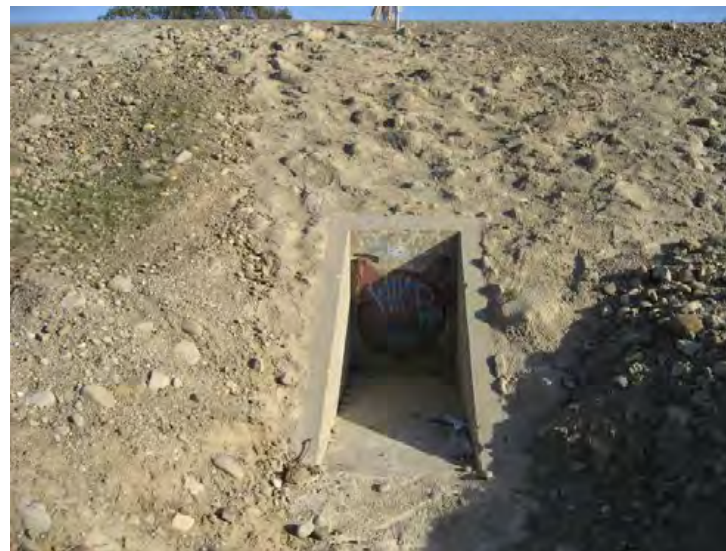
Ventura River Levee, From Ocean to Canada de San Joaquin. (Photo No. P8) - 36" Flap Gate, Vince Drain (riverward side)

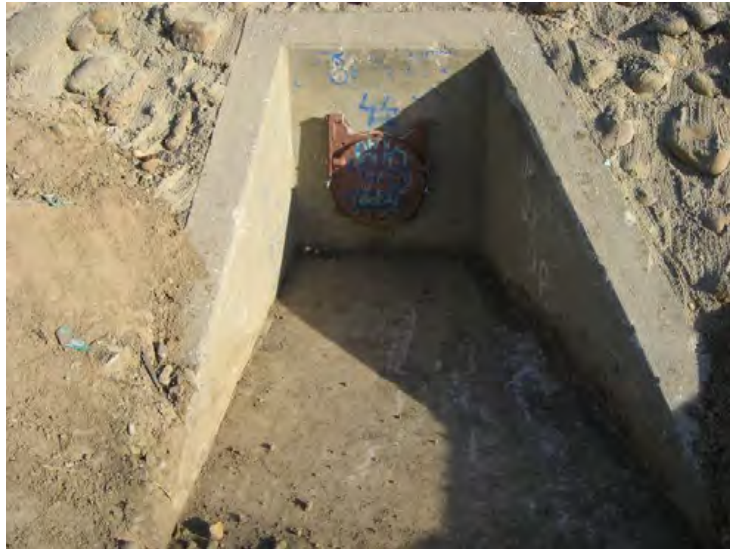
Ventura River Levee, From Ocean to Canada de San Joaquin. (Photo No. P9) - 24" CMP with flap gate, FWY #3 Drain (riverward side)

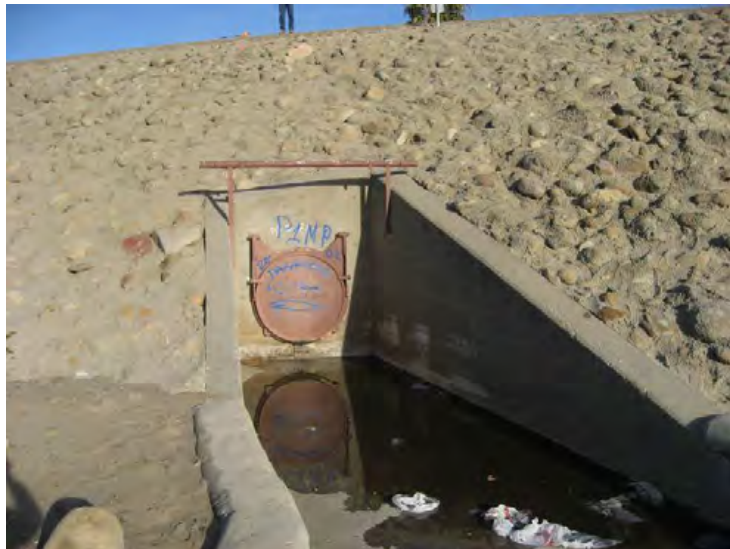
Ventura River Levee, From Ocean to Canada de San Joaquin. (Photo No. P10) - 48" CMP with flap gate, FWY #2 Drain (riverward side)

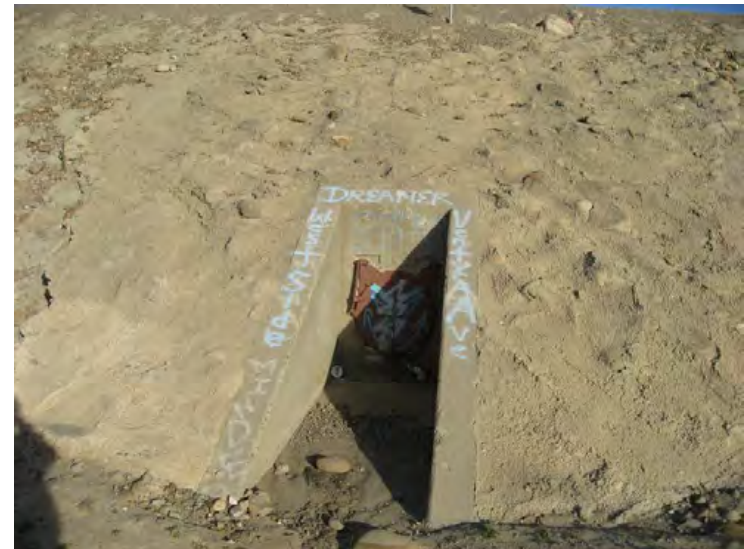
Ventura River Levee, From Ocean to Canada de San Joaquin. (Photo No. P12) - 24" RCP with flap gate, FWY #1 Drain (riverward side)

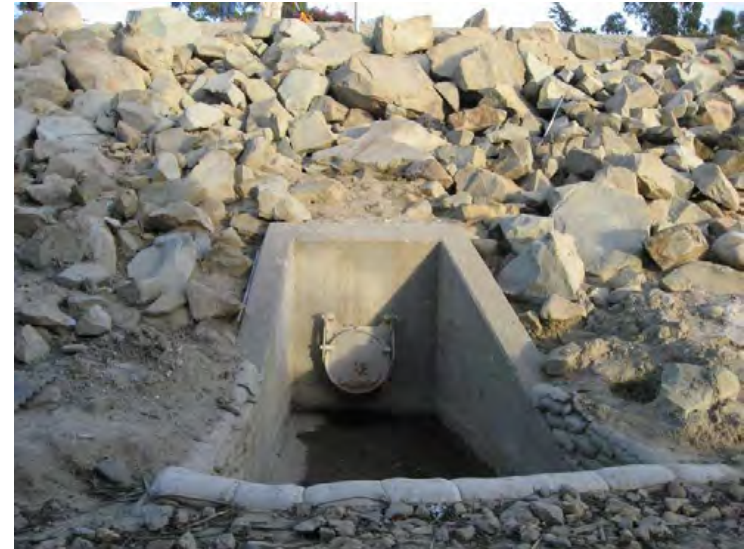
Ventura River Levee, From Ocean to Canada de San Joaquin. (Photo No. P15) - 24" CMP with flap Gate, Peking Drain (riverward side)

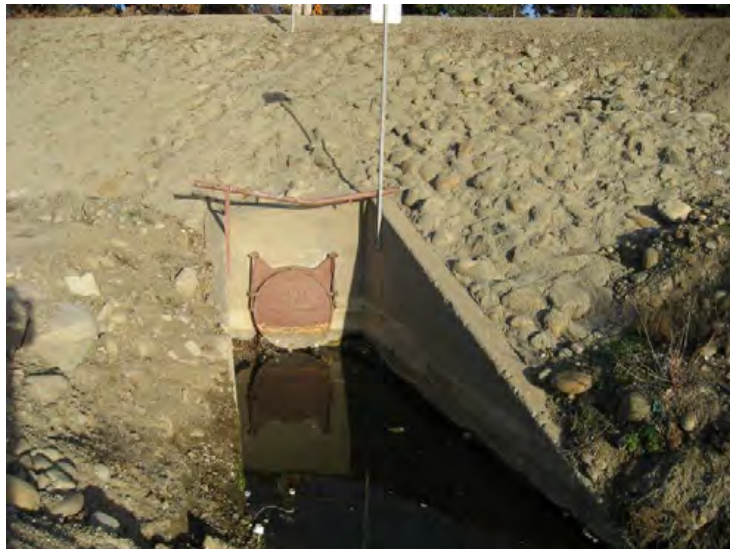
Ventura River Levee, From Ocean to Canada de San Joaquin. (Photo No. P14) - 48" CMP with flap gate, Harrison Drain (riverward side)

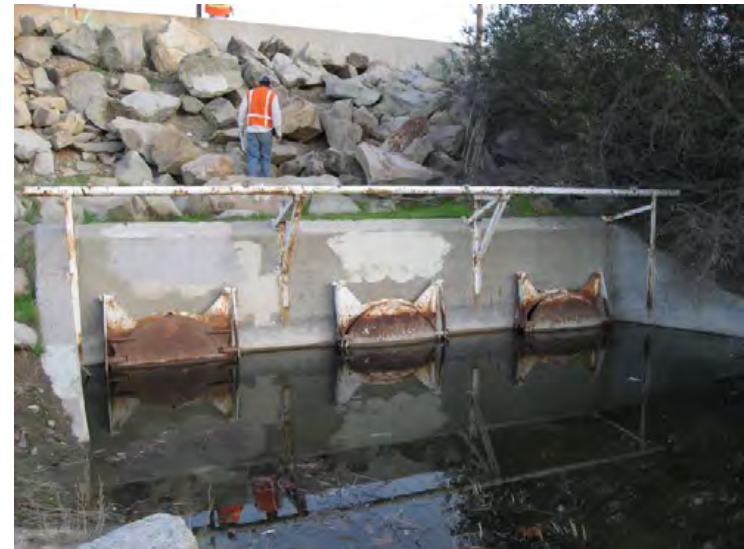
Ventura River Levee, From Ocean to Canada de San Joaquin. (Photo No. P16) - 3-48" CMP with flap gates (riverward side)

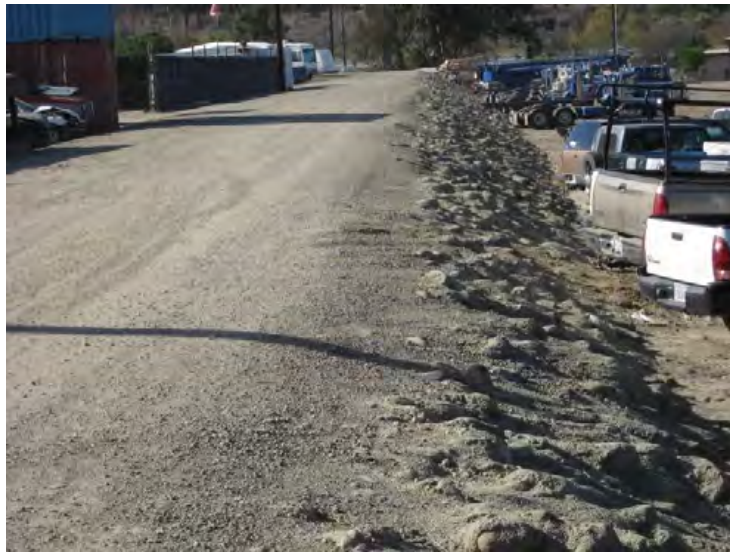
Ventura River Levee, From Ocean to Canada de San Joaquin. (Photo No. F1) – Top of levee looking downstream at grouted levee bank (riverward)

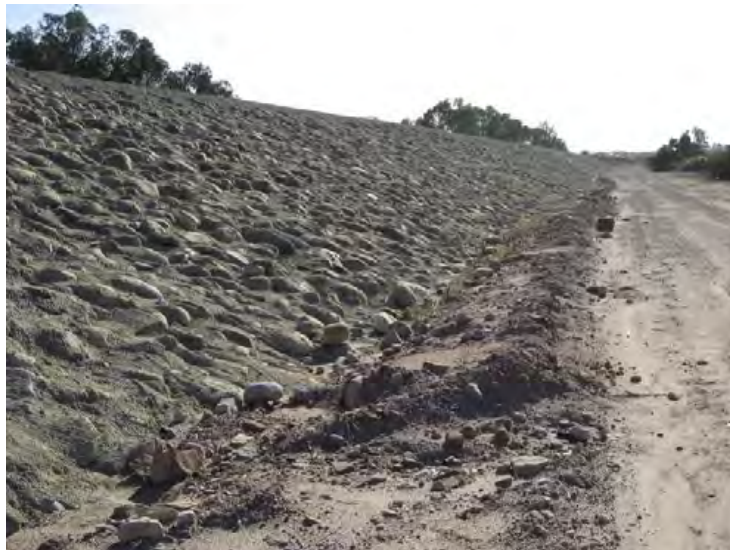
Ventura River Levee, From Ocean to Canada de San Joaquin. (Photo No. F2) – At toe of levee looking downstream (riverward side)

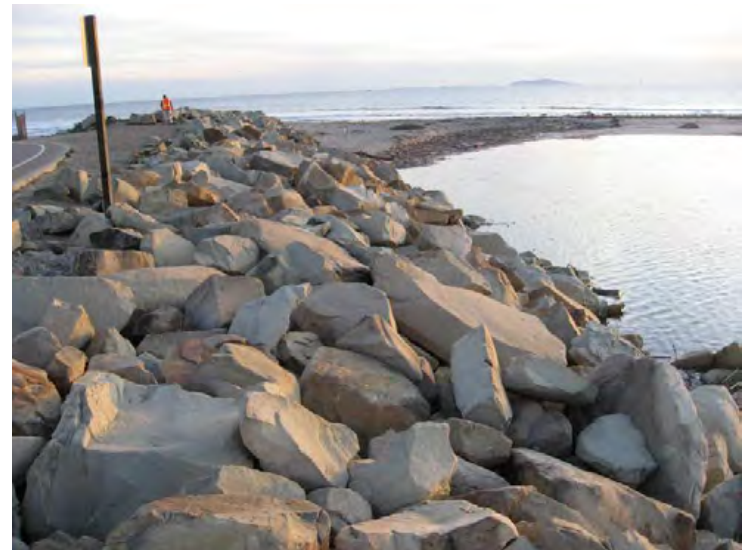
Ventura River Levee, From Ocean to Canada de San Joaquin. (Photo No. F4) – Looking d/s at ungrouted levee bank protection (riverward side)

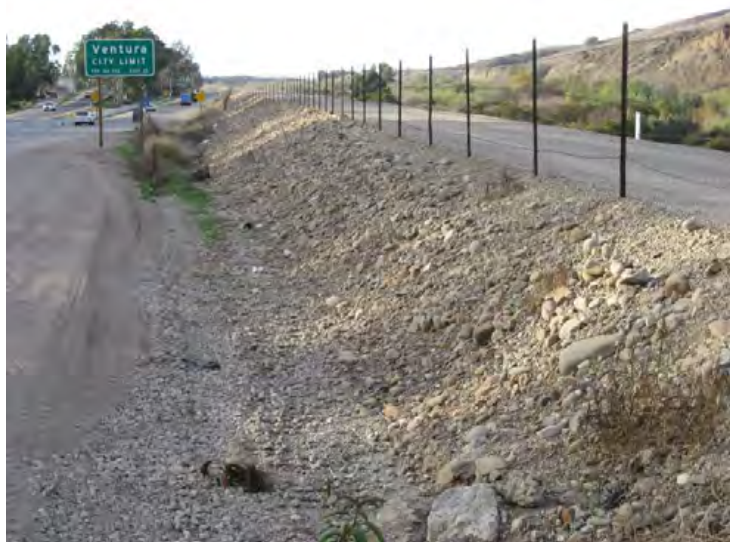
Ventura River Levee, From Ocean to Canada de San Joaquin. (Photo No. F5) – Looking downstream at levee embankment & toe (landward side)

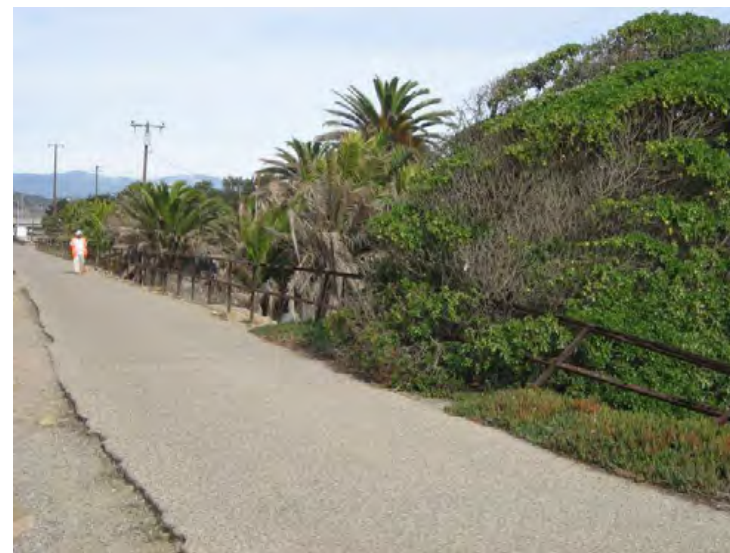
Ventura River Levee, From Ocean to Canada de San Joaquin. (Photo No. F7) – Looking u/s at bike path on top of levee (landward side)

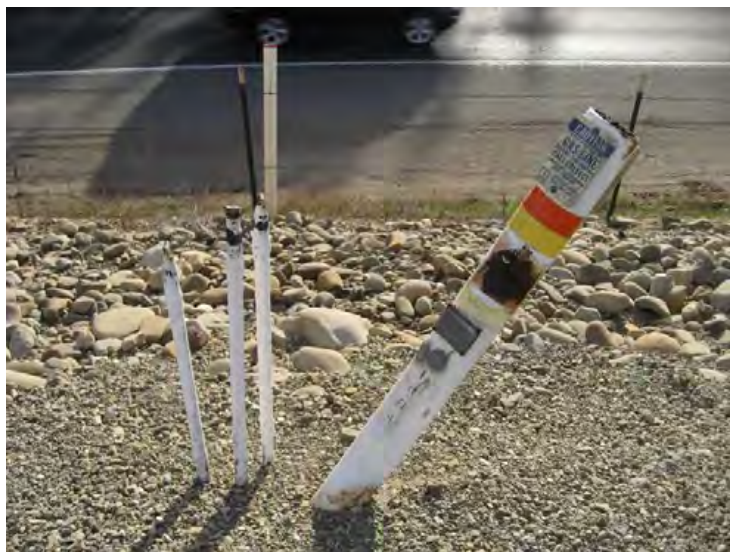
Ventura River Levee, From Ocean to Canada de San Joaquin. (Photo No. F6) – Gas line crossing (landward side)

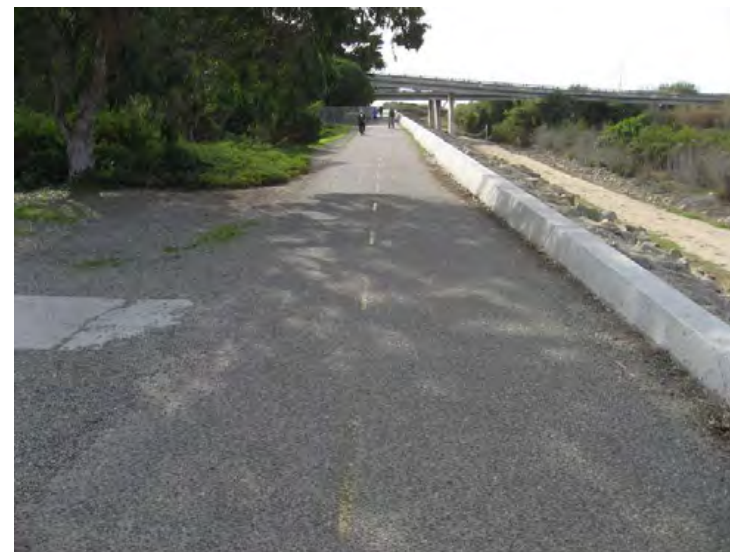
Ventura River Levee, From Ocean to Canada de San Joaquin. (Photo No. F8) – Looking d/s at bike path and flood wall on top of levee
