VENTURA RIVER 1 LEVEE SYSTEM
VENTURA COUNTY, CALIFORNIA
NLD ID # 380510086

PERIODIC INSPECTION REPORT NO 1
GENERALIZED EXECUTIVE SUMMARY
8 JUNE 2012

PERIODIC INSPECTION REPORT PREPARED BY: FUGRO WEST, INC.
SUBMITTED: JUNE 2011
INSPECTED: 25-26 MAY 2010

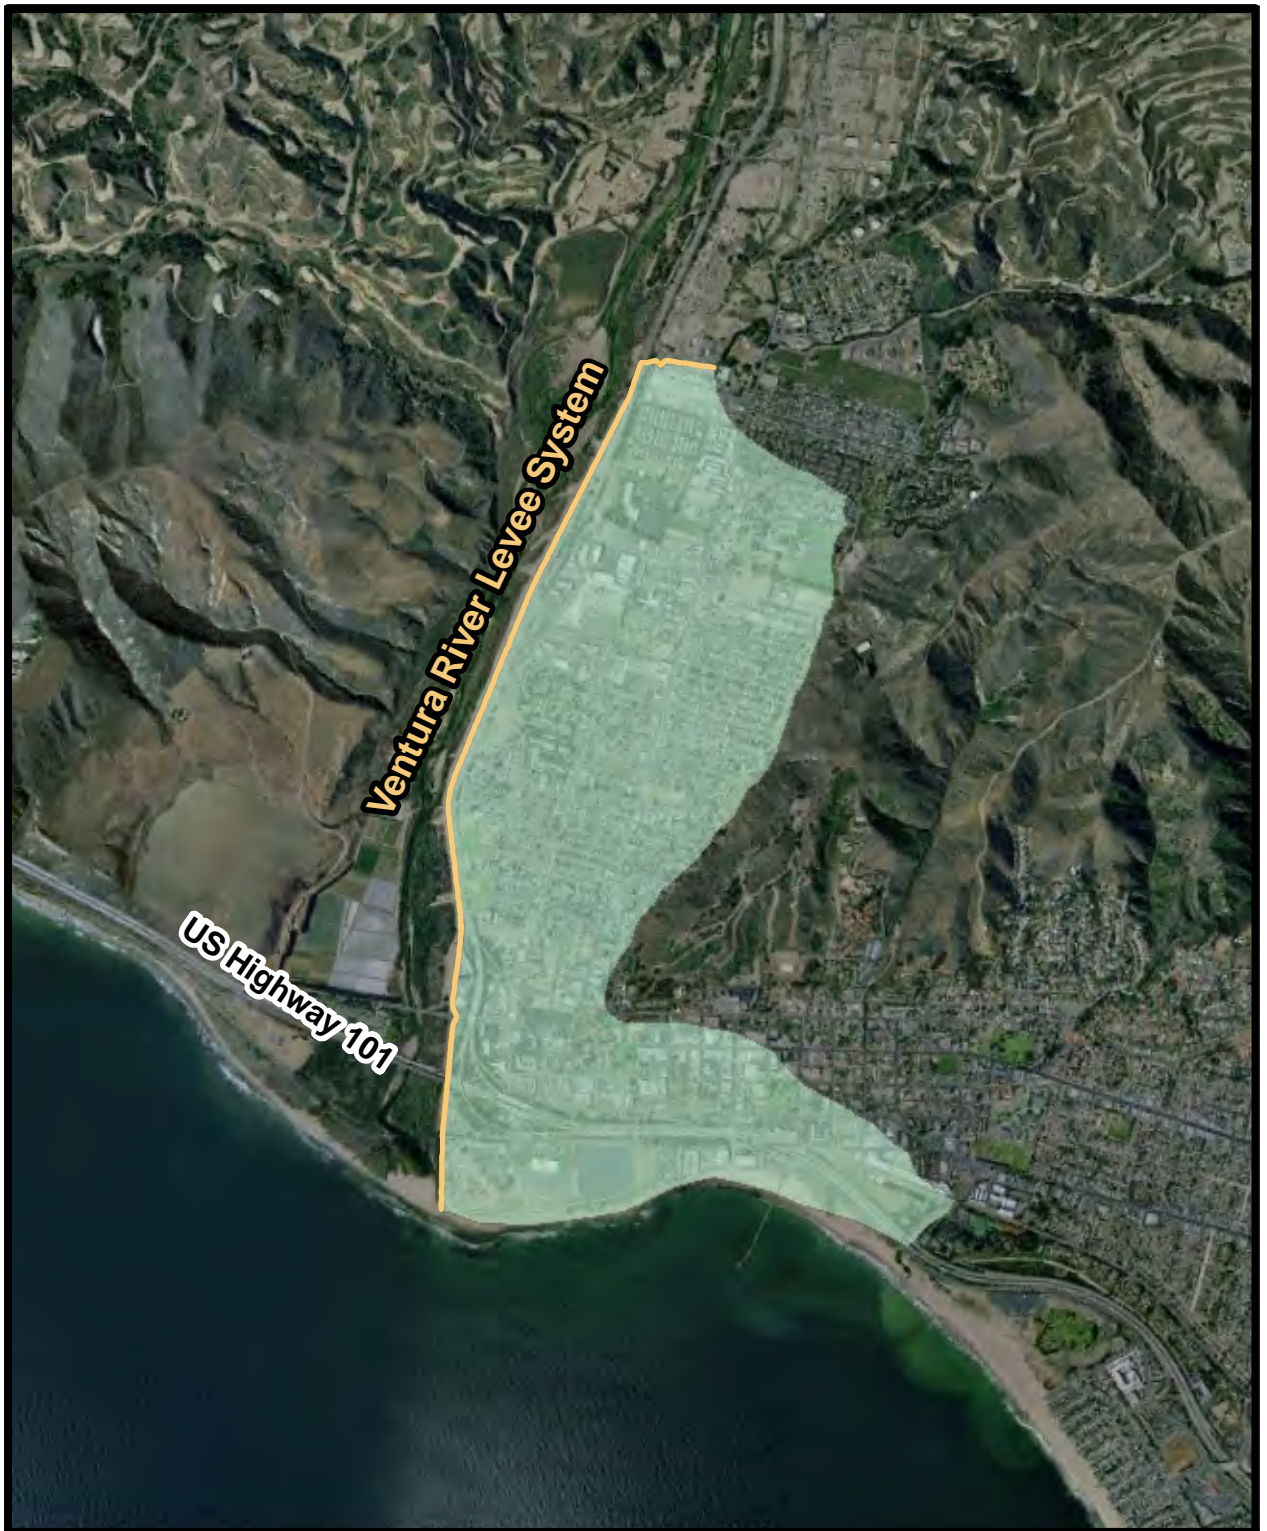
VR-1 is the reach of the Ventura River Levee system that has been designated by the Corps for PI, and consists of an approximate 2.65-mile-long stone-revetted left (east) bank levee that extends from the Pacific Ocean (Station 10+95) to the intersection with Canada de San Joaquin, where it continues approximately 1,100 feet along the left (south) bank of Canada de San Joaquin (Station 150+57). VR-1 provides flood control for the western portion of the City of San Buenaventura (Ventura) and adjacent areas along the Ventura River in Ventura County, California. Construction of the levee was completed by the Corps' L.A. District in December 1948. Other system features include: 15 culverts and side-drainage structures; the Southern Pacific Railroad (SPRR) Main Line Bridge crossing; the U.S. Highway 101 crossing; State Route 33 and Main Street crossings; the Stop-log Closure Structure at the SPRR (Ojai Branch) crossing; and Floodwalls #1 and #2. The Ventura County Watershed Protection District, or VCWPD (County), formerly known as the Ventura County Flood Control District (VCFCD), is the local agency responsible for the operation and maintenance of the levee. Figure 1 shows the location of VR-1.
