VENTURA RIVER LEVEE SECTION 905(b) (WRDA 86) ANALYSIS VENTURA COUNTY, CALIFORNIA

DRAFT-FINAL REPORT

APRIL 2012

Prepared by:
Tetra Tech, Inc
17885 Von Karman Avenue
Irvine, CA 92614

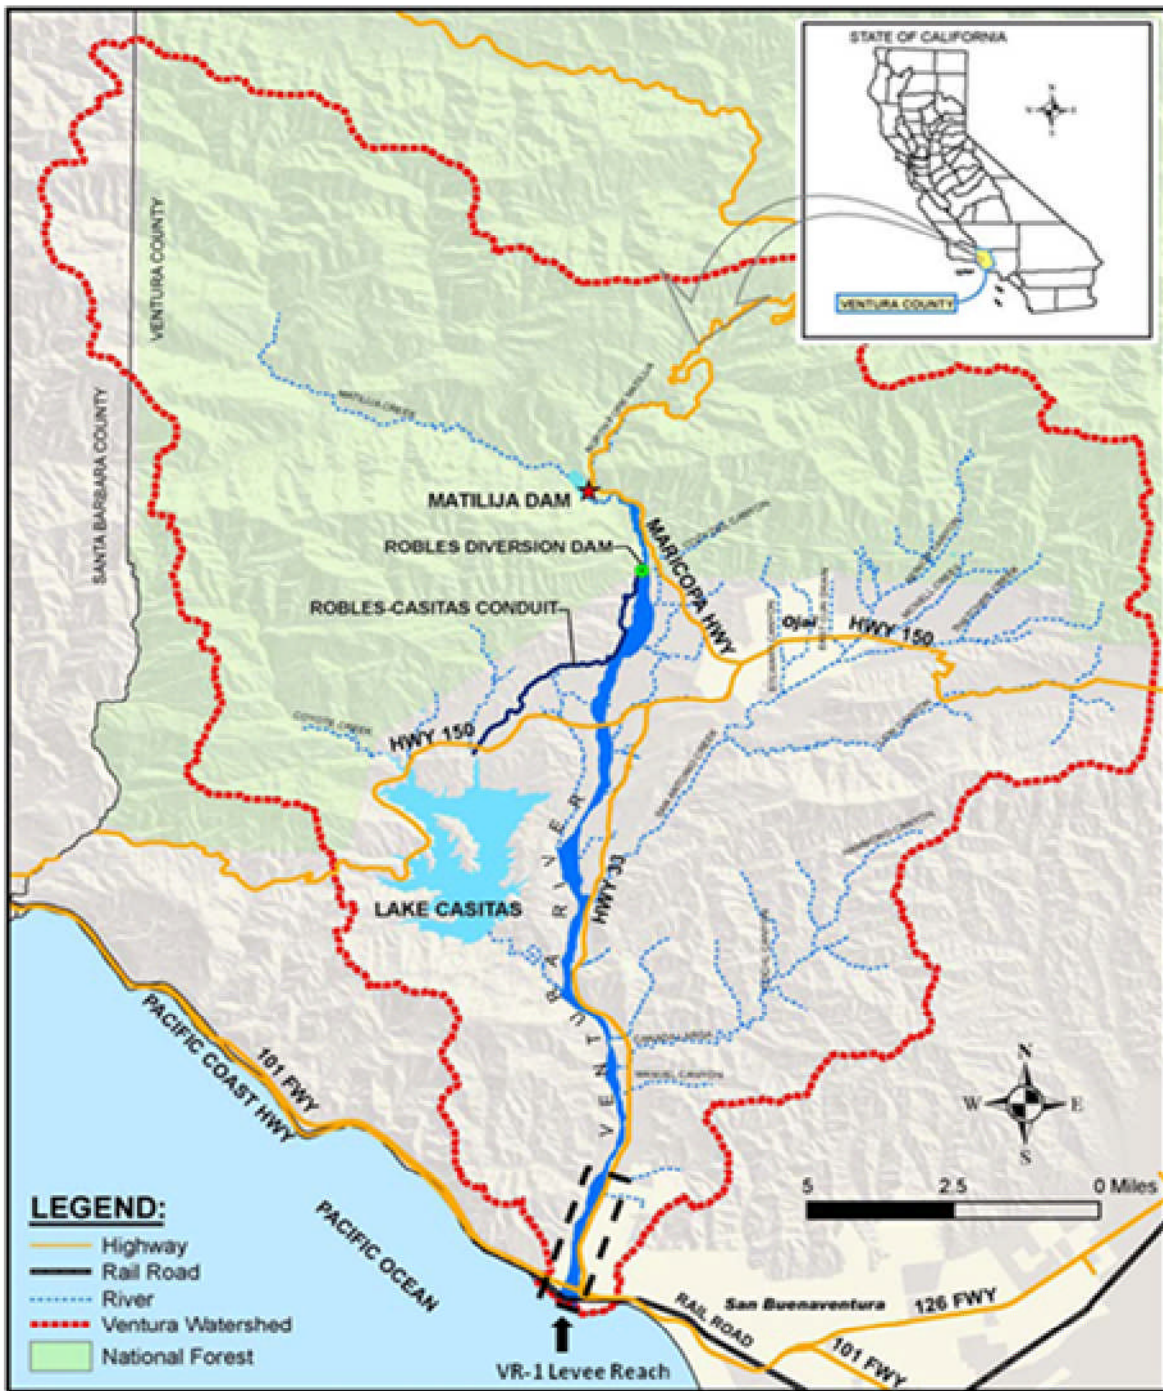
Figure 1: Study Area is identified at the Bottom/Center. Source (Matilija Dam Feasibility Report, USACE)

- a. The Ventura River project was Authorized by Section 10 of the Flood Control Act of 1944; the Ventura River Levee was constructed between April 2 and December 21, 1948. The Ventura River Levee (VR-1) is located in the City of San Buenaventura in Ventura County, California (Figure 1). The levee system is located along the left side of the

Large manmade features affecting the watershed include the following dams and debris basins. Structures located throughout the watershed can be seen on Figures 1 and 3.

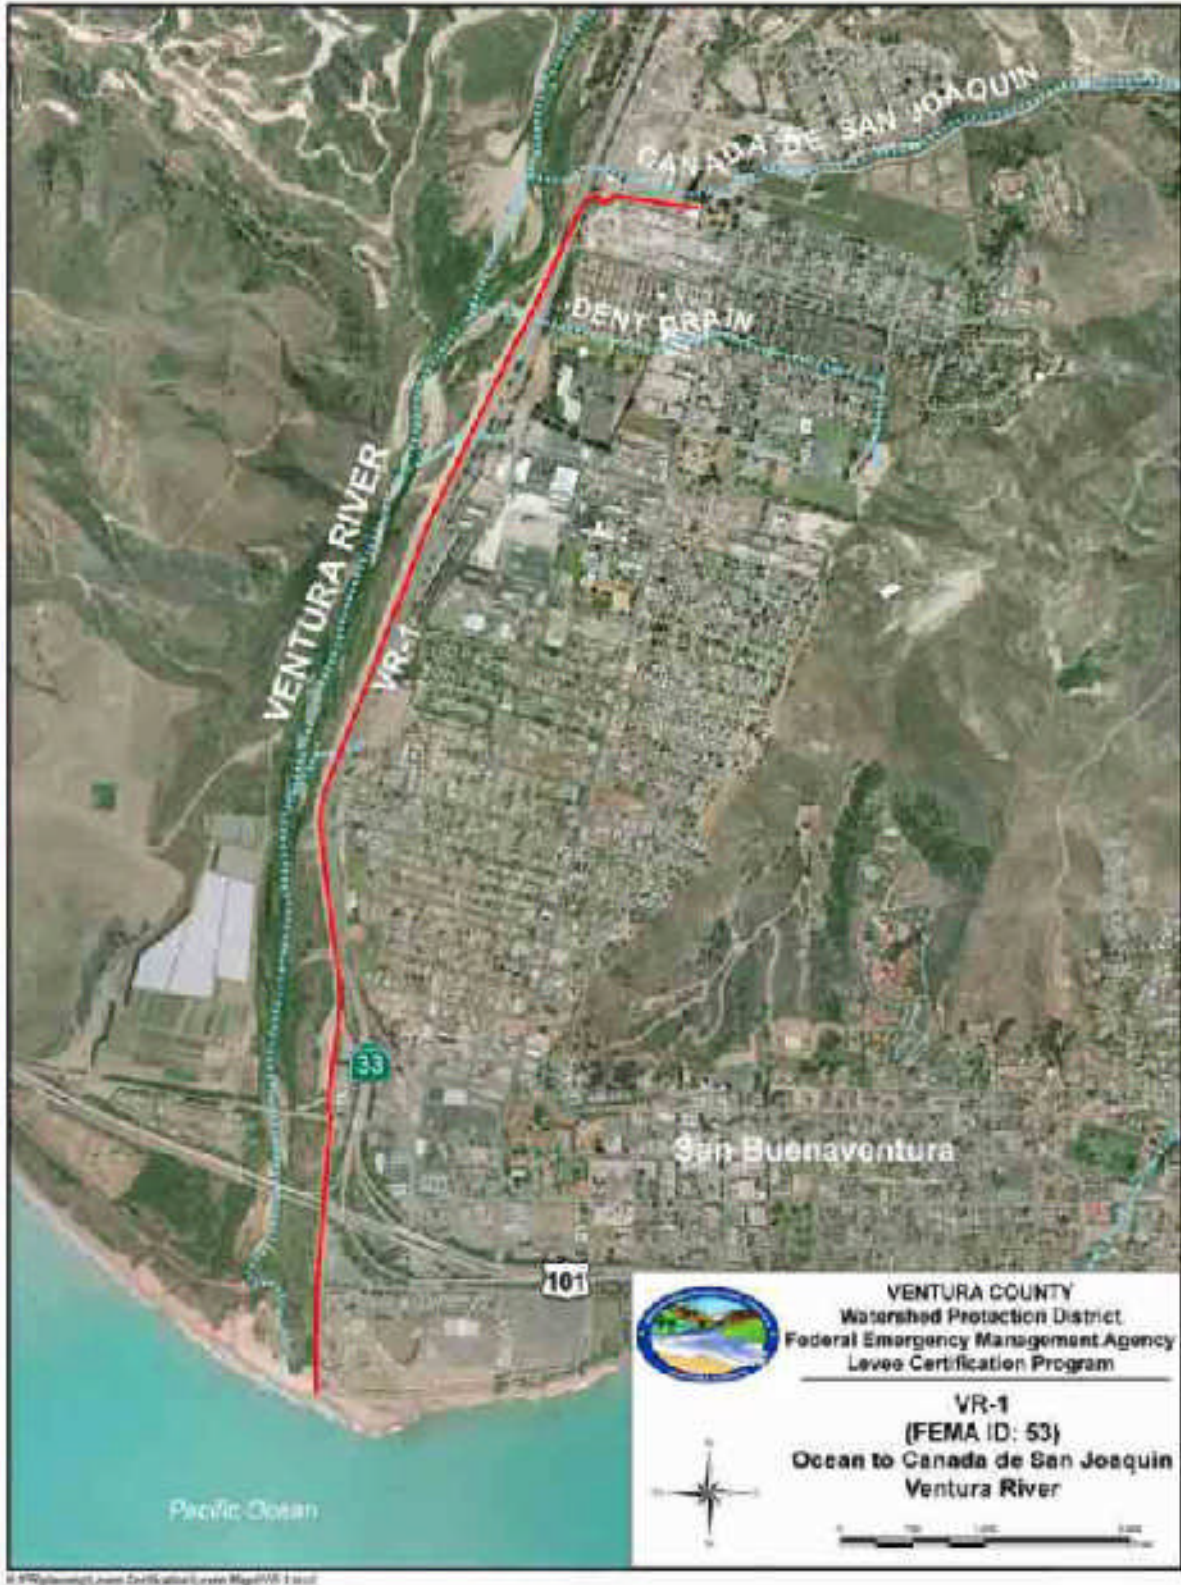
Figure 2: Location Map for Ventura River (VR-1) Levee

Ventura River (Figure 2) and consists of embankment levees, side drainage penetrations, and a stop-log structure in the levee at a bike trail crossing.
